Making waves

CAMPAIGN
FEBRUARY 2024

TABLE OF CONTENTS

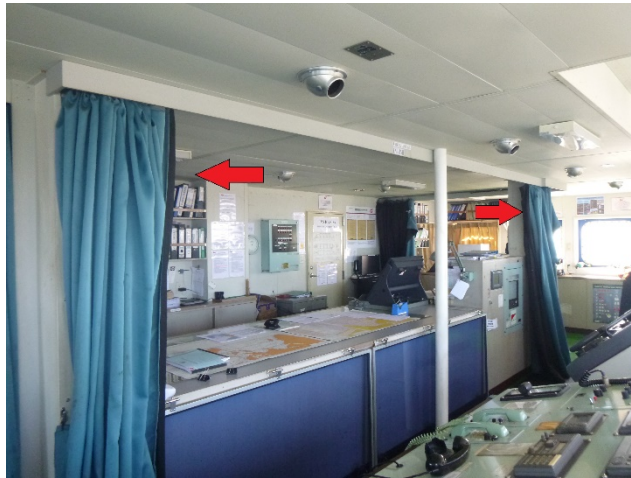
The bridge curtains for the chart table shall be removed as it will impair the keeping of effective lookout. The curtains shall be kept in the pilot cabin locker.

Curtains to remove (red arrow)

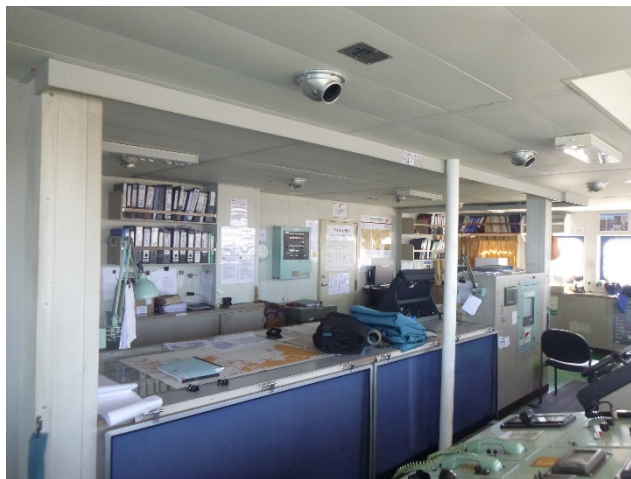
Curtains removed

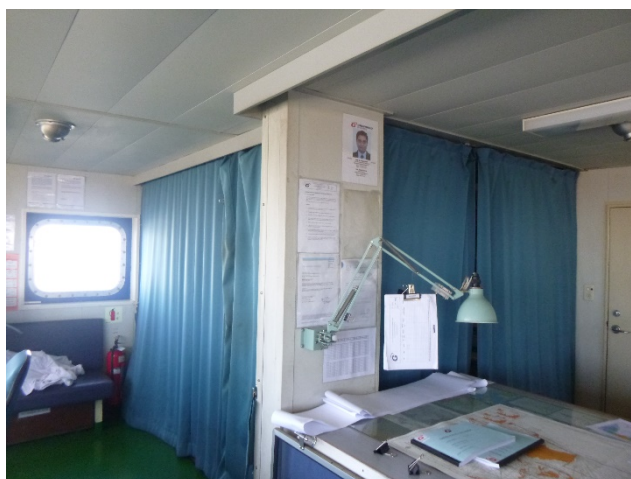
However, the GMDSSS equipment curtain shall be retained and used during hours of darkness.

Curtains during night (only for GMDSS Equipments)
