Making waves

IVSS AND TAMAR CAMPAIGN AUG 2025

Table of Contents

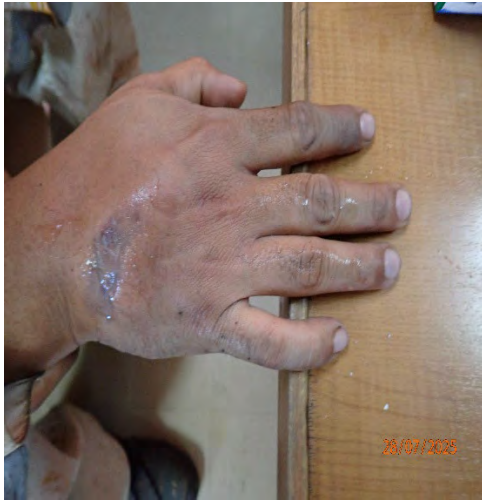
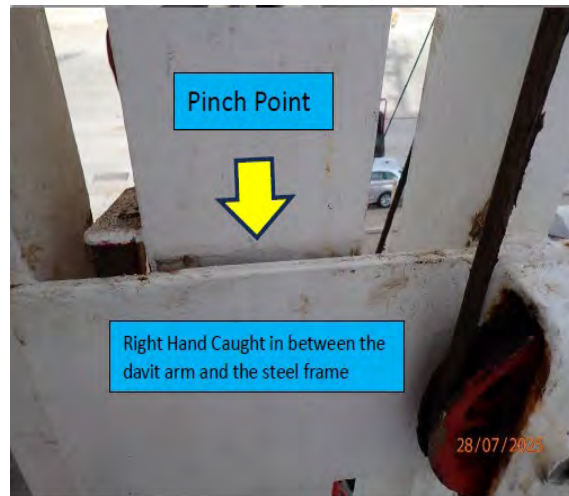
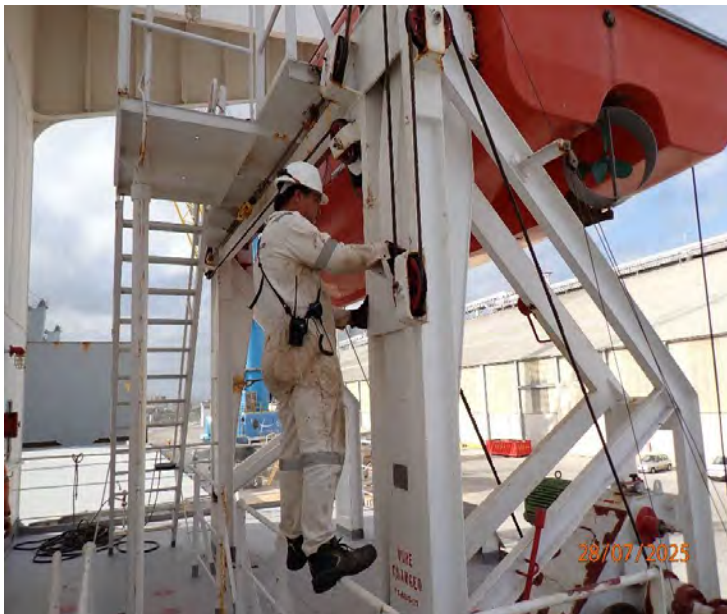
Third officer - Right hand Injury when hoisting star board lifeboat

While hoisting, it was observed that the starboard lifeboat could not be hoisted up using the remote control.

Upon inspection, it was found that the limit switch was stuck and not functioning properly.

Improper position for task - After the limit switch was freed, the hoisting was resumed by the technician however the third officer was still positioned near the davit arm where the limit switch was located and during this process the third officers right hand got caught between the davit arm and the steel frame near the limit switch (Pinch point)

Group	Root Cause	Remark
IC - Substandard Acts	05 Failure to Inform / Warn	After the limit switch was freed, the technician commenced hoisting the lifeboat without informing the third officer who was positioned near the davit (In the Line of fire). For inspecting the limit switch, the third officer was standing on the ship's inboard railings near the lifeboat davit. A secured portable ladder was not used to climb and inspect the limit switch.
IC - Substandard Acts	08 Improper Placement	If a proper ladder had been used for the task, the third officers' hands would have been on the ladder, and he could have avoided the pinch point.
IC - Substandard Acts	09 Improper Position for Task	The third officer was on top of the railing and was in an improper position (Line of fire) when the davit was hoisted.
RC PF-05 Lack of Competence	5.06 Lack of situational awareness / risk perception / risk awareness	The Technician, Chief officer and the third officer lacked situational awareness when the lifeboat was being hoisted.

RC SF-09 Inadequate Supervision/Coaching	9.03 Lack of supervision	The chief officer did not effectively supervise the job and did not establish adequate communication with the third officer when the davit was being hoisted.

Reenactment photos were taken showing the location of the crew and the pinch point where the incident occurred

The third officer was briefed to position himself properly, keep the body away from pinch points, maintain situational awareness, establish proper communications when doing any task and use a secured ladder with safety harness / fall arrestor when working at heights. A safety meeting was held onboard with all crew and the root causes of the incident were discussed.
