Company Circular no. 01 - 2026

MONTHLY SAFETY CAMPAIGNS - JAN 2026

1. ClassNK PSC Bulletins

Refer attached **ClassNK PSC Bulletin - 19** “Termination of sounding pipe for tanks containing fuel oil in engine room is not fitted with a small-diameter self-closing control cock.”,

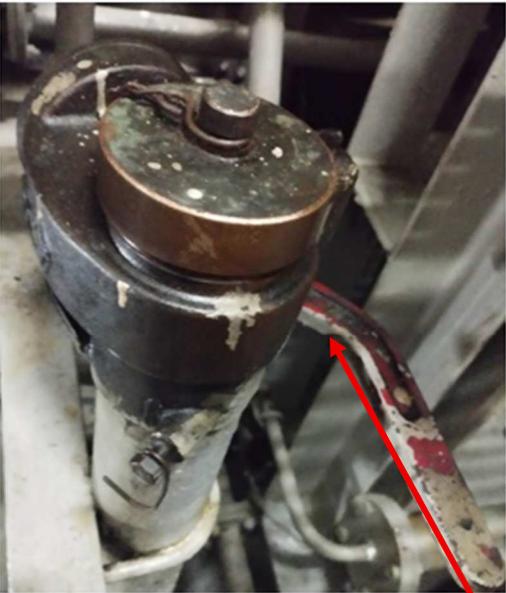
<p>Bilge Separated Oil Tank Sounding head, not fitted with overflow indicator</p>

1. Inform office if sounding pipe is not fitted with **small-diameter self-closing control cock** or **Safety check signal**
2. Ensure that **self-closing blanking device** operate smoothly and close the sounding pipe fully. It was often found that horizontal spring type not operating smoothly. Carry out maintenance if required.
3. **Small-diameter self-closing control cock** – these are normally push-button type, check and confirm these operate smoothly.
If vessel is provided with Safety Check Signal, ensure the glass is clean so that any oil leakage is visible before removing the cap from the sounding pipe.
4. Ensure all sounding pipes are fitted with cap.

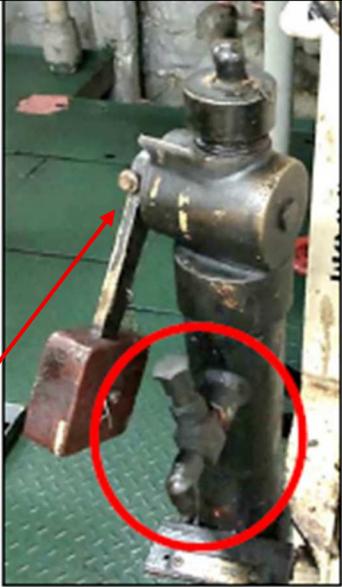
As per SOLAS requirement, sounding pipes of fuel oil tanks that terminate in the machinery space are to have a **small-diameter self-closing control cock** fitted at the top of the sounding pipe in addition to **self-closing blanking devices**.

<p>Example of small-diameter self-closing control cock</p>
<p>Self-closing blanking device</p>

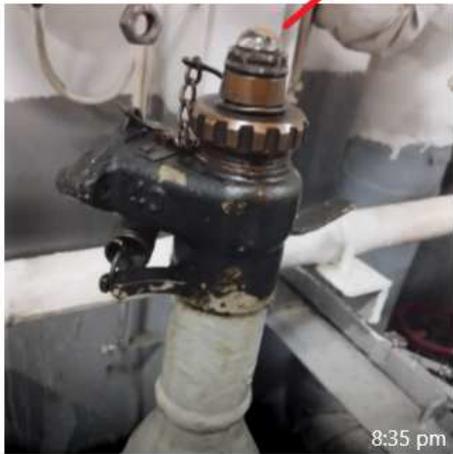
Above is also acceptable.

The Safety Check Signal is mounted on the top of the sounding pipe head. It has the same role as the “small-diameter self-closing control cocks” to confirm that that oil fuel is not present as described in the SOLAS regulation, and it is widely used. Inform third party inspector if a defect is pointed out stating that **self-closing control cock** is missing.

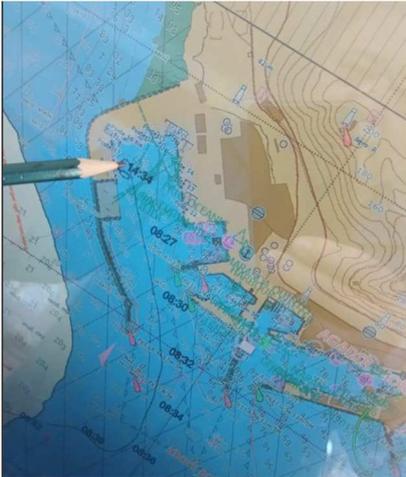
Port Agadir, Morocco

The vessel berthed port Agadir terminal No.17 at 1830LT/11Dec2025 for cargo discharge operation. The weather with about 1.5m swell experienced at berth from 0100LT/13Dec2025 onwards, vessel started rolling and surging due to improper shelter at the berth. Port's breakwater was unable to protect the vessel against the sea and swell. The vessel's movement at berth imposed excessive strain and damaged the ropes due to chafing resulting in failure of the ropes. By 0600LT/13 Dec 2025, 6 pcs mooring lines had parted at fore and aft stations, making it extremely difficult vessel to stay at berth. Vessel had to shift to anchorage until improvement of weather. Other vessels in port reported similar issue and were shifted to anchorage.

- Inform office immediately when such adverse weather is experienced at berth.
- Collect evidence of the ship's surging and rolling by taking video showing ship side movement against the berth and general condition of the sea around vessel
- Capture vessel movement at berth using ship's position in ECDIS
- Issue Note of protest to Port Authority and Charterer against unprotected berth
- Keep all concerned parties informed of the parting of the mooring lines.
- Refer SMS – 'HSE Procedure Manual/4.12 Safe Moorings/5.Mooring roles and responsibilities' for further guidance.

- Use mooring rope protector in way of fairleads, ensure sufficient protectors are on board.
- Check all fairleads/rollers, these should be smooth, smoothen if you find any sharp edge, you may also apply thin coat of grease around fairlead.

- Check and ensure that all rollers are turning
- Avoid ropes via sharp edges, especially spring ropes which may come in contact with the ship side, refer item 3 in the attached OJT 078. you may insert damage rope or canvass at such points

- Don't over tighten the mooring winch brakes, refer your last mooring winch brake rendering mark for tightening
- Keep equal tension on all ropes
- Where possible depending upon the bollard's location at berth, try to use longer length of the rope.

- Tend the mooring ropes regularly
- Monitor the weather forecast and keep the tide timings in the ship's office
- Brief crew on snap-back zones, donning of PPE, high tension on ropes due to surging/rolling

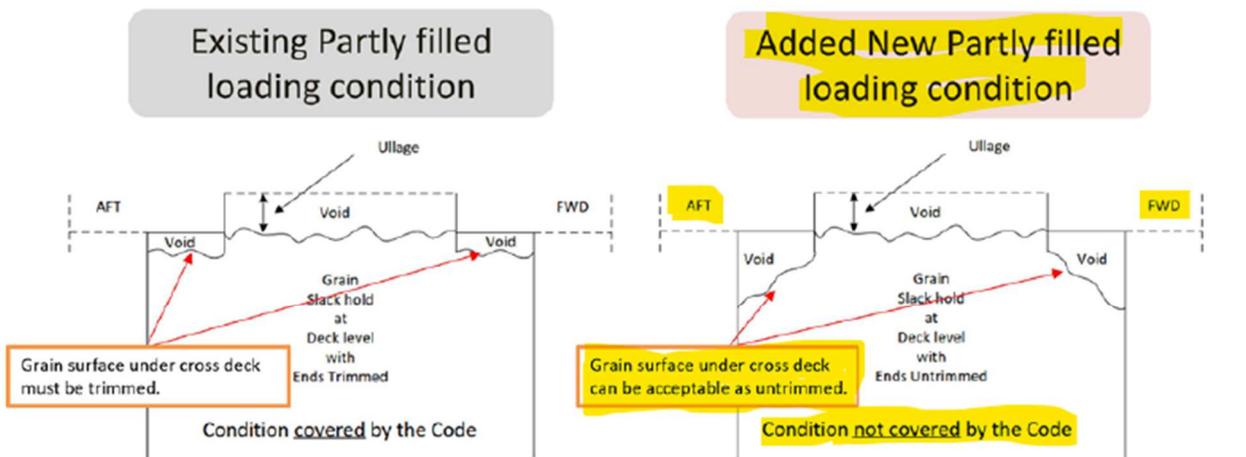
When grain cargo is **filled partly in way of hatch opening and the fwd and aft ends of the cargo hold remain untrimmed**, this condition is not covered in the existing grain stability booklet and loading computer calculation. As per our information, the grain loading terminals in Canada/USA require when grain filled partly in the hatch coaming with ends untrimmed to comply with this new requirement for which this new condition needs to be added in the grain stability booklet and adding corresponding feature in the loading computer for calculating the grain stability and heeling moment.

At present our ships don't comply with this requirement unless grain surface is trimmed under cross deck, refer left side below figure. Surface trimming requires engaging the shore labour which is not easily available in USA/Canada/Australia/European ports or cost is very expensive.

Refer below figure - right side condition is not included in the existing Grain Stability Booklet and Loading Computer calculation.

Figure 1 Existing partly filled condition(left) and Newly defined partly filled condition(right)

- When planning grain cargo stowage, **avoid the condition of partly filled grain cargo in way of the hatch coaming** as following, these conditions are there in the Grain Stability Booklet.
 - **Keep the hatch coaming 100% full of grain (Full Untrimmed), or**
 - **Keep level of the grain below the bottom of the hatch end beam, and the hold is then considered partly full. (load less cargo in the hold)**
- **Inform office if condition of partly filled grain cargo in way of hatch coaming is not avoidable.**
