## Company Circular no. 02 - 2026

### MONTHLY SAFETY CAMPAIGNS - FEB 2026

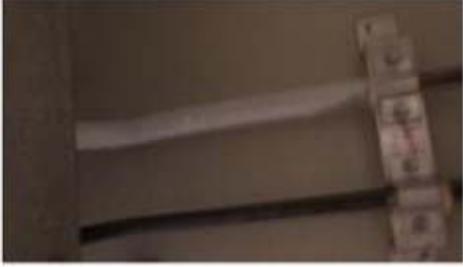
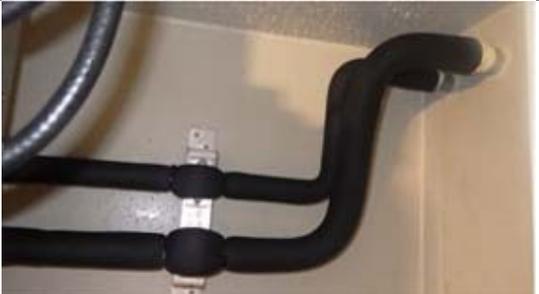
| <p>Before without lagging</p> | <p>After installing lagging</p> |

- The line found frosted by the PSC inspector was the gas return line after the evaporator which does not require lagging as per the maker and will automatically defrost during the set defrost cycle. There was no requirement from the maker to insert lagging on this line.
- Refer to the maker drawings and ensure that the refrigeration room pipelines are covered with appropriate lagging material (if applicable) to prevent icing of the pipeline.

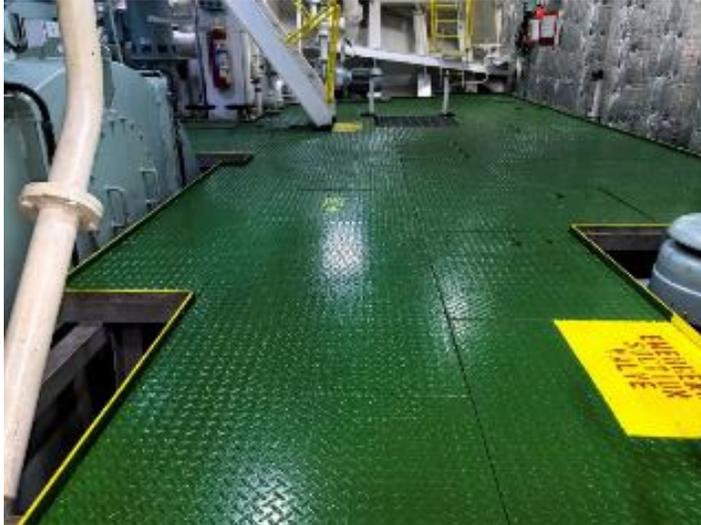
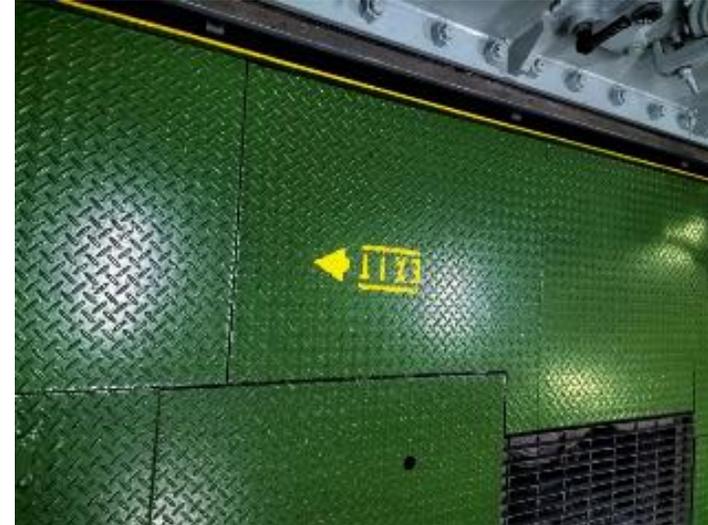
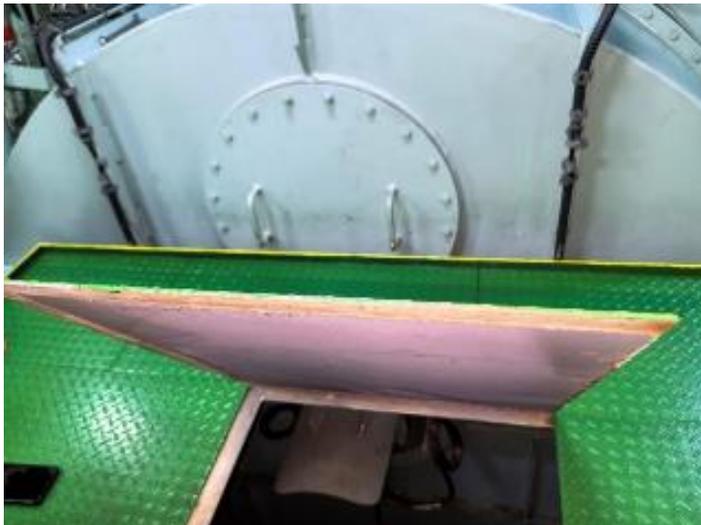
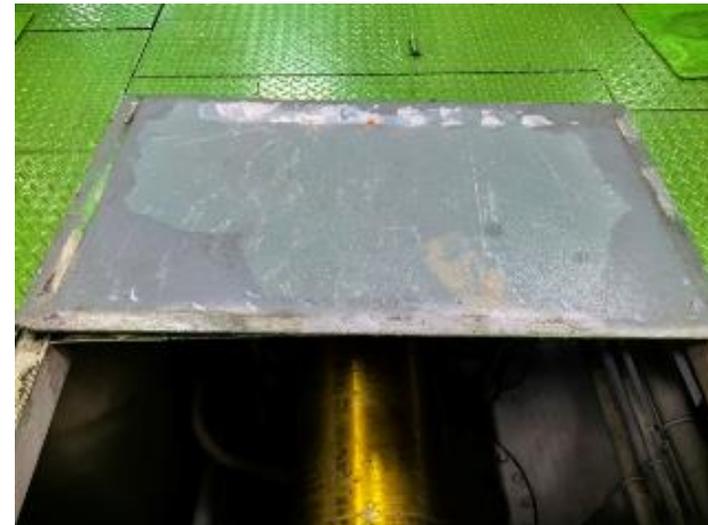
| Code | Description |
|---|--|
| | <p><b>DEFICIENCY</b> - Floor Plates in Engine room not secured or properly fastened. As per PSCO requirement, the floor plates in ER should be secured on the frame to avoid shifting in case of ship rolling &amp; pitching at sea / listing / flooding.</p> <p><b>Company comments:</b><br/>It was observed that many vessels were delivered from the shipyard and the floor plates were not secured.</p> <p><b>Root cause:</b></p> <ul style="list-style-type: none"><li>• <b>Inadequate design</b></li><li>• <b>Lack of situational awareness</b></li><li>• <b>Inadequate identification of hazards</b></li></ul> <p><b>Preventive Actions:</b><br/>The Engine room floor plates should be secured on the frame to avoid injury to the crew .<br/>The floor plates may shift due to<br/>a) heavy rolling and pitching at sea<br/>b) listing of ship during cargo operations in port<br/>c) flooding of engine room (water sloshing the bilge area due to rolling creating a hydraulic hammer and forcing the deck plates upwards)</p> <p>Floor plates to be secured as per attached guidelines where the details of tools and brass countersunk screws to be used for securing, are provided.</p> <p>Floor plates with hinge or the sections of floor plates that need to be removed for valve operation below the floor plate should not be secured permanently by screws.</p> <p>The valve number should be stencilled on the top of these plates for easy identification of the valve underneath the plate.</p> <p>Requisition for necessary tools and screws to be raised , if not on board . The PO raised shall be informed to the Ship Manager .</p> <p>The Chief Engineer to confirm present condition and send pictures of the floor plates to the Ship Manager using picture submission form.</p> <p><b>Target date for compliance: 30th July 2024</b></p> |

At delivery from shipyard, the floor plates are not secured.

As per PSCO requirement, the floor plates in ER should be secured on the frame to avoid shifting in case of ship rolling & pitching at sea / listing / flooding.

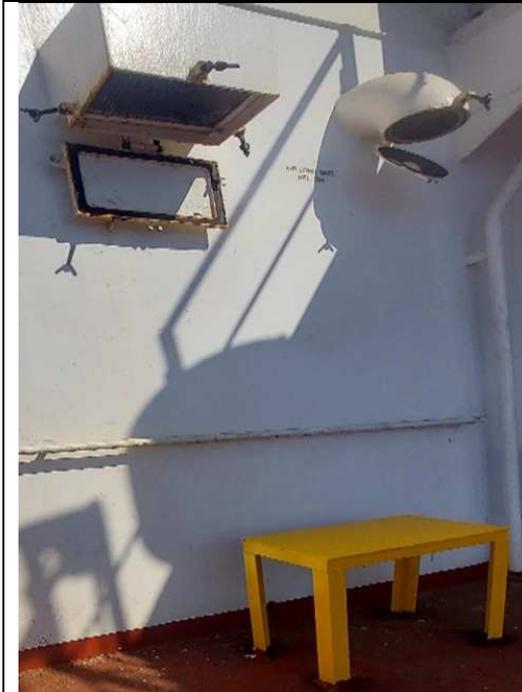
| S.No./ Code | Description |
|---|---|
| 4/18327 | <p><b>Some opening /closing devices of ventilation on outside decks are put in too high position that cannot be reached in safely because steps are missing.</b></p> |

Step installed on deck

- If the air vents around accommodation are not reachable safely from the deck level, please inform your Ship Manager/Superintendent for installing the step below the air vent.

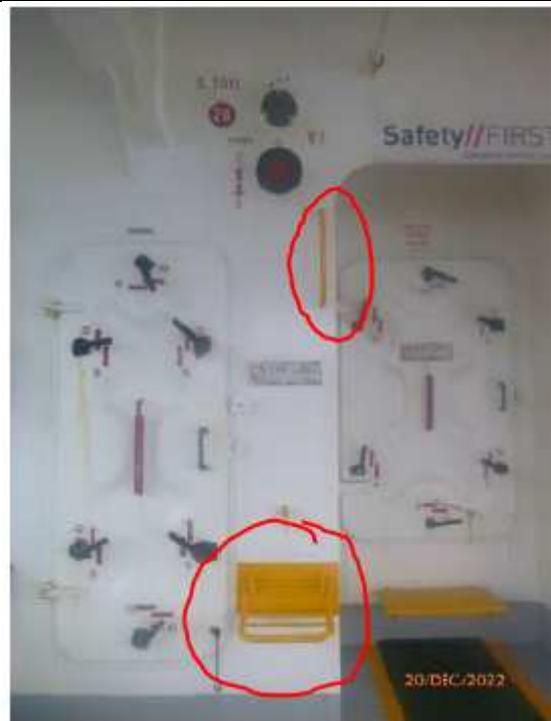
Step and hand hold installed on bulkhead

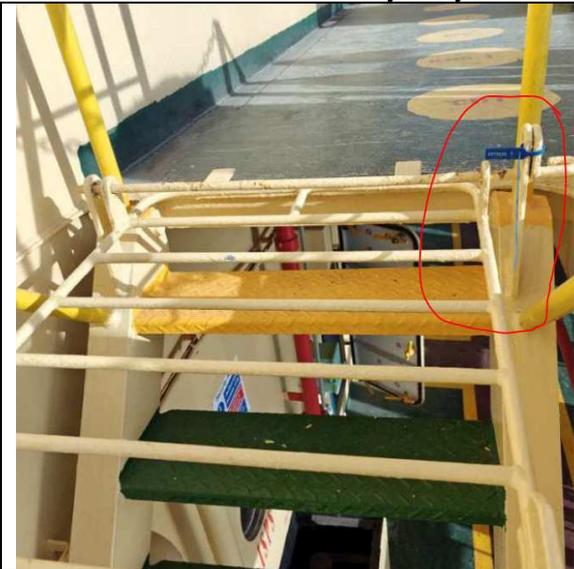
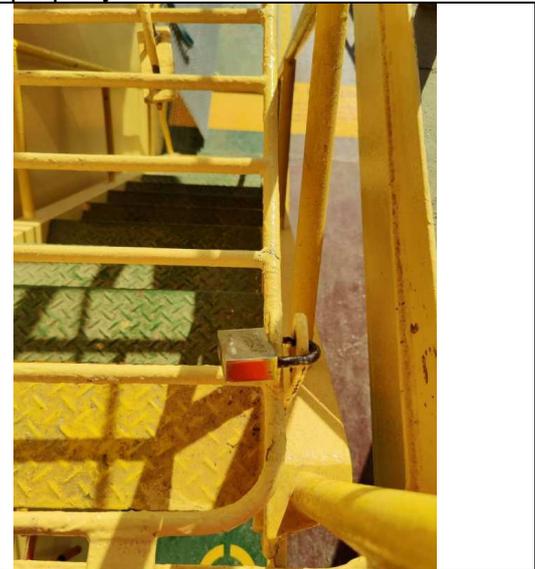
| S.No./ Code | Description |
|---|---|
| 1/ 16101 | <p><b>One port side, a padlock has been found used to close a gate for security purposes along with a means of escape.</b></p> <p><b>Comments:</b></p> <ul style="list-style-type: none"> <li>The plastic security seal is to be preferred for locking the accommodation external ladders in place of a padlock in ports where there is a negligible security risk of theft, stowaways, contraband etc.</li> <li>The accommodation external ladders are to be padlocked in ports where there is a security risk of piracy, robbery, theft &amp; stowaway/contraband and during transit of high-risk areas.</li> <li><b>In port:</b> If external ladder is locked using a padlock, the key is to be kept at the gangway security desk and another key is to be kept in ship's office.</li> <li><b>At sea:</b> During high-risk transit area when external ladder is locked using padlock, the key is to be kept in wheelhouse and another key is to be kept in ship's office.</li> <li>All crew is to be made aware of the locations of the keys keeping in mind that safety of the crew overrides the security. Keys are to be properly marked for the location.</li> </ul> <div style="display: flex; justify-content: space-around;"> <div data-bbox="343 1272 917 1841"> </div> <div data-bbox="949 1272 1484 1841"> </div> </div> <div style="display: flex; justify-content: space-around; margin-top: 5px;"> <div data-bbox="343 1841 917 1877">Plastic seal in use</div> <div data-bbox="949 1841 1484 1877">Pad lock in use</div> </div> |

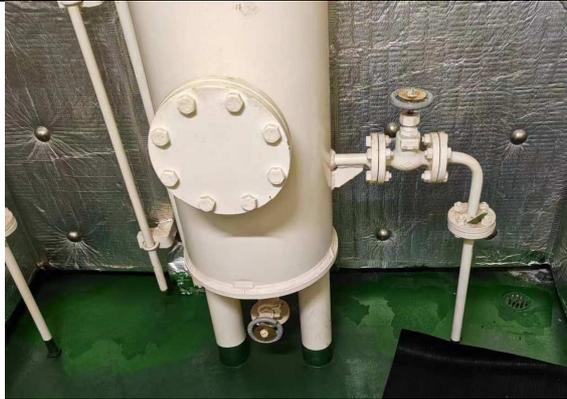
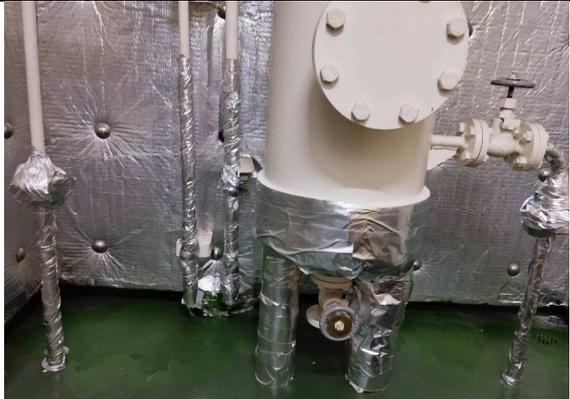
| S.No.<br>/<br>Code | Description |
|--|---|
| 1/<br>0710<br>1 | <p><b>Decks bulkheads and penetrations -<br/>Insulation materials for pipes from E/R to fire station on A-60 deck not extended 450mm.</b></p> <p><b>Comments:</b></p> <ul style="list-style-type: none"> <li>• The insulation was not installed on the two compressed air pipes passing through the A Class floor to the fire station.</li> <li>• All other pipes, ducts and penetrations passing through the A-Class protection deck are to be insulated up to 450 mm.</li> <li>• Check pipes penetrating the A-Class division are insulated until length of 450mm.</li> </ul> <div style="display: flex; justify-content: space-around;"> <div data-bbox="316 898 895 1301"> </div> <div data-bbox="895 898 1481 1301"> </div> </div> <div style="display: flex; justify-content: space-around; margin-top: 5px;"> <span data-bbox="328 1323 679 1357"><b>Before</b> - without insulation</span> <span data-bbox="911 1323 1198 1357"><b>After</b> - with insulation</span> </div> |

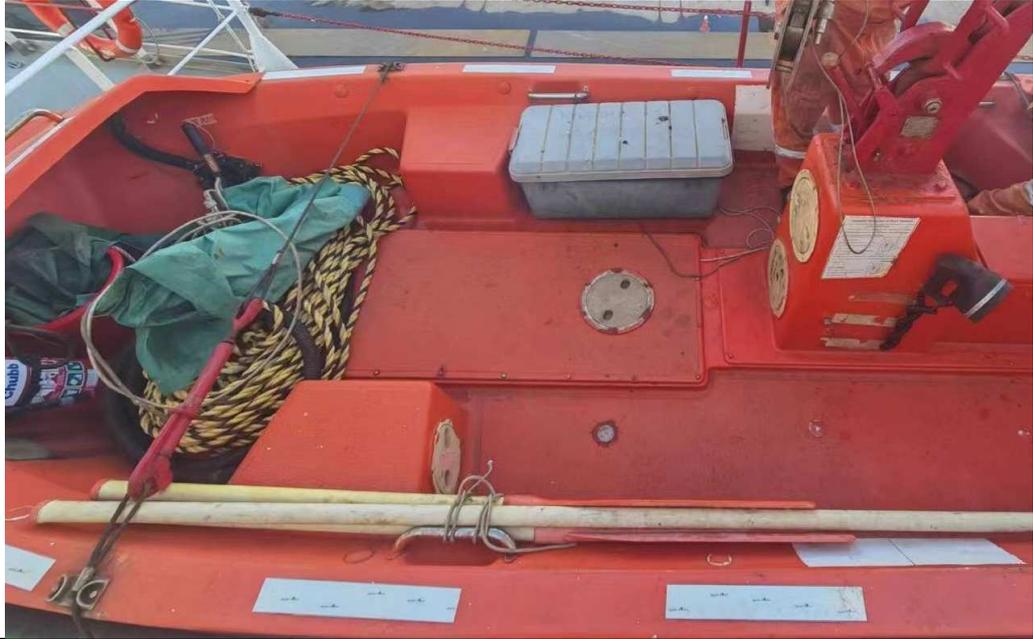
**Rescue boat - Seating position of R/B not marked.**

**Before – without marking the seat**

- If the rescue boat seats are not marked, please mark the seats in accordance with the maker's manual and send the photo to your Ship Manager/Technical Superintendent for verification.

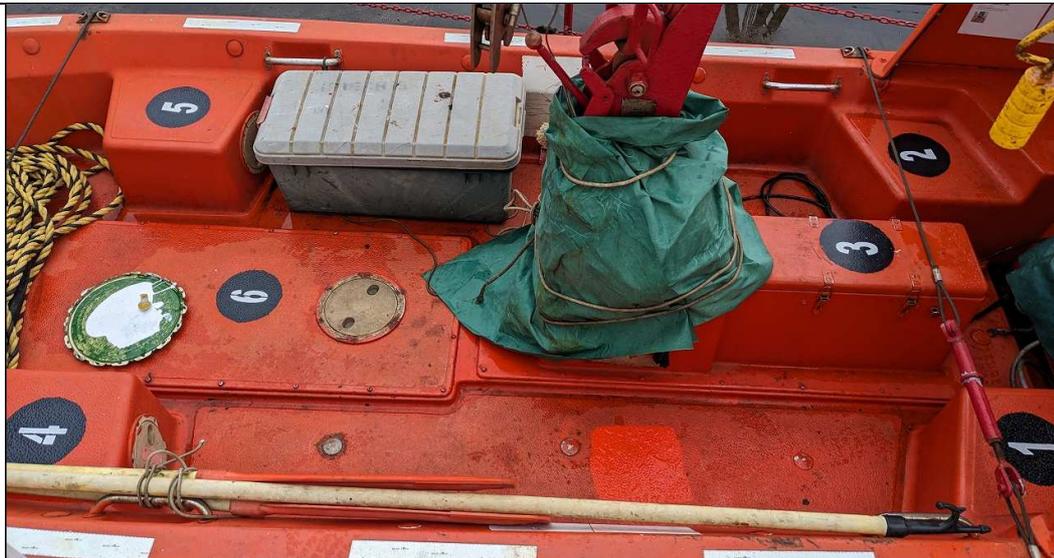
**After – seat marked**

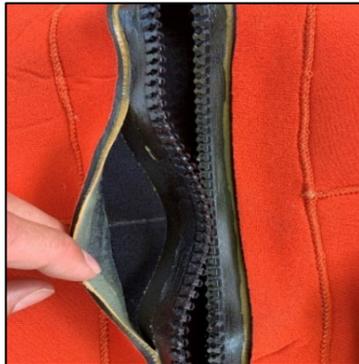
U.S. Coast Guard (USCG) inspectors frequently find immersion suit defects caused by adhesive failures between the main zipper and the suit body. These failures, illustrated in Figures 1 and 2, compromise watertight integrity and pose serious survival risks from water ingress. Contributing factors to the defects include improper maintenance (e.g., the use of non-approved petroleum-based lubricants or scented powders), improper storage, and neglecting to conduct periodic pressure testing. Seam and closure deterioration may not always be detectable during routine visual inspections. Adhering to USCG regulations, manufacturer instructions, International Maritime Organization (IMO) regulations and guidance, and performing regular inspections and testing are essential to ensuring immersion suit reliability.

*Figure 1: Zipper failure due to glue separation.*

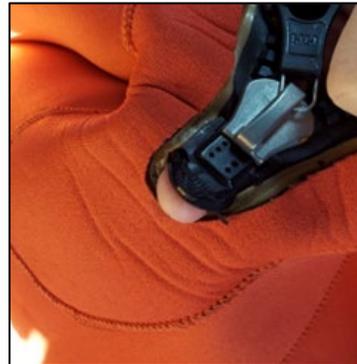
*Figure 1: Bottom of zipper failure due to glue separation.*
