Company Circular no. 03 - 2026
MONTHLY SAFETY CAMPAIGNS - MAR 2026

Dear Captain/CE

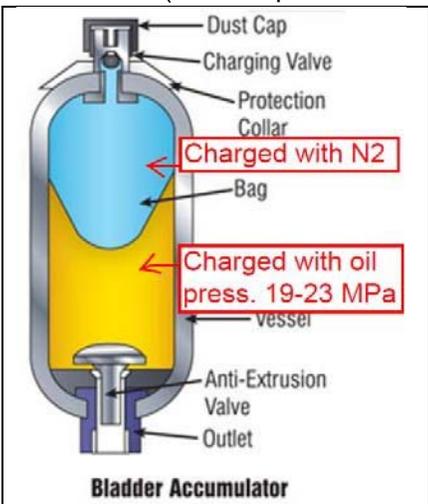
| Code | Description |
|---|--|
| 11113 | <p>Rescue boat unable to be launched using accumulator.</p> <p>Comments:</p> <ul style="list-style-type: none"> • AMSA inspector instructed the crew to swing the rescue boat davit by means of accumulator. The davit only moved to about 30 degrees and the pressure from the accumulator dropped down to zero. The investigations revealed that there was no nitrogen gas in the cylinder as it ruptured the internal bladder. • New accumulator was ordered and installed in place. • Test rescue boat davit operation on all modes – electric/accumulator/manual handle during monthly drill and revert with the result to your Ship Manager. Ensure all three modes operating instructions are displayed and crew is trained to operate davit by all three modes. • Ensure accumulator pressure is maintained as per the manufacturer’s manual. Check maker’s manual of your vessel in this regard. • As per the inspected ship maker’s manual: <ul style="list-style-type: none"> ➤ The charging pressure of accumulator is to be kept 8 MPa (80 bar) and accumulator is to be charged with nitrogen if pressure falls below 8 MPa. There is a bladder (an elastic bag) inside the cylindrical unit which is charged with nitrogen gas. ➤ The accumulator pressure is to be kept in the range of 19 – 23 MPa (190-230 bar). This pressure in the accumulator is maintained by automatically controlled electric pump. When accumulator pressure falls below 19 MPa, pump charges the pressure to 23 MPa with the hydraulic oil. • There is to be always one 230 Bar 50 litre Nitrogen bottle ready for use. Please order if it is not on board. There is a specific fitting with gauge that is needed to fill Nitrogen. Ships are to order this from their manual. Stow this item in the safety locker properly labelled/marked. • The accumulator shall be serviced/bladder renewed ashore at 5 yearly intervals during dry docking. <p>Accumulator (General picture for understanding, not ship specific)</p> <p>The diagram illustrates a bladder accumulator. It consists of a cylindrical vessel containing a blue bladder (labeled 'Bag') and yellow hydraulic oil. The bladder is charged with nitrogen gas (N2), while the vessel is charged with oil at a pressure of 19-23 MPa. Key components labeled include the Dust Cap, Charging Valve, Protection Collar, Anti-Extrusion Valve, and Outlet.</p> |

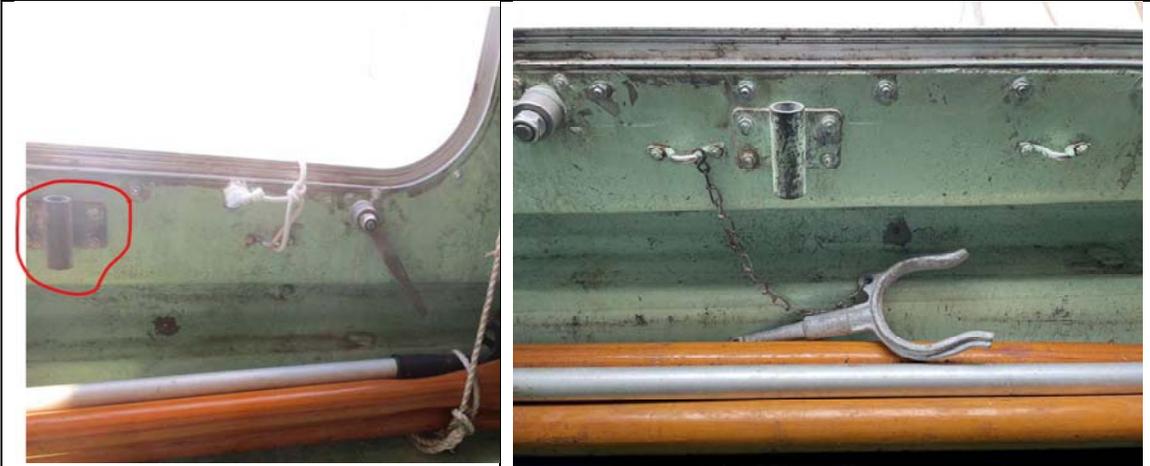
| Code | Description |
|---|--|
| 11101 | <p>Oar crutches of lifeboats (both side) - not attached to hull lifeboat by lanyards or chains.</p> <p>Comments:</p> <ul style="list-style-type: none">• The lifeboats were provided with the oar crutches with chains attached to the boat hull. The ship staff had disconnected the oar crutches and chains as it was creating an obstruction for the crew entering through the lifeboat door and had safely kept them inside the lifeboat equipment locker.• The oar crutches of the lifeboats were immediately attached to the hull by chains.• LSA CODE 4.4.8.1, sufficient buoyant oars shall be provided to make headway in calm seas. Thole pins, crutches or equivalent arrangements shall be provided for each oar provided. Thole pins or crutches shall be attached to the boat by lanyards or chains;• Ensure that the lifeboat fittings are maintained as per the LSA code and not altered in any manner or removed from its location. Crutches are kept attached to the boat by lanyard or chain. <div data-bbox="313 1438 1463 1904"></div> |

| | During PSC inspection, crutches were disconnected and kept in the L/B equipment locker | Crutches are to be kept connected to boat by lanyard or chain as above |

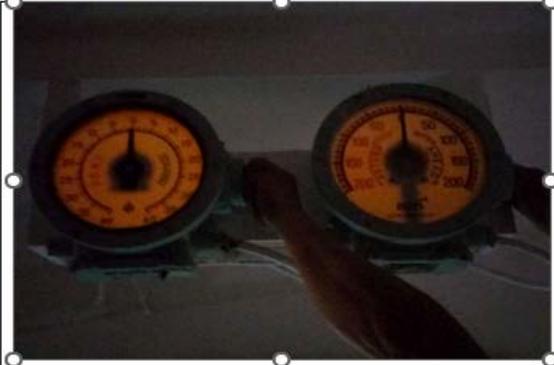
| Code | Description |
|---|---|
| 3.10 | <p>Is navigation equipment in good order? (V)</p> <p>Finding description The illumination for the bridge wing tachometers and rudder angle indicators was not functional at the time of inspection. Rectified during inspection. The dimmer controls on all of these units were seized.</p> <p>Root cause:</p> <ul style="list-style-type: none"> • Inadequate inspection and maintenance of dimmer controls • Lack of compliance with Company SMS requirements – The Company’s “NAVB22 - DAILY CHECKS” form clearly specifies that buzzer / lamp tests / dimmer lights on each equipment shall be tested which was not complied with in true spirit by the OOW <p>Preventive action:</p> <ul style="list-style-type: none"> • Ensure strict compliance with all the bridge checklists paying attention in detail to each item. • Ensure that each bridge equipment including indicators ,dimmers and associated controls are operational. Any defect identified shall be promptly reported through the defect list and rectified at the earliest opportunity. • The Master shall also make random checks on the operational status of the bridge equipment and its controls during daily bridge rounds and during navigational audit. <div style="display: flex; justify-content: space-around;"> <div data-bbox="288 1317 842 1682"> </div> <div data-bbox="847 1317 1409 1682"> </div> </div> <div style="display: flex; justify-content: space-around; margin-top: 5px;"> <div data-bbox="288 1720 842 1798"> <p>Starboard Rudder Angle Indicator and Propeller Shaft revolution Indicator DIMMER ON</p> </div> <div data-bbox="847 1720 1409 1798"> <p>Starboard Rudder Angle Indicator and Propeller Shaft revolution Indicator DIMMER OFF</p> </div> </div> |

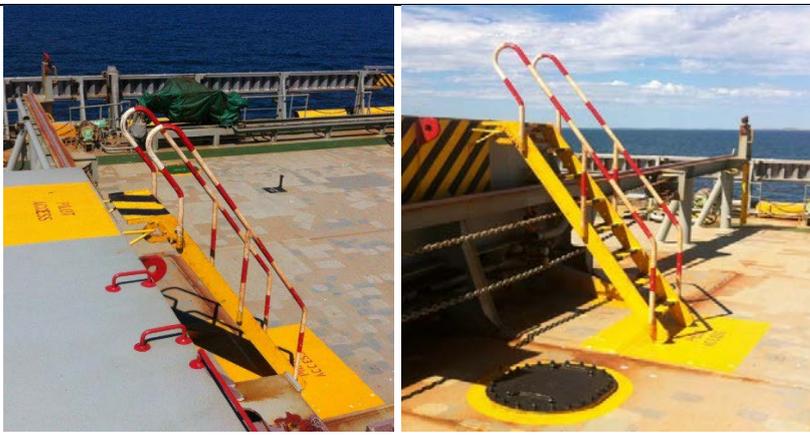
| 4.39 | <p>If the vessel is provided with a helicopter operating area, does the area comply with the requirements of ICS guidelines, and is there a safe access from the hatch cover to deck? (V)</p> <p>Findings: The helicopter operating area was said to be "winch only" but was not marked accordingly. The access ladder was not fitted with a front platform with operational load for two persons 150 kg. There was only one access / egress route provided for embarking / disembarking passengers.</p> <p>Root cause:</p> <ul style="list-style-type: none"> • Inadequate record keeping – The Class approved helicopter landing certificate was not filed onboard in BASSNET system as per Company requirements • Lack of familiarization – The Master was not aware that the vessel hatch No 5 was certified for helicopter landing • Lack of compliance with SMS – The SMS procedures regarding the access ladder requirements from hatch cover to deck was not complied with by the ship staff. <p>Preventive action:</p> <p>The Master shall ensure that all certificates are filed promptly in BASSNET once received from the Company. If any certificate is missing or if there are any doubts , the Company shall be consulted.</p> <p>The Master shall also ensure the following SMS requirements regarding helicopter operations:</p> <ul style="list-style-type: none"> • Strength confirmation letter from the classification society shall be available for the helicopter landing hatch (if hatch is certified for landing) • The access from hatch cover to deck should be a fixed height inclined ladder with fixed handrails and front platform with operational load for two persons (150 KG). The ladder must have “two persons up 150 kg” marked on it. The steps and platforms should be made of non-slip materials. (a set of steps that will at all times provide the user with three points of contact two hands, one foot / two feet, one hand) . The platform shall be painted as per below photos. |

- Master should ensure that, a minimum of two access/egress routes to and from the landing area is available to ensure that, in the event of an incident on the landing area, helicopter passengers and crew can escape upwind of the incident

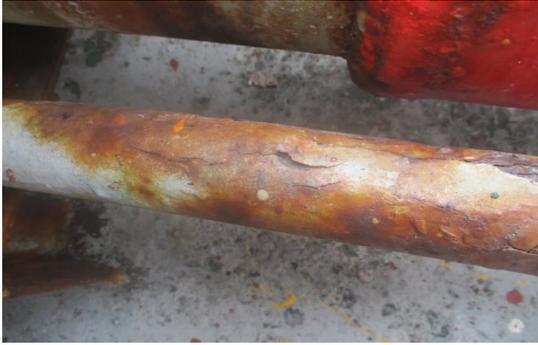
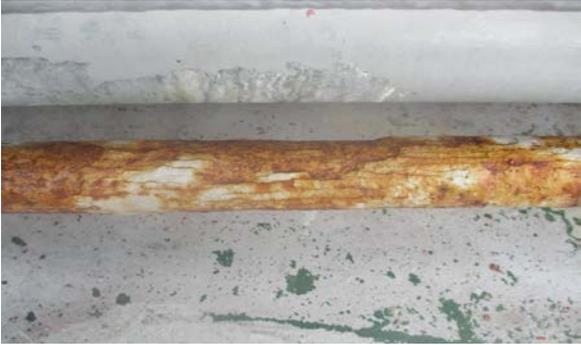
Before maintenance:

Findings: The pneumatic line on the starboard side upper deck was severely corroded over approximately 30% of its length. Wastage of approximately 25% was noted over extended sections

- Lack of maintenance
- Inadequate planning/preparation - Ship staff did not plan and complete the maintenance of the pneumatic line in a timely manner.

- The Chief officer shall pay attention in detail and look out for excessive corroded areas while taking routine rounds on deck .
- A maintenance plan shall be prepared by the Chief officer and the deck crew shall be instructed to carry out maintenance of these areas in a timely manner.
- Sufficient stock of paints shall be always kept on board.
- The ship Manager shall be informed if any materials are required for repair.

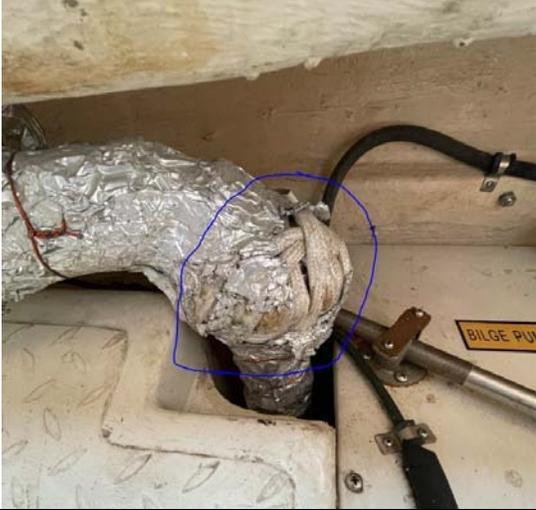
| S.No. / Code | Description |
|---|---|
| Before Inspection | After covered by foil |

| S.No. / Code | Description |
|---|---|
| 2/ 1110 1 | <p>The smoke exhaust pipe for free fall lifeboat lack of some fire isolation material.</p> <p>Comments:</p> <ul style="list-style-type: none"> • The insulation around the exhaust pipe was intact, it was the superficial covering/foil around the insulation material at small section of the smoke exhaust pipe, which was missing. • The superficial covering around insulation was immediately installed after pointing out of the deficiency by inspector. • Check and ensure that the smoke exhaust pipe in your lifeboat is covered with the insulation material for protecting persons from coming with hot parts accidentally. <p>Refer LSA Code 4.4.6.9 The lifeboat engine, transmission and engine accessories shall be enclosed in a fire-retardant casing or other suitable arrangements providing similar protection. Such arrangements shall also protect persons from coming into accidental contact with hot or moving parts and protect the engine from exposure to weather and sea.</p> <p>Photo of the insulation</p> |

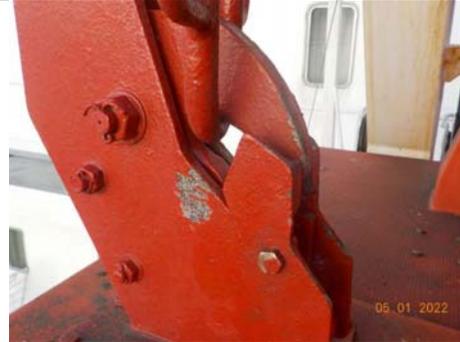
- Starboard side lifeboat link stoppers were recently painted due to which it was stuck. Movable parts should be not painted. Please ensure whenever a device is painted around a moving part, it is exercised to move free.

Stbd side L/B forward part link stopper stuck due to paint.

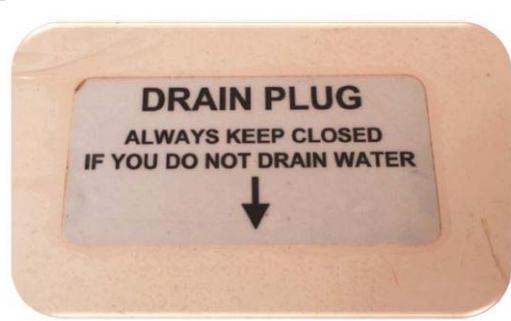
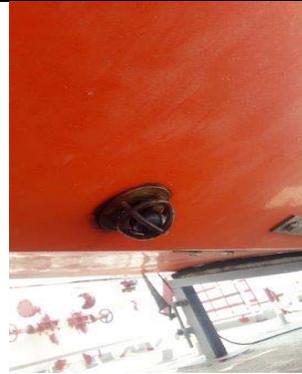
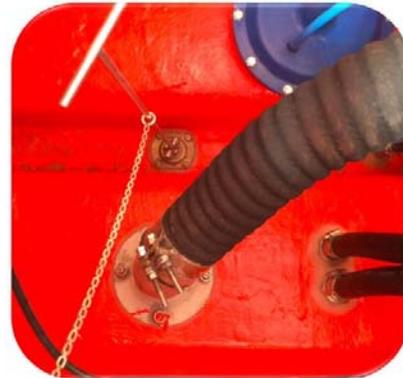
- Bottom plug for the stbd lifeboat was fitted in place but the chain connecting the plug to the boat was found missing during the inspection. Refer SOLAS regulation:

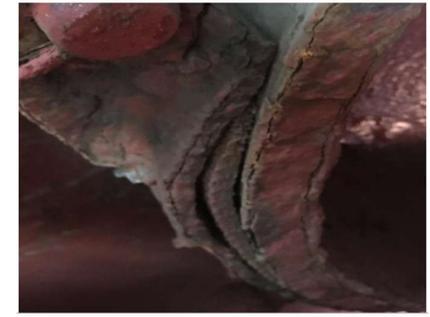
Poor Condition of Band Plate

- Inspect brake bands, linings, and drums for wear and contamination
- Verify brake band clearance against OEM limits
- Conduct brake rendering tests at defined intervals
- Align testing with OEM instructions and OCIMF guidance
- Ensure PMS addresses brake wear based on usage
- Inspect motors for condition affecting controlled paying/heaving
- Review the suitability of the winch design and controls for HMPE rope use
- Address equipment and operational limitations in MSMP / LMP
- Record pre-arrival functional checks and adjustments

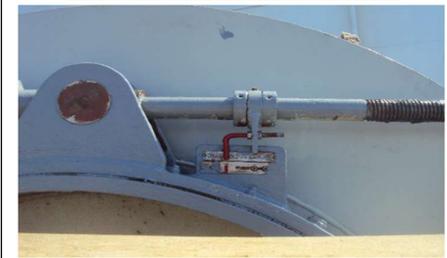
Correct Brake Mark
