Company Circular no. 11 - 2025

MONTHLY SAFETY CAMPAIGNS - OCT. 2025

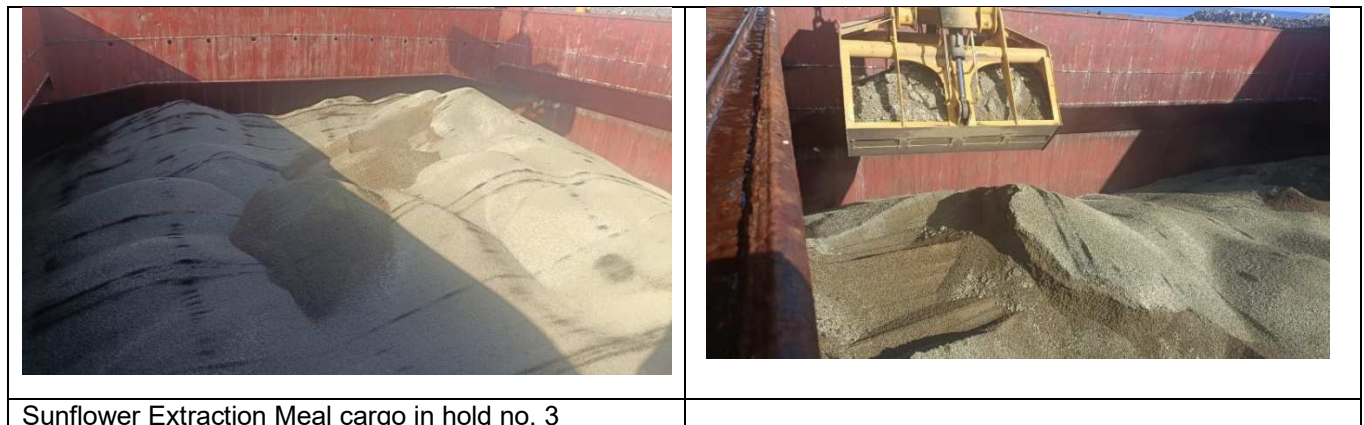
Vessel had loaded the Sunflower Extraction Meal cargo in Constanza, Romania for discharge in Port Reunion. The cargo damage to the top layer approximately 4–5 cm deep was observed in cargo hold no.3 at discharge port upon opening the cargo hold, refer below photographs. P&I Club surveyor boarded the vessel for assessing the damage to cargo.

It is very likely that the load port air (27 deg. C) inside the cargo hold condensed during transit of the Cape of Good Hope (air temperature 15 deg. C) due to cooling down of the hatch covers and coaming, and condensation on the underside of the hatch cover in the cargo hold no.3 led to droplets falling onto the cargo, resulting in the surface damage to the top layer of the cargo.

- The cargo hold no.3 should have been ventilated during transit when air temperature was at least 3 deg. C below that of the cargo temperature (temperature taken at the load port). There was no restriction on ventilation by charterer/fumigation etc.
- Keep daily record of the cargo temperature taken during loading.
- Maintain proper daily record of the temperatures, action taken using SMS Form – Cargo Temperature / Ventilation Log
- All deck officers to familiarize with the Chapter 12.1 Cargo Ventilation/Dry Cargo Manual
- Don't hesitate to contact office for any clarification

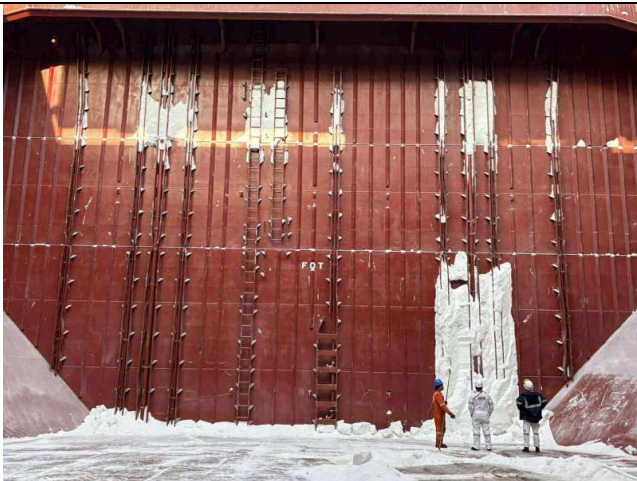
During discharging of Urea at 2nd disport, the stevedores noticed compacted cargo on the aft bulkhead of the cargo hold no.5, the agent and crew including Master was informed, initially the cause of the cargo damage could not be established but wet damage was suspected. Approximately 0.5mt of Urea was hardened due to this incident. After discharge of the cargo and departing port, crew carried out inspection of manholes, airpipe by pressing up the WBT No.5 P/S. The water was found leaking from the air vent pipe at the location where cargo had hardened. Air vent pipe was leaking from the air vent pipe sleeve which was repaired permanently.

Hardened cargo at cargo hold no. 5

- Master reported cargo damage to office on 2nd day, any damage to cargo **is to be immediately reported to office when sighted**. So that immediate action can be taken by arranging the P&I Club representative's attendance on board the vessel to protect the owner's interests to avoid heavy claims by charterer/receiver/shipper.
- Inspect all air vent/sounding pipes which pass through the cargo hold for any crack or corrosion. Ensure these are maintained in good condition without excessive corrosion.
- Test/check all ballast/fuel air vent pipes and sounding pipes exposed inside the cargo holds for any leakage.
- Inspect the cargo holds internals and pipes for any stevedore discharge.
- Ensure no water leakage from the WBTs manhole, check gasket before boxing the manhole cover.

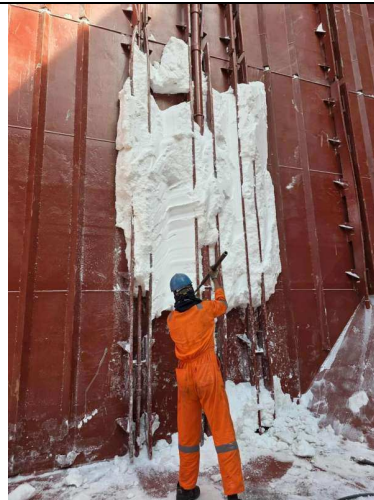
Hardened cargo at cargo hold no. 5 in way of airvent pipe WBT No. 5 (P)

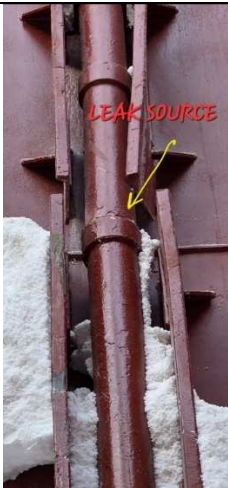
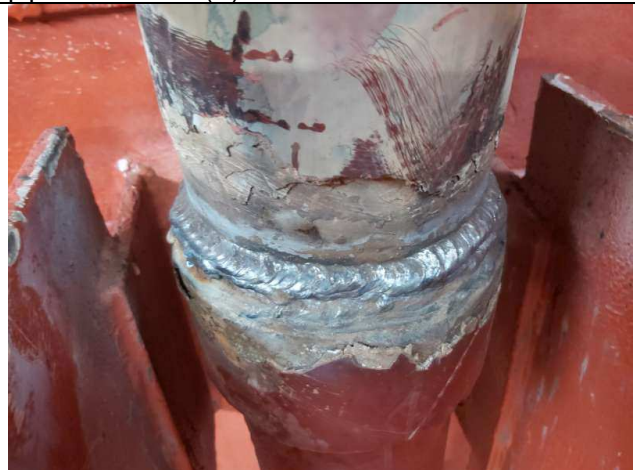
Water source was from broken welding seam at air vent pipe sleeve approx. 5 meters from the tank top	After repair

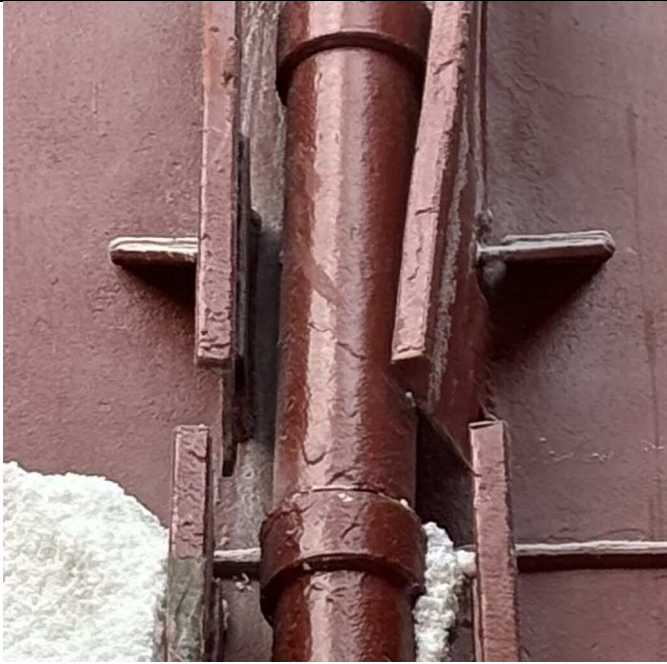
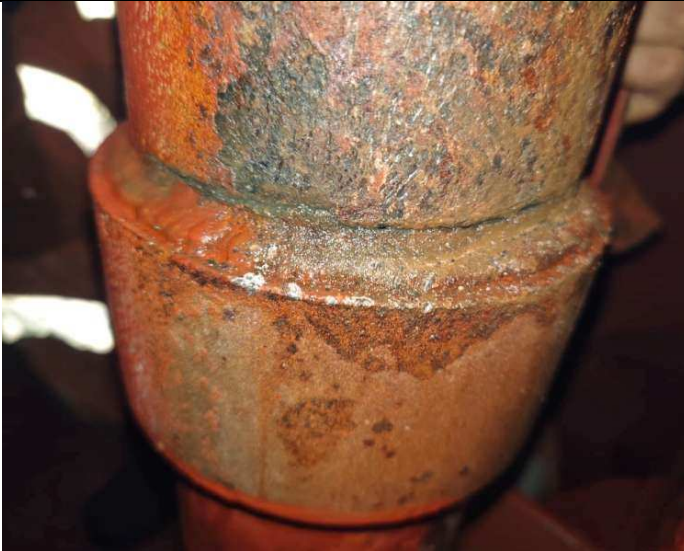
All WBTs airvent pipes were tested for water leakage, one more airvent pipe was found leaking in cargo hold no. 3.

Same air vent pipe was also found leaking again at different location before loading the next cargo. It was noticed that air vent pipe was in poor condition due to corrosion.

WBT No.3(S) vent pipe was found leaking from the pipe sleeves approximately 12 meters from the tank top, the stevedore damage went unnoticed.	WBT 5(S) air vent pipe was found leaking again at different location during cargo hold inspection before loading next cargo. Permanent repair was carried out before hold was passed.
