Management Review

2024

Brett McElligott, HSEQ Manager
Island View Shipping Services

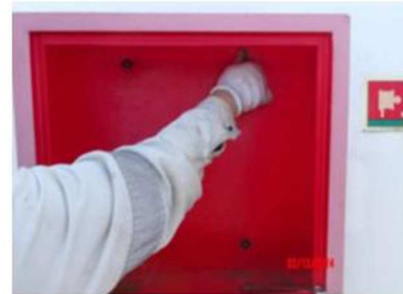
1. 07 - Fire safety - 07113 Fire pumps and its pipes. **Deficiency - Bridge wing stbd side fire hose punctured and leaking**

All fire hoses were inspected prior Arrival New Plymouth on 13 Nov.2024. While testing the fire hoses during the PSC inspection, the inspector observed that the stbd side fire hose was punctured and leaking at one location.

Upon investigation, it was observed that the hose box was mounted with a bolt protruding inside the hose box. The hose was tightly stowed in direct contact with the bolt (which was rusted and sharp) and due to ships vibration, the bolt had punctured the hose. Refer below photo.

In Office Done A fleet advisory will be sent and all vessels will be instructed to check for protruding objects in the hose box and take necessary actions like applying Denso tape so that the hose is stowed in a safe manner. Compliance shall be verified by the safety officer onboard. Compliance shall also be verified by Company staff during ship visits.
