Service Letter

SL05-454/HMH
August 2005

Tool for Lifting of Main Bearing Cap
Engine types: 60-98MC/MC-C/ME/ME-C
Action Code: IMMEDIATELY

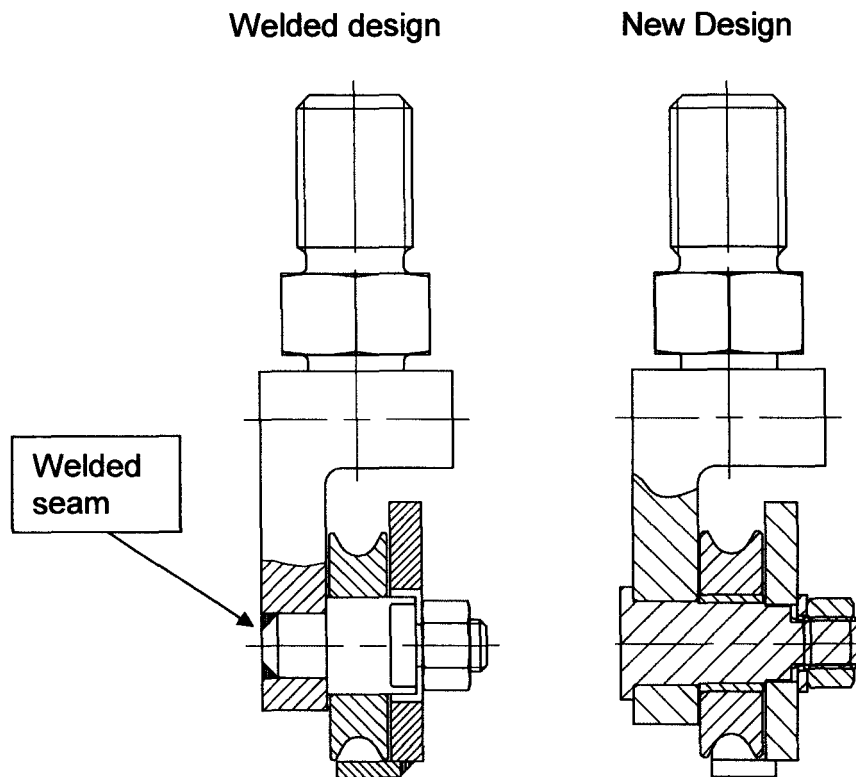
The accident happened during the overhaul of a main bearing on a 90-bore engine. A main bearing cap lifting pulley, which is fitted in the bottom of the crosshead guide shoe, broke, and the bearing cap dropped down and injured the leg of an engineer.

Please note that it is only necessary to make the modification if you have the “welded” version of the tool (see sketch below). If you have the new design with sleeve, further modification is not necessary.

The test result shows that the tool can be used on the 60 and 70-bore engines without any modification. However, to avoid any risk on the 80-bore engines, we recommend this tool to be modified as well (see encl. B of the enclosed SL). Therefore, please fill out and return the check-table and we will send you the instruction and spare parts to modify the tool.

Until the necessary modification of the tool has been made, the crew onboard the vessels must exercise extra caution when lifting the main bearing cap during a main bearing overhaul.
