Service Letter

SL07-474/JJP
March 2007

**Lifting Tool for Crosshead Bearing Cap
80-98MC/MC-C and ME/ME-C Engines**
Action Code: IMMEDIATELY

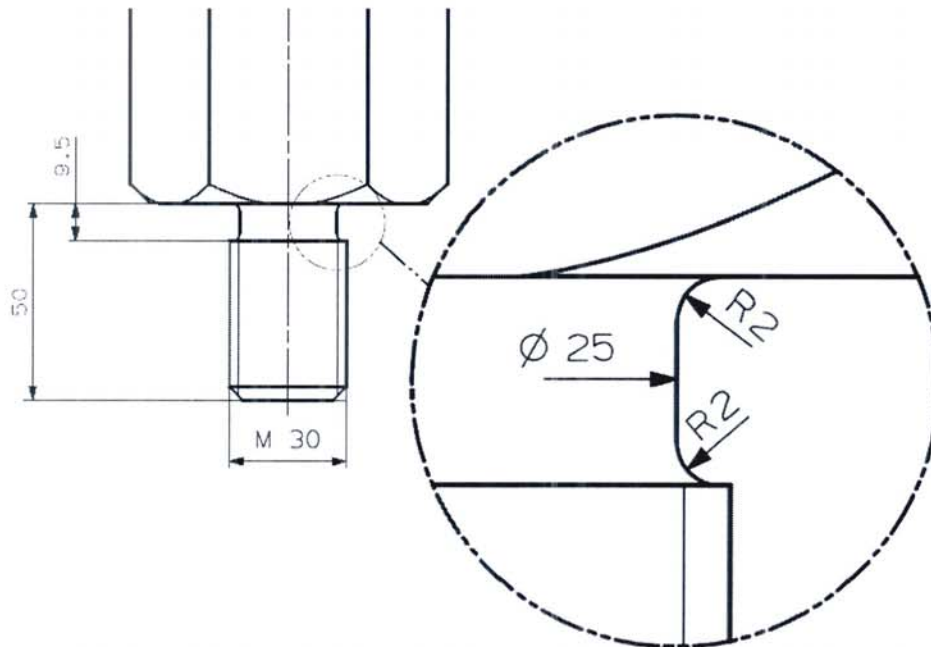
Fig. 1: Lifting tool for K98MC-C

The stud has not been made from adequate material and, equally important, it appears not to have been machined as specified. One important fillet was smaller than specified. Furthermore, the thread tap on the extension tool seems to have been pre-bent from an earlier lift.

We recommend engine crews to check the fillets on the lifting tools, see Fig 1.

If an insufficient fillet or signs of cracks, bending or other misuse is found, we strongly recommend to discard the extension stud and order a new one, either from the engine builder or from MAN Diesel A/S, PrimeServ in Copenhagen.

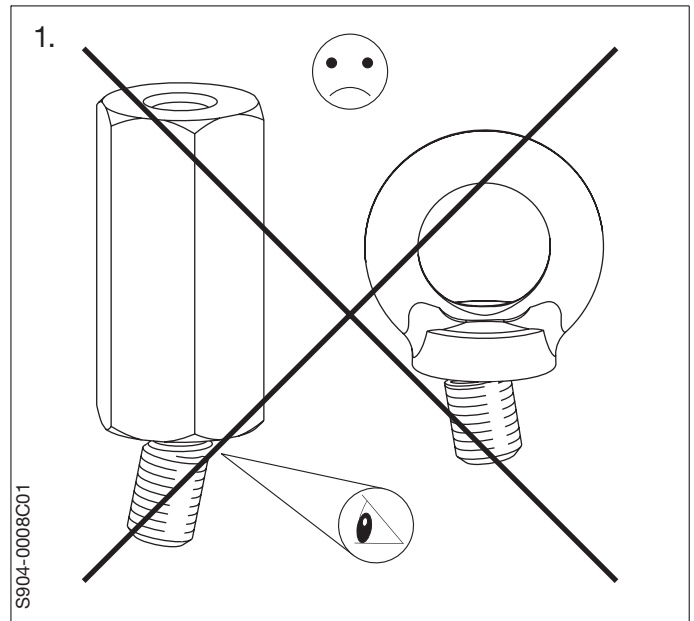
Extension studs or eyebolts which show signs of overload or misuse must NOT be used. Lifting components which shows signs of bended threads or cracks must be discarded and new parts must be ordered.

1. Inspect the lifting tools:
Check that all necessary lifting tools are in proper condition.
