Service Letter

SL07-481/OLS
June 2007

**Lubricating Oil Filter
with Notch Wire Element**
Action Code: At First Opportunity

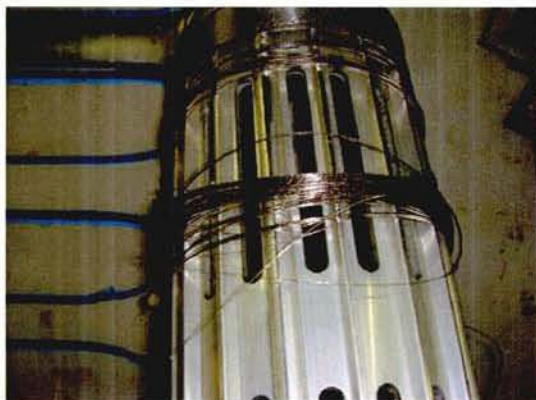
During the last few months, MAN Diesel in Copenhagen has received reports of several cases where serious damage to crankshaft bearings and journals has been caused by broken and wrapped-off wire from lubricating oil filters of the Notch Wire Element type.

Notch wire wrapped off the element

In most of the reported cases, the breakdown of the filter occurred shortly after maintenance or manual cleaning of the filter.

- Inspect filter elements for damage, and make sure that the filter manufacturer's maintenance and safety instructions are observed.

- Inspect filters according to the filter manufacturer's inspection intervals.
- Daily observe and record the number of flushing times if applicable.
- Daily observe and record the differential pressure across the filter.
The filter should be inspected if a sudden drop of the differential pressure is recorded. However, it should be noted that, depending on filter type, number of elements, etc., a wire may also break without causing a drop in the differential pressure.
- The Notch Wire Element filter should be inspected if the filter in the back flushing line (if applied) is to be changed more frequently than normal.

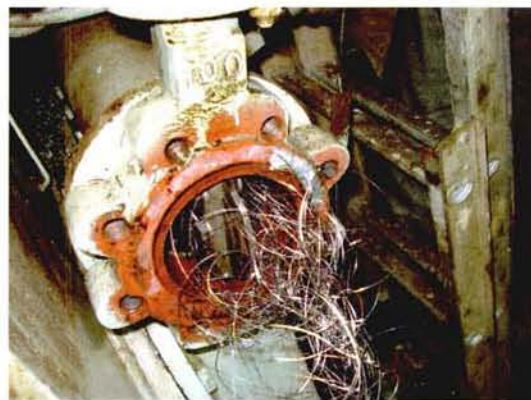
Wrapped-off notch wire in engine lube oil pipe system
