Service Letter

SL07-483/HRR  
August 2007

**Condition-based Piston Overhaul  
MC/MC-C and ME/ME-C type engines  
Container Vessels, Bulk Carriers and  
vessels with similar trade pattern  
Action Code: WHEN CONVENIENT**

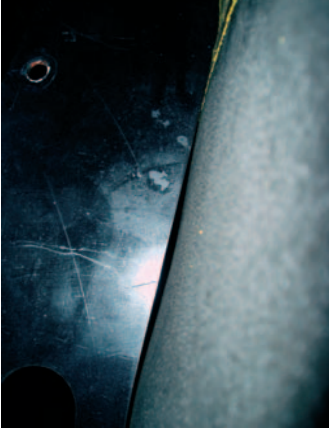
- Before piston burning reaches the max. allowed

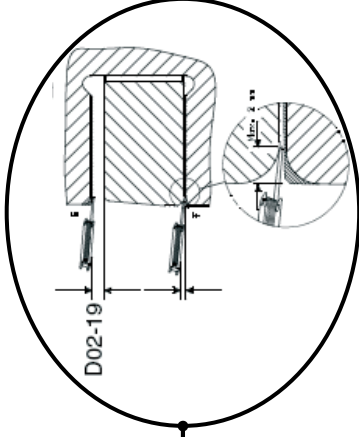
- Before ring groove clearance reaches the max. allowed

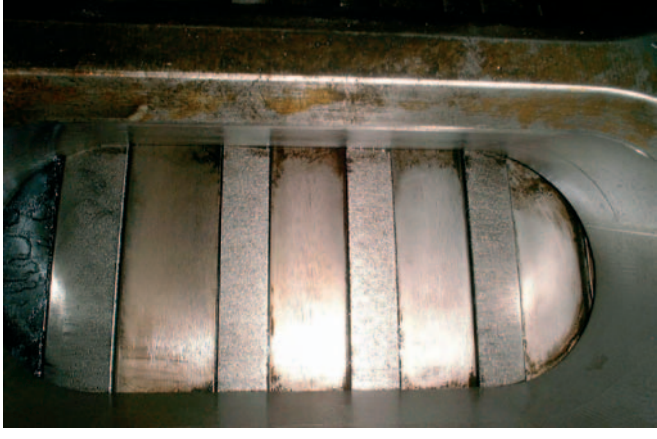
- In case of macro-seizures on the rings (scuffing)

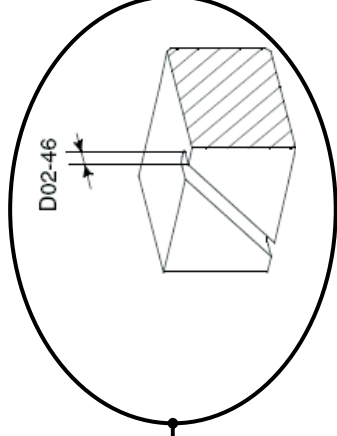
- When the wear on the top piston ring has reduced the CL-grooves to the minimum

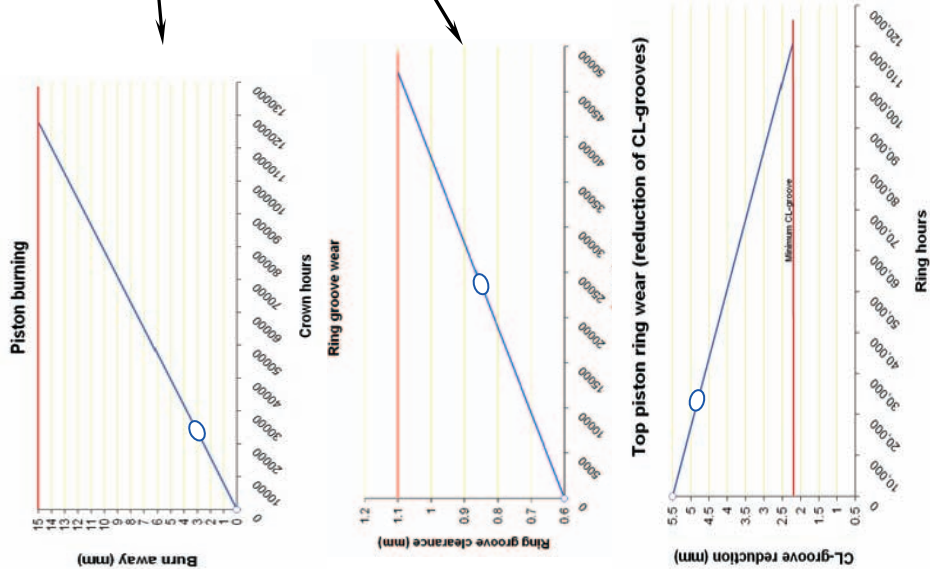
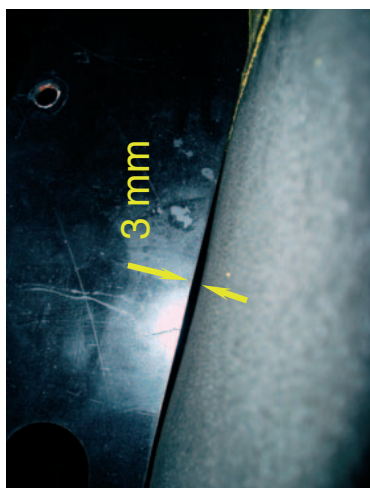
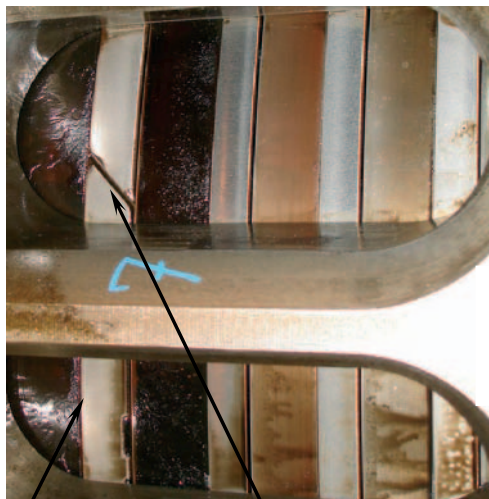
Fig 2

## How to judge, example from a 10K98MC-C with 23,500 running hours without overhaul

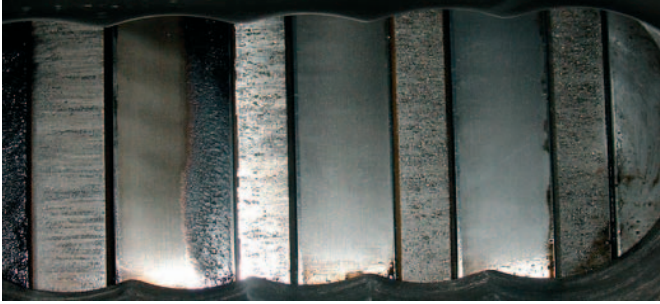
Fig. 3. Totally scuffed unit. Lubrication should be increased to maximum until overhaul is convenient with regard to the schedule of the ship. Due to the friction heat developed, the piston rings get hardened, and the wear rate of the liner increases significantly. However, the hardening protects the rings, which is why the operation may be continued safely until next convenient port stay.

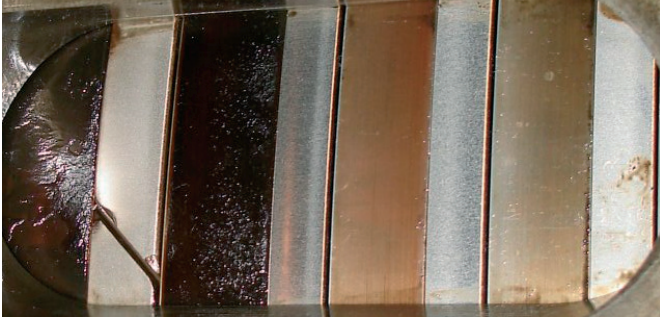
Fig. 5. Unit with 23,500 hours without piston overhaul. Note that most of the rounding is still intact, indicating that only  $\frac{1}{4}$  of the wear potential is used. Further, the measurements above from the same unit shows that only  $\frac{1}{2}$  of the ring groove wear potential is used, and the rate of burnings on the piston top is insignificant. Consequently, overhaul of that unit is not needed at this stage.

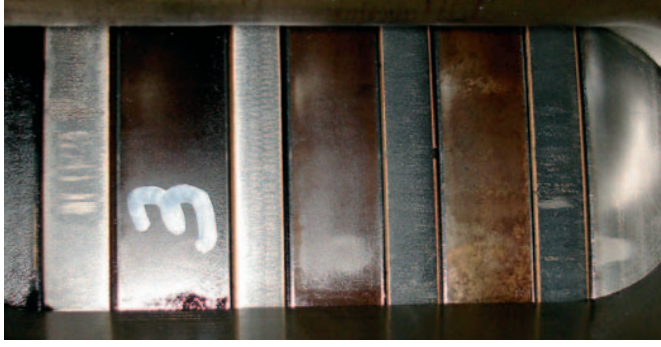
In case of micro-seizures (mz), lubrication should be increased temporarily according to the standard lubrication guidelines. However, it is important to lower the lubrication to normal as soon as the active mz-attack is stopped. It should be noted that old, not active, mz-marks remain visible long time after the attack has stopped, which does not call for increased lubrication. Figs. 4 and 7.

Fig. 7. Unit with micro-seizures on the top and bottom rings as a result of metal-to-metal contact. Should be counteracted by temporarily increased lubrication. It is important to lower the lubrication to normal as soon as the active mz-attack is stopped. Note that old, not active, mz-marks remain visible a long time and do not call for increased lubrication.

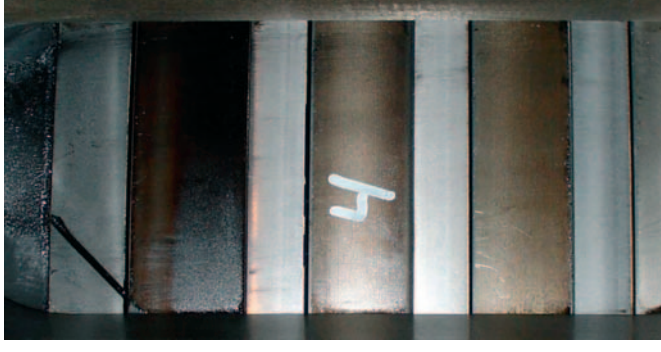
Fig. 8. Unit running very well after 20,021 running hours. Note that the last remains of the alu-coat are still visible on the lower edge, indicating remaining rounding left. This means that the ring wear is less than 2 mm out of possible 3 mm. Consequently, many more hours are left from the point of view of wear.
