Replacement Campaign of CEJN Female Couplings

SL11-543/PRP
May 2011

Replacement Campaign of CEJN female couplings, series 125

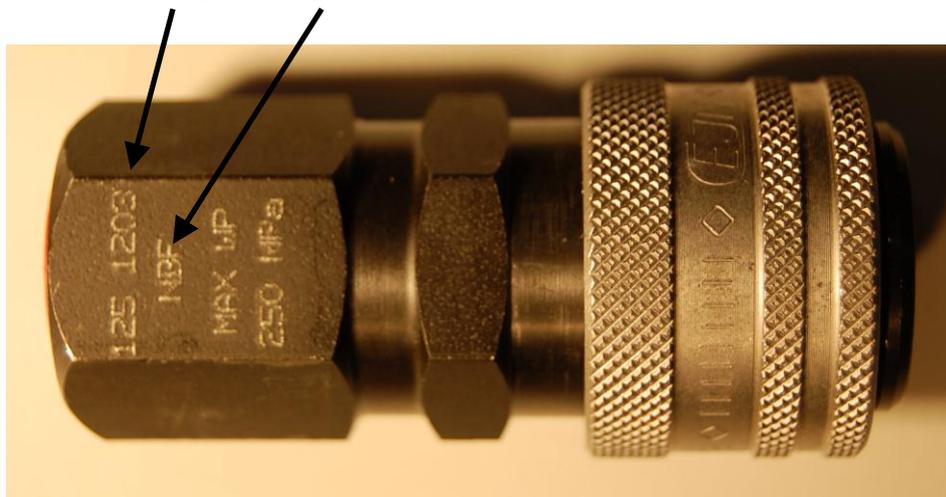
Picture 1.

Product number affected: 10 125 1203, 10 125 1237, 10 125 1248, 10 125 1283,
Production lot affected: NB*, CL* (where * can be any letter from A to N) Produced
from October 2010 up to March 2011

Product number and Production lot.

Check the number of affected couplings you have in service and on stock and report to your nearest CEJN office no later than 2011-08-31 where shipping of replacement couplings will be taken care of.

As soon as you have received replacement couplings, the replacement of your stock and couplings in service shall be done as soon as possible and return the replaced couplings to your CEJN office.

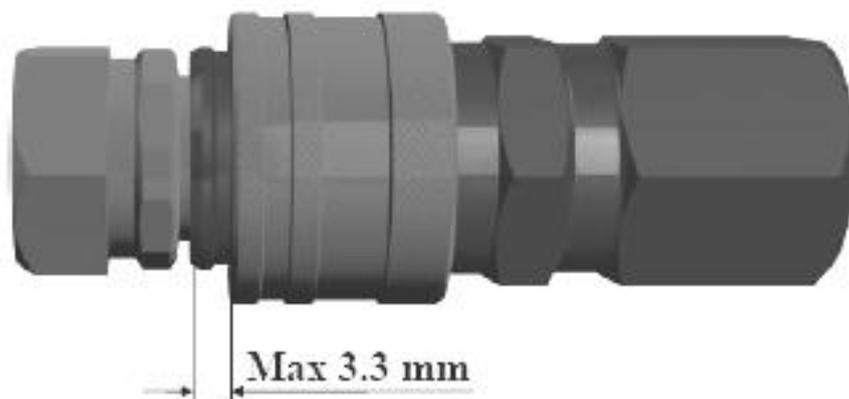
Picture 2.

As always during connection of male and female part make sure that the locking sleeve is in full engaged position. See picture 2.
