Lifting of Cylinder Liner

35-98 bore engines

SL2012-566/PRP
August 2012

Check procedure when mounting cylinder liner lifting tool, in order to ensure full contact between lifting tool and cylinder liner.

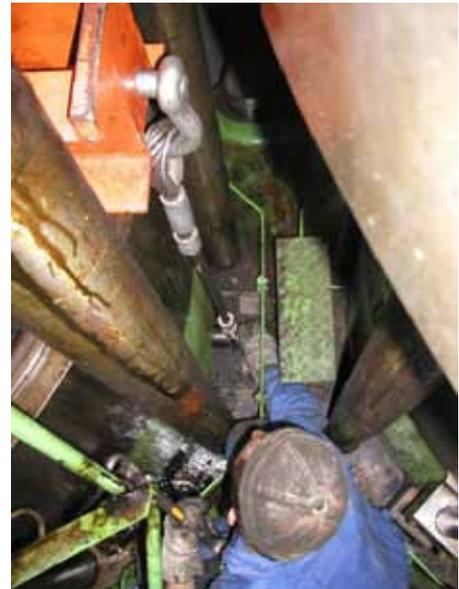
It has been discovered that, in some cases, the diameter of the machined spot-face on the cylinder liner is insufficient to assure full contact with the lifting tool, thus obstructing the required contact between the liner and the shoulder of the screw (see Fig. 1). Similarly, in some cases, it has also been discovered that the threaded hole for the lifting tool in the cylinder liner is too short (see Fig. 3).

The designs of both the lifting and tilting screw and the cylinder liner were updated in 2000 to ensure full contact.
