## Alpha Lubricator

Service Experience

SL2016-632/AAB

Type: MC/MC-C

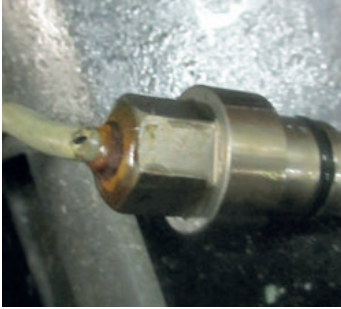
Fig. 2a: Defective feedback sensor

As a defective sensor may cause oil to enter the junction box and printed circuit boards (PCB), attention should be paid to the condition of the feedback sensor, see Figs. 2a and b showing a faulty feedback sensor.

Based on our service experience and our guideline for overhaul intervals, the following parts must be replaced every 5 years or 32,000 R/H to ensure optimal and trouble-free operation.

We have now created maintenance and service kits on the basis of the feedback and service experience, containing all the necessary parts as listed above. These kits are available through our spare-part department.

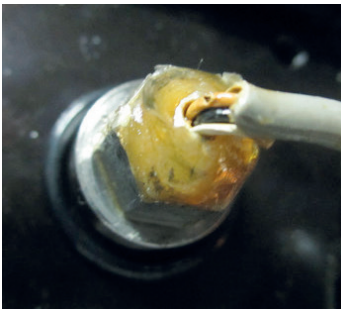
Fig. 2b: Defective feedback sensor

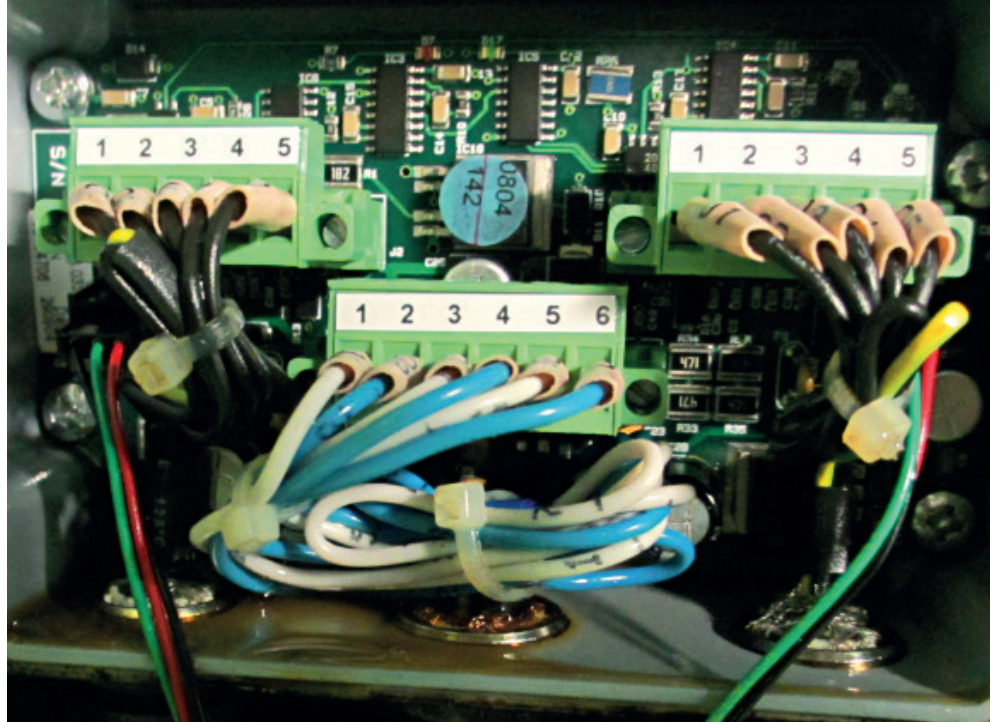
Fig. 2c: Oil in junction box and PCB for feedback loop due to the defective sensor

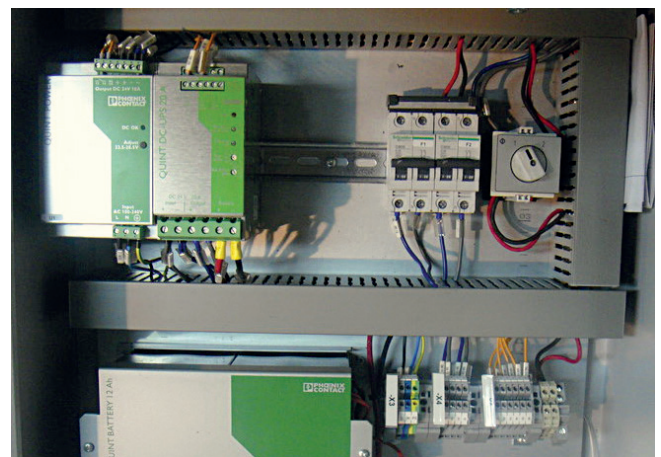
Based on feedback from vessels with Alpha lubricator units in service, we have, in addition to the above, observed that a large part of the experienced difficulties, including damage to PCBs (i.e. the master control unit (MCU), backup control unit (BCU) and switch board unit (SBU)), can be ascribed to the fact that the 24V power supply to the Alpha lubricator system is made through the ships common supply.

Our standard and specified system includes a stand-alone 24 V supply with uninterruptable power supply (UPS), see Fig. 3. If installed, such a system will improve the margin to failures, false alarms and damage to PCBs contrary to an installation connected to the common 24 V supply system on board.

Fig. 3: The 24 V stand-alone power supply with UPS

We recommend that the mentioned stand-alone power supply with UPS is installed when convenient. Technical questions should be submitted to: [dt-cph@mandieselturbo.com](mailto:dt-cph@mandieselturbo.com).
