Insulation of indicator cock

SL2019-675/SBE
July 2019

Owners and operators of MAN B&W two-stroke marine diesel engines.
Types: All 26-98 bore MC/MC-C and ME/ME-C engines

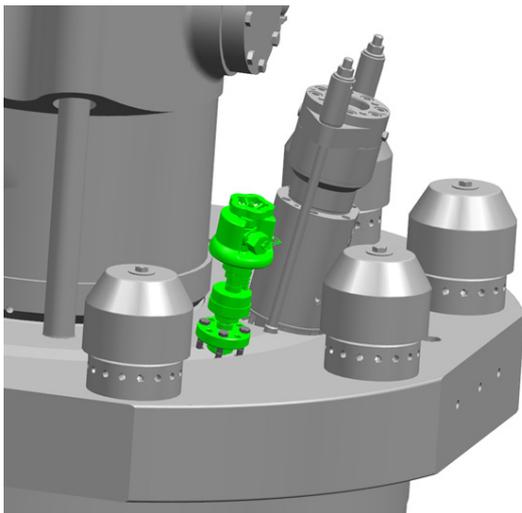
Engine running at higher load profiles will typically raise the temperature in the indicator pipe arrangement. This may affect the performance of the PMI sensor, causing signal failure. In those cases, removing insulation will lower the temperature in the sensor and restore normal performance.

Note that ABB sensors should never be insulated, only the indicator cock, as illustrated in the drawings.
