Service experience with
2020-compliant fuels

Fuel equipment

SL2022-726/KNB
July 2022

Owners and operators of MAN B&W
two-stroke marine combustion engines.
Type: All MAN B&W engines.

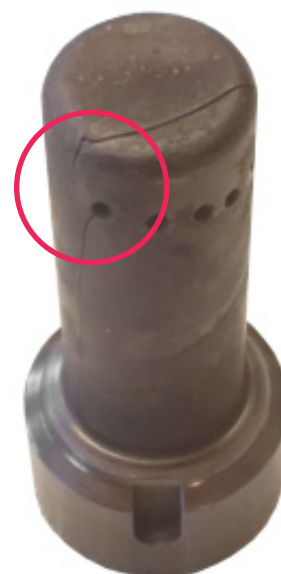
Some vessels have reported cracks in fuel nozzles after switching to a 2020-compliant fuel. Fig. 1 shows a nozzle tip with a crack. This is most dominant for engines of

The reason why this has become an issue is related to the higher delta temperature between the max. temperature for the nozzle during combustion and the cooling effect from the injected fuel.

HFO typically has a temperature of 130 to 140 degrees Celsius whereas the fuels of today may have a viscosity that does not require heating. On the contrary, some new fuel types may need to be cooled in order to ensure a minimum of 2 cSt at engine inlet.

In some cases, this increased temperature difference may challenge the lifetime of the nozzle and thus reduce the specified time between overhaul (TBO).

Fig. 1: Crack found on the tip of a nozzle

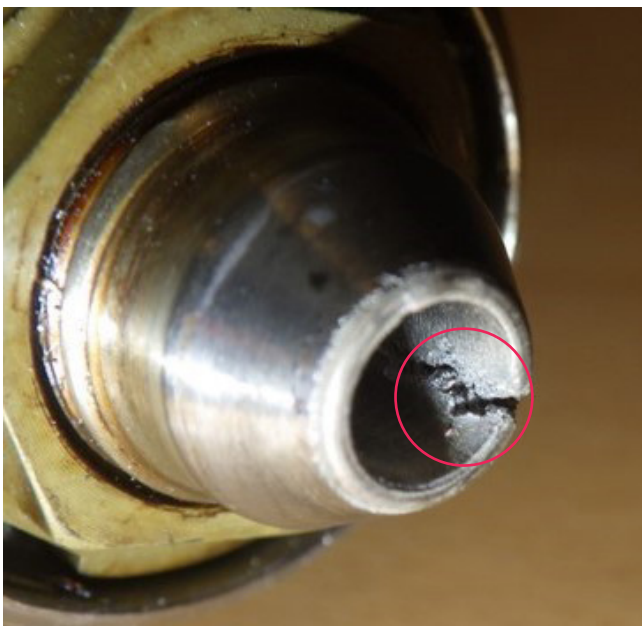
Fig. 2: Inspection of the high-pressure pipe end/seat reveals a crack – no special equipment required

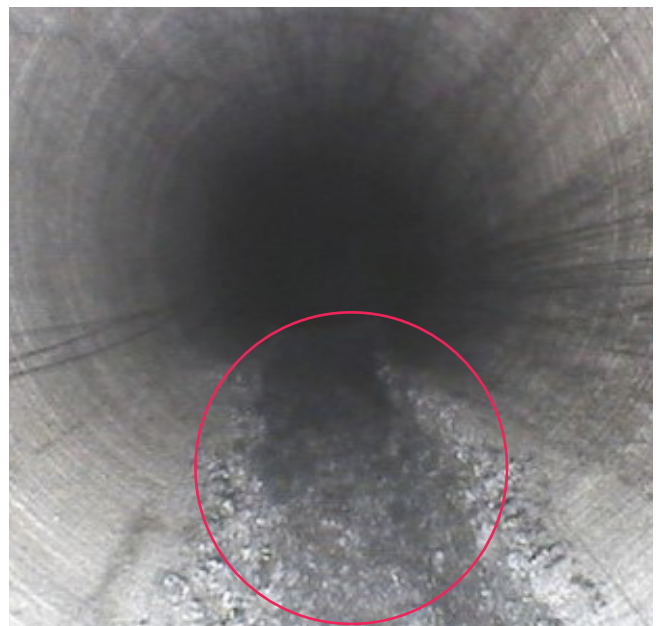
We have received a few reports of cavitation in the high-pressure pipes for engines operating only or mainly on distillate or ULSFO, see Fig. 3.

In most cases, the pipe cavitation seems to have progressed slowly and is often detected when overhauling/exchanging the fuel valves.

If the high-pressure pipe cone suffers severe cavitation damage that leads to a high-pressure fuel oil leakage and, therefore, erosion damage, this may ultimately lead to damage on the top cover mating surface between the top cover and the high-pressure pipe.

Fig. 3: An endoscope was used to inspect for damage inside the high-pressure pipe

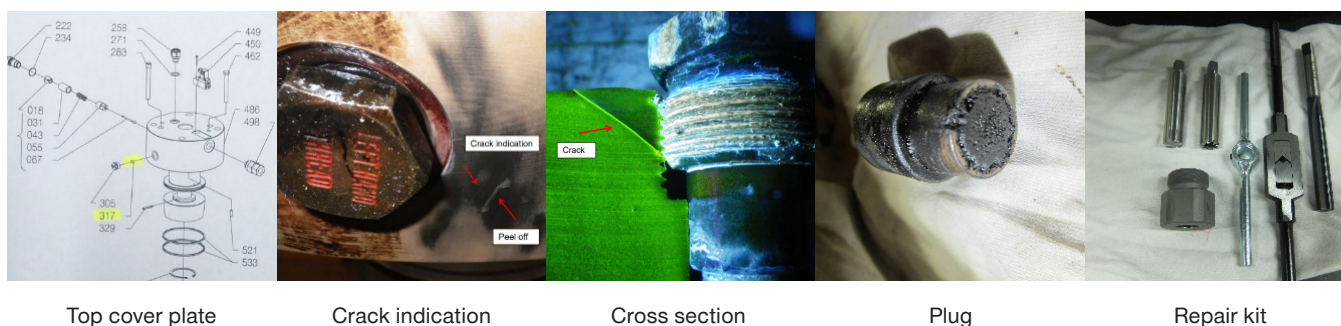
Crack formation around the plug screw in the top cover has been reported in a few cases. The root cause has been identified to be a loose plug behind the plug screw.

The loose plug would “hammer” against the plug screw at every injection, and thus stress the threads in the top cover and initiate a crack at the thread in the top cover. Cavitation on the plug may lead to loose plugs.

Fig. 5: Crack indication around the plug screw in the top cover, top cover plate and repair kit

A repair kit consisting of new plugs and tools for overhauling the mating seat in the top cover can be ordered from PrimeServ, see Fig. 5.

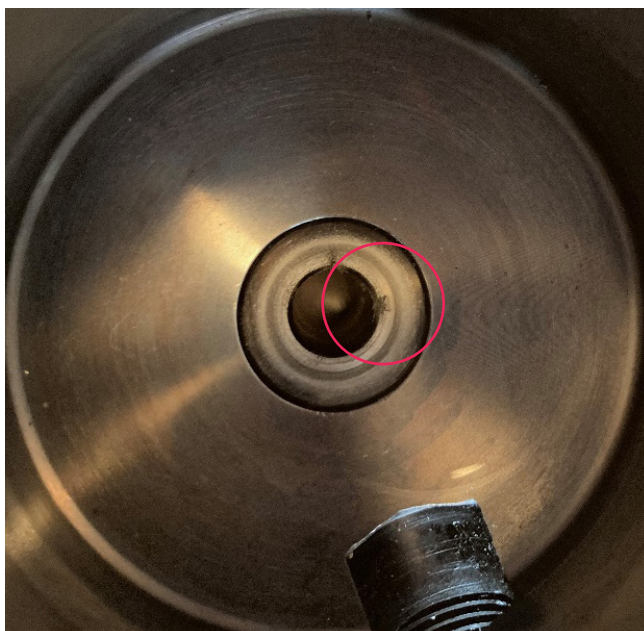
Cavitation has been found inside the fuel valve head, see Figs. 7 and 8.

Fig. 7: Cavitation found inside fuel valve head – towards non-return valve

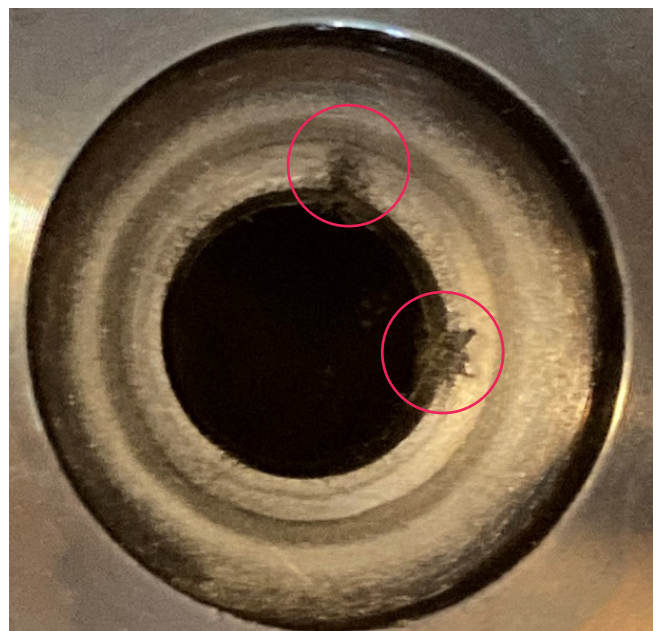
Fig. 8: Close-up of cavitation damage

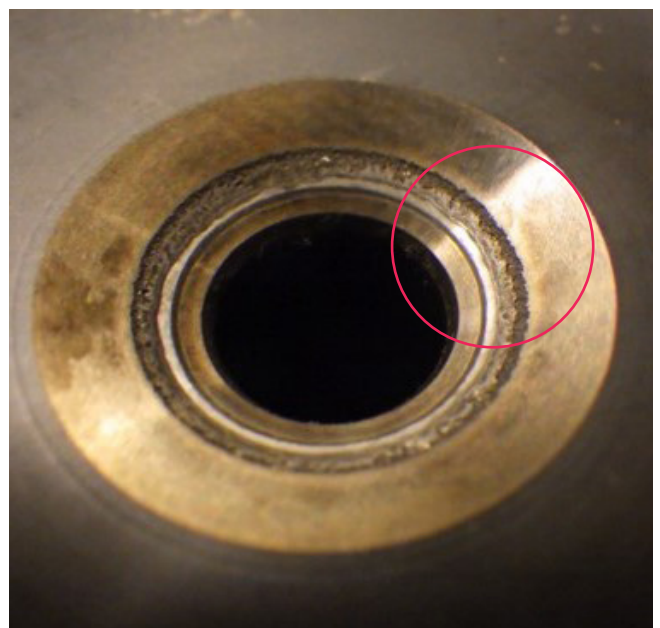
Whereas cavitation is rarely found on the upper end of the non-return valve (Fig. 10), cavitation has been found on the lower end (Fig. 11).

Fig. 11: Close-up of cavitation damage found at lower end of non-return valve – towards thrust spindle pipe

Introduction of the combined one-unit non-return valve for the 80, 90 and 95-bore engines. Cavitation is avoided by omitting of the mating sealing surfaces.

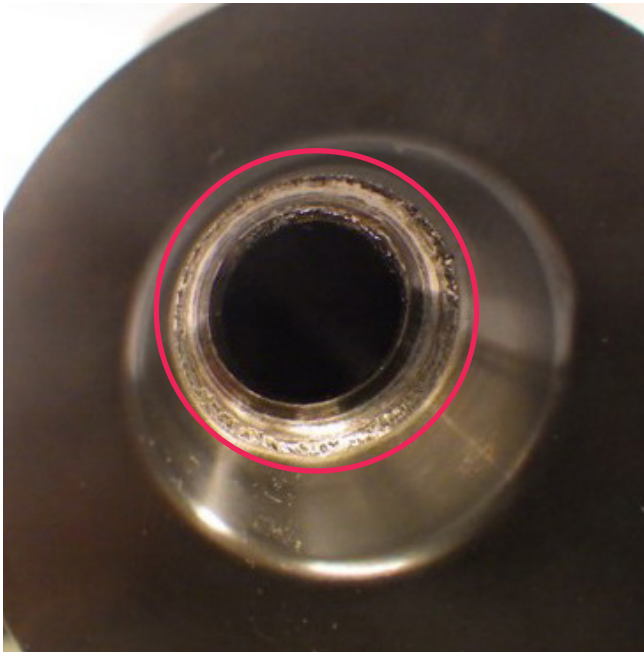
Cavitation has been reported on the mating face at the top position towards the non-return valve, especially for 80, 90 and 95-bore engine fuel valves, see Fig. 12. In severe cases, the cavitation will intersect the circular sealing area and bypass the injection pressure. Cavitation occurs also in more rare cases at the lower end, see Fig. 13.

Fig. 12: Cavitation found on upper end of thrust spindle pipe – towards non-return valve

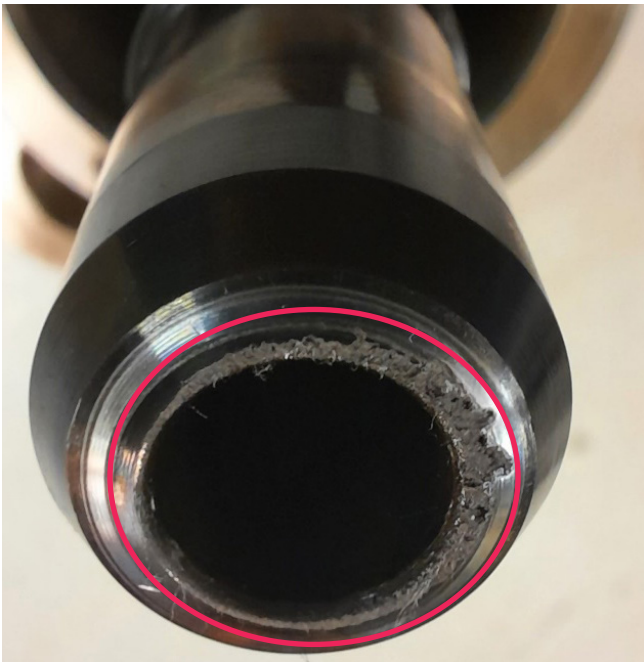
Fig. 13: Cavitation found on lower end of thrust spindle pipe – towards spindle guide

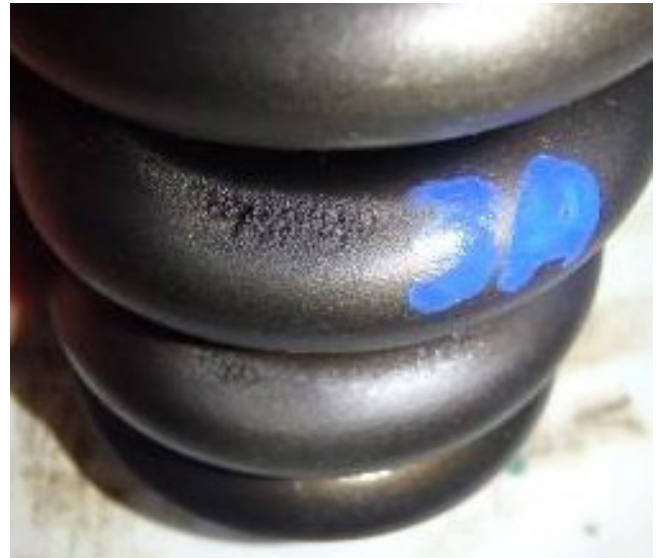
In a few cases, cavitation has been found on the inner diameter of the spring coils, see Fig. 14. Cavitation marks might also be found on the thrust spindle pipe, see Fig. 15.

This type of cavitation occurs when the circulation pressure is too low for the fuel circulating loop, and it is mainly related to an incorrect pressure setting or a worn out “pressure holding valve”.

Fig. 14: Cavitation found on spring

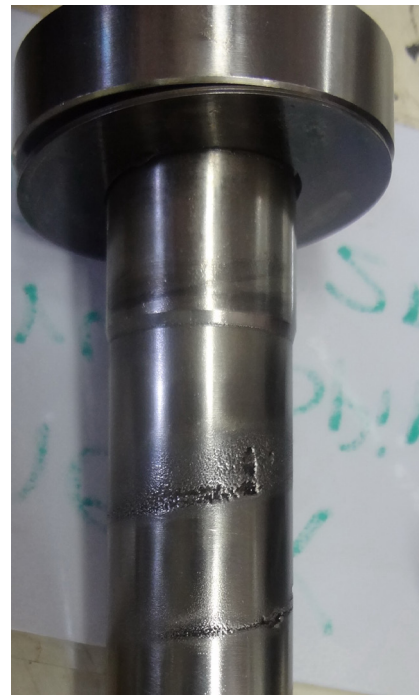
Fig. 15: Cavitation found similarly on cylindrical part of thrust spindle pipe

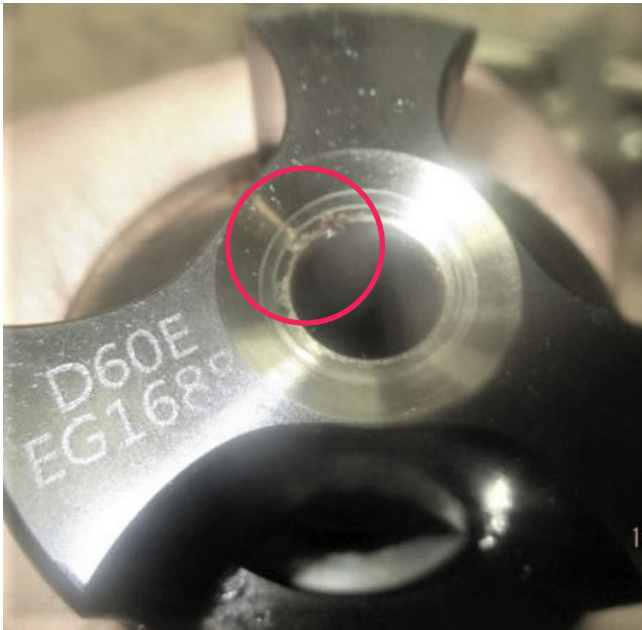
We have seen very few cases of cavitation on the spindle guide. The cavitation has been found on the mating face towards the thrust spindle pipe, see Fig. 16. In such cases, cavitation was also found on the position for the thrust spindle pipe. Fig. 17 shows an example purely cosmetic cavitation.

Fig. 16: Cavitation found on thrust piece in spindle guide

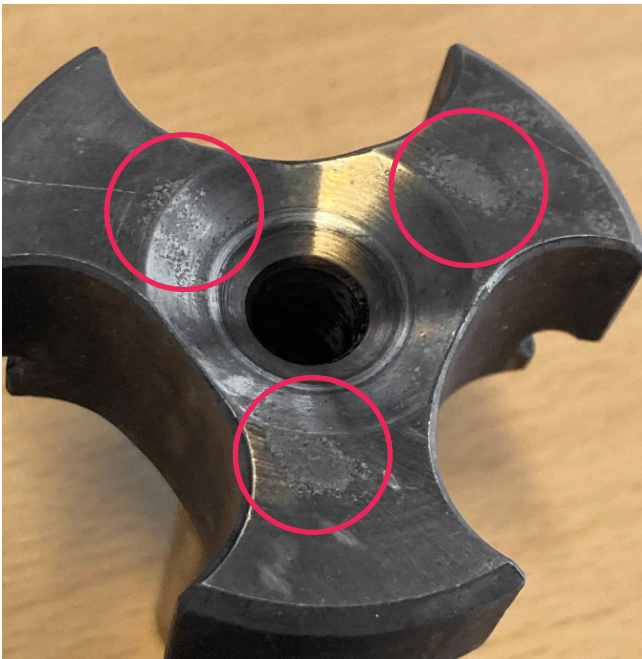
Fig. 17: Cavitation marks are considered to be merely cosmetic

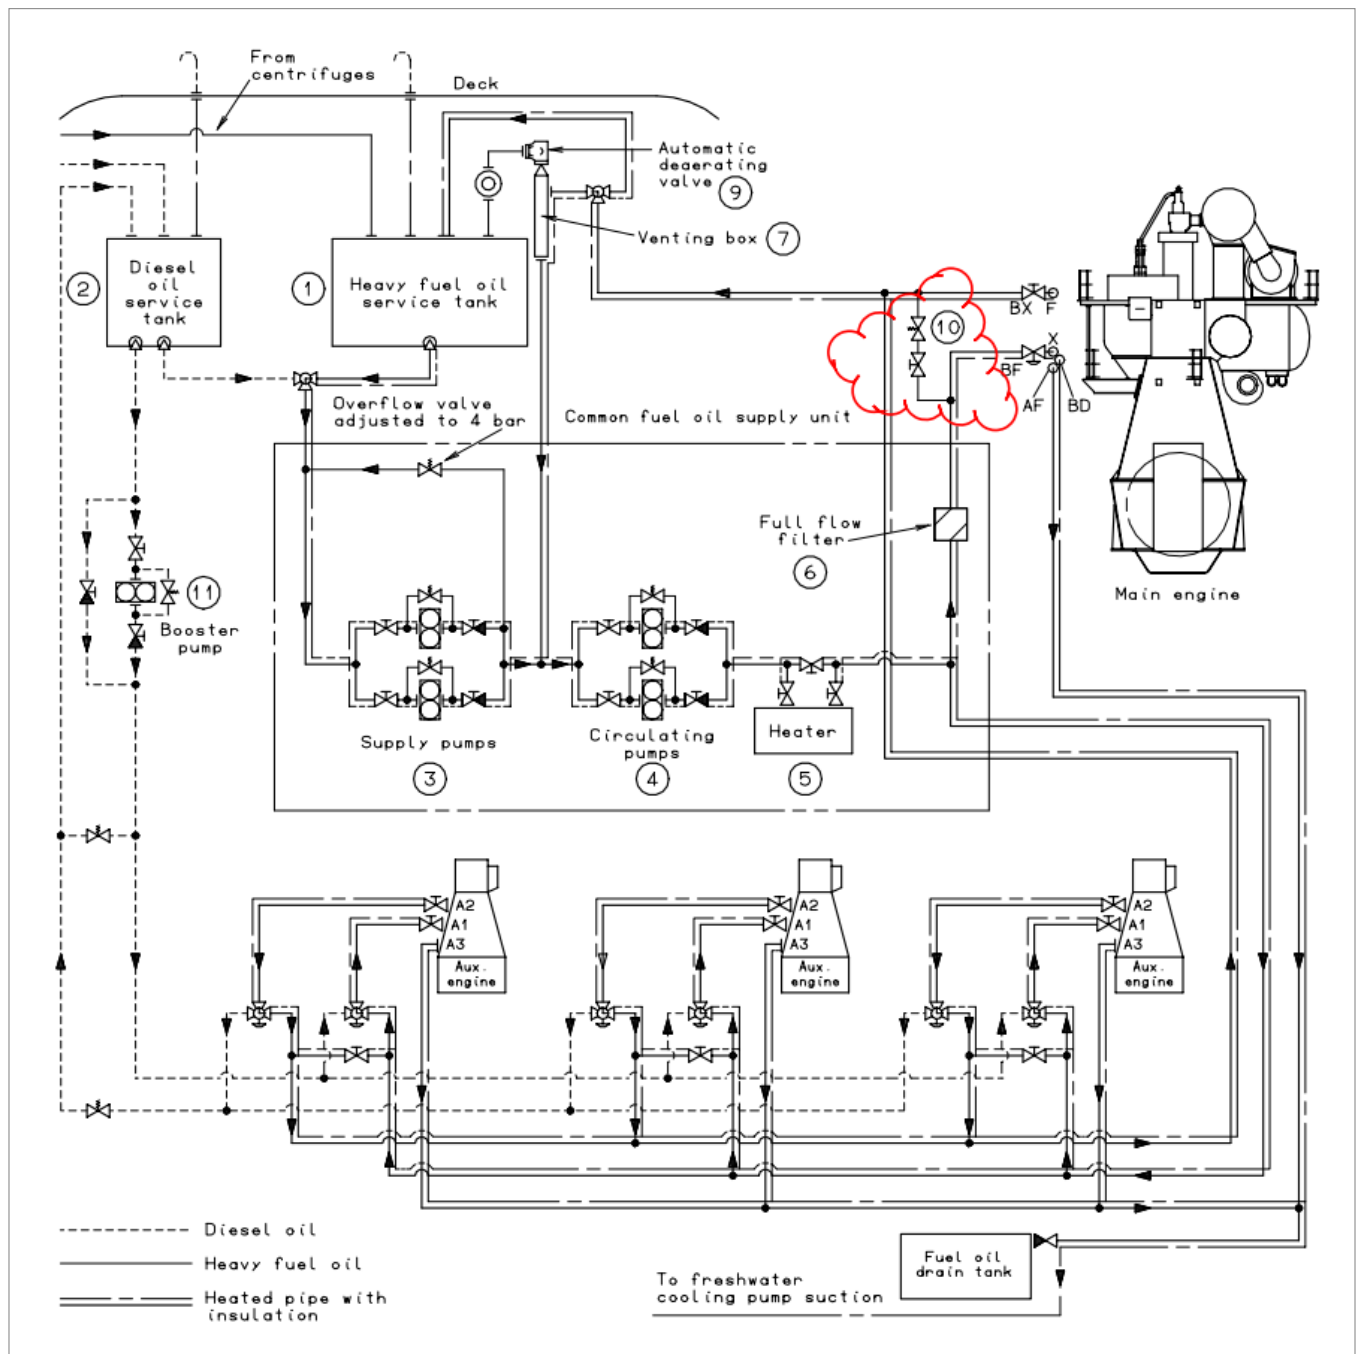
Fig. 21 highlights item 10 between the inlet and outlet of the main engine. The bypass line with overflow valve, item 10, serves the purpose of bypassing the main engine if, for instance, the main engine fuel oil system needs a major

overhaul. During this bypass, the overflow valve takes over the function of the internal overflow valve of the main engine.

During normal operation of main engine and gensets, the shut-off valve in the bypass line (below item 10) must be closed. Otherwise, the two overflow valves will be in series and act against each other!
