Reconditioning of exhaust valve spindles

Do not recondition some spindle types until further notice

SL2023-735/AGC April 2023

Owners and operators of MAN B&W two-stroke marine combustion engines.

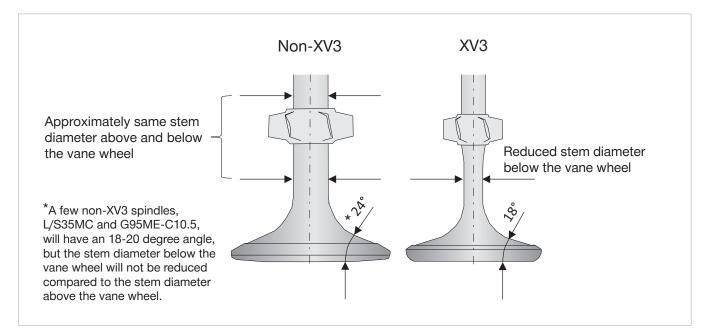
Fig. 1: Exhaust valve spindle types

To distinguish between the spindle types, see Fig. 1.

All XV3 type spindles have:

- Smaller stem diameter below the vane wheel compared to above the vane wheel.
- 18° degree angle between the spindle disc bottom and the spindle disc top.

All non-XV3 spindles have:

- Approximately same stem diameter above and below the vane wheel.
- 24° degree angle between the spindle disc bottom and the spindle disc top (see Fig. 1).

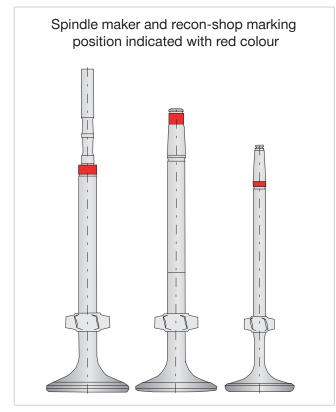
Fig. 2: Spindle marking position

If the spindle marking was performed in accordance with MAN Energy Solutions guidelines, the following marking should clarify which spindle material was utilised originally when the spindle was new and prior to any reconditioning, see Fig. 2.

- SEAT
- HEAT RESISTANT LAYER

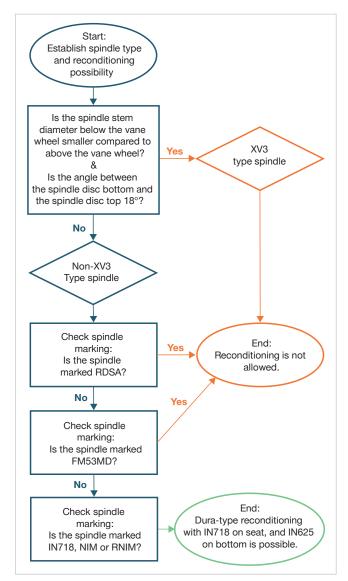
Fig. 3: Flow diagram - spindle types

We recommend using the flow diagram in Fig. 3 and Table 1 to evaluate whether or not spindle reconditioning is possible.

Consequence		
No reconditioning available regardless of the spindle type		
No reconditioning available regardless of the spindle type

No reconditioning available if the spindle type is XV3
Dura-type reconditioning is available if the spindle type is non-XV3
Dura-type reconditioning is available if the spindle type is non-XV3
Dura-type reconditioning is available
