Bearing Wear Monitoring System update

SL2013-569/HWC
May 2013

Owners and operators of MAN B&W two-stroke marine diesel engines. Type: MC/MC-C/MC-S, ME/ME-C, and ME-B

A BWM system update lowers the response time from 46 min. to 9.5 min.

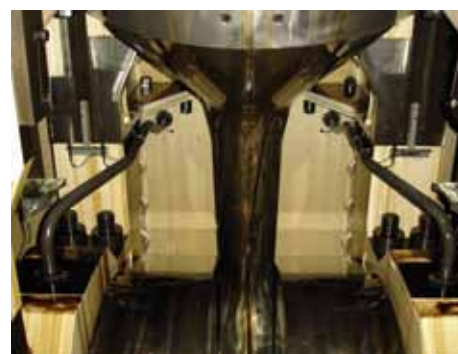
Bearing wear monitoring installation

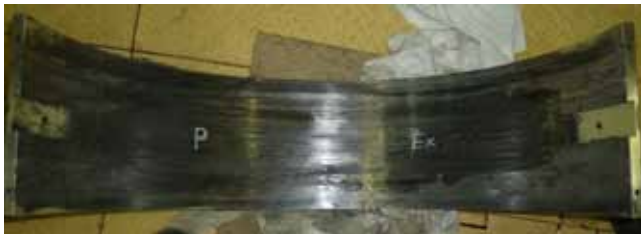
Fig. 1: Damaged bearing shell

A main bearing damage was recently experienced on an MAN B&W S-MC-C main engine of medium bore size. The damage was caused by a sudden ingress of foreign matter into the bearing via the lubricating oil system, and it developed rapidly into a bearing seizure.

Operation of the engine continued until the oil mist detector (OMD) alarm set off and requested slow-down. At this stage, the bearing damage had evolved into a situation where comprehensive repair of the crankshaft and bearing housing (bedplate) was called for.

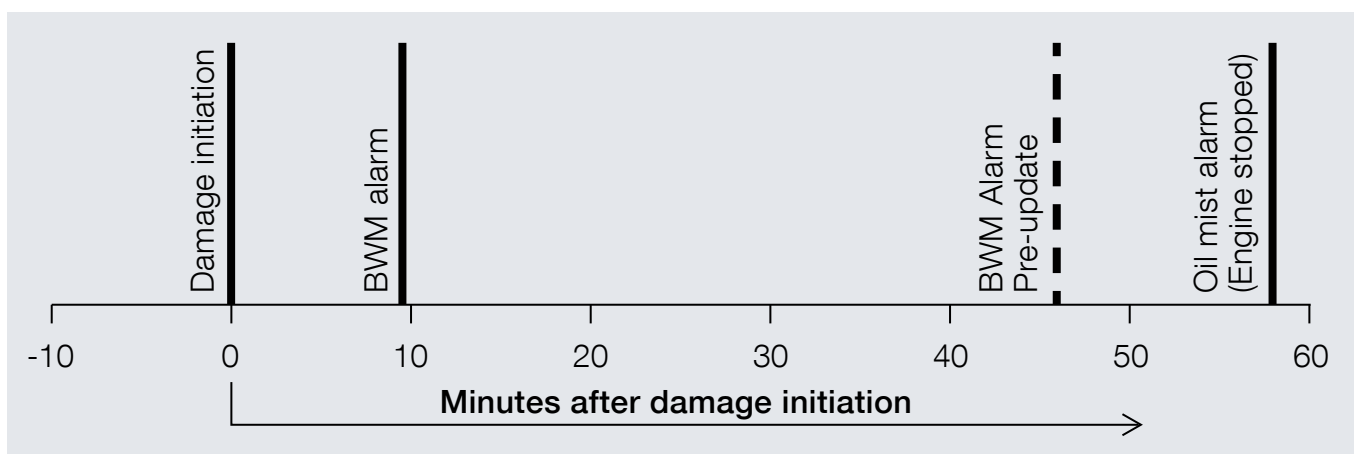
Fig. 2: Sequence of alarms

- 9.5 minutes passed from the initial stage of the seizure until the alarm set off and slow-down was requested by the BWM system.
- 58 minutes passed from the initial stage of the seizure until the alarm set off and slow-down was requested by the OMD system.

- a BWM system of the early type (pre-update) would have set off an alarm 46 min. after the initial stage of the seizure.

Fig. 2 shows the alarm times of an updated BWM system installed and of an earlier type system (pre update).

Considering the response time of the pre-update type BWM (46 min.) and of an updated type BWM (9.5 min.), the updated system provides a significantly better protection against severe bearing damage.

MDT recommends that owners of engines fitted with pre-update BWM systems arrange for an update.
