Action code: **WHEN CONVENIENT**

Lifetime of Fixed Cylinder Pressure Sensors

SL2016-621/CLN
August 2016

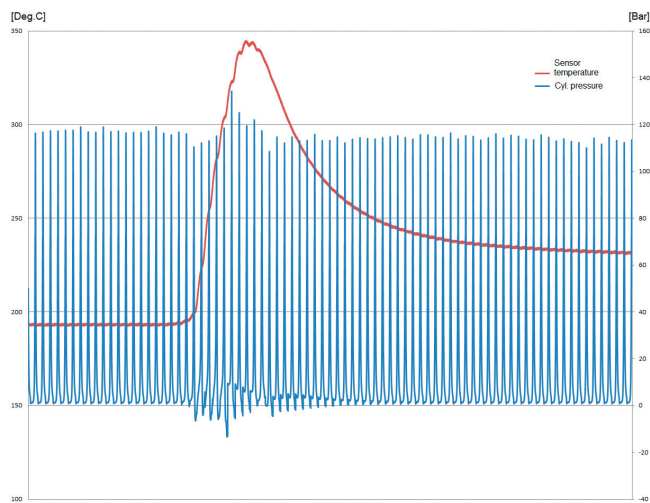
The sensor housing temperature increases dramatically when the indicator valve is open. This causes drifting of the sensor signal or even damage to the sensor if the period with blowing through is excessively long. Depending on the actual engine load and the duration of a previous period of blowing through of the indicator valve, the measuring results can be influenced up to 10 minutes after the indicator valve has closed and, therefore, they are potentially incorrect during this period.

Fig. 1: Sensor core temperature and pressure signal during indicator valve blow through

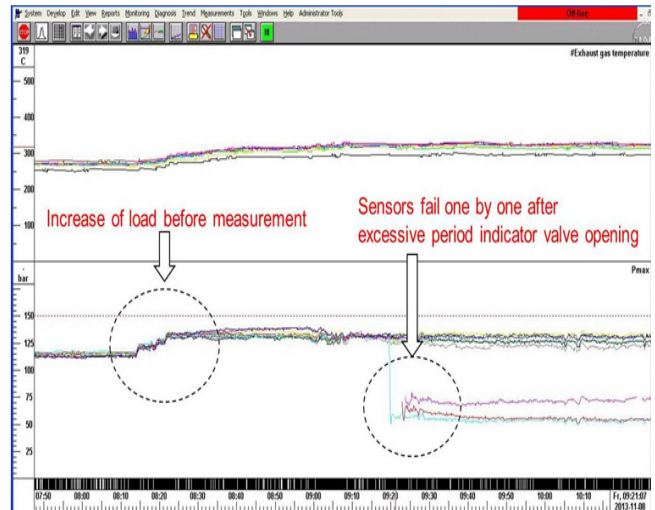
Fig. 2: Incorrect measuring procedure where the engine load is first increased, followed by an excessively long period with open indicator valve

Blowing through the indicator valve for more than one engine revolution or a leaking indicator valve may lead to faulty measurements, reduced lifetime of the sensor and even sensor failure.

In general, it is recommended only to open the indicator valve while the starting valves are open and the engine is turned by air. Indicator pipes and valves clogged with exhaust/soot deposits should be cleaned manually before starting the engine.

Do not to blow through the indicator valve right before taking a manual calibration measurement. If clogging is suspected, blow through the indicator valve at low load for maximum 1 engine revolution. Disassemble and clean the valve manually if it is still clogged.

Wait for minimum 10 minutes after the indicator valve has been blown through, before mounting the handheld pressure transducer to take a calibration measurement.

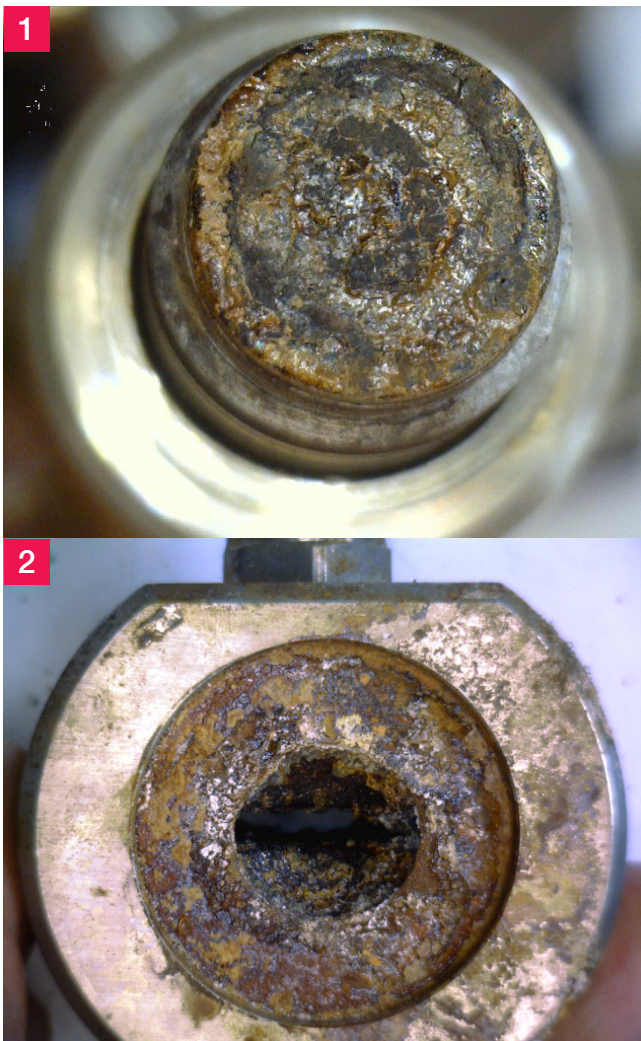
Investigation of the sensors returned to Kistler showed signs of extreme corrosion of the stainless steel, both on the sensor element itself and also on the sensor adapter.

Fig. 3: Corroded sensor (1) and adapter (2)

An inspection of the sensors and indicator pipe arrangements on board the vessel showed severe corrosion on all parts in the indicator pipe arrangement, including sealings, sensors and adapters. The inspection on board revealed that the vessels in question were mainly operating the engine at low load, and this load pattern combined with missing insulation on the indicator pipe arrangement led to low temperatures in the indicator pipe, in this way causing condensation of water with a high level of sulfuric acid. This was confirmed by temperature measurements on board, and further investigations of deposits performed by MAN Diesel & Turbo.

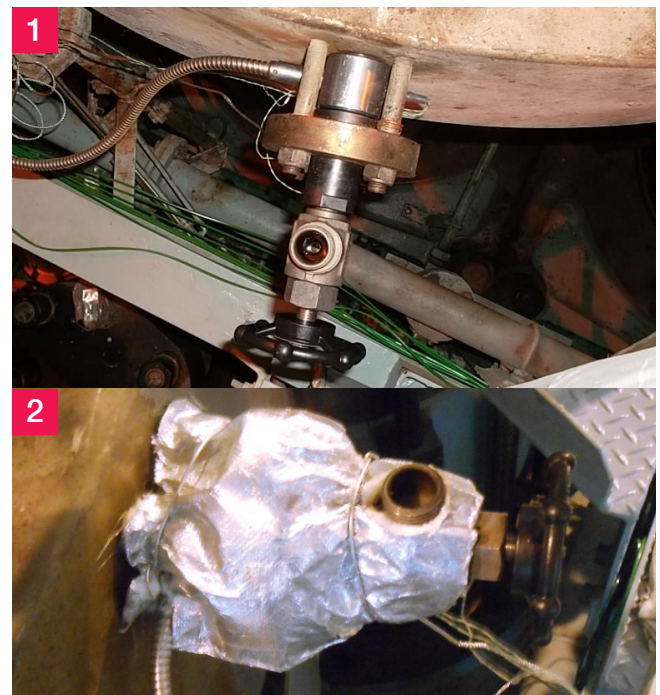
On-board measurements at low load also showed that insulation of the indicator pipe arrangement increased the temperature of the sensor by approximately 20 degrees. Furthermore, the cylinders for which most failures were reported were located directly below the fresh air blower, leading to further cooling of the indicator pipe arrangement.

Fig. 4: Indicator pipe with water condensation (1) and with insulation (2)

Ensure that the indicator pipe arrangement is insulated at all times in order to raise the temperatures above the acid dew point.

Divert the air from the blower inlet away from the cylinder covers on the engine.
