Gas-tight Lock
Top Piston Ring

SL2016-625/AAB
September 2016

Owners and operators of MAN B&W two-stroke marine diesel engines with semi-high or high piston top-land. Type: MC/MC-C/MC-S, ME/ME-C, ME-GI/ ME-GI-S and ME-B

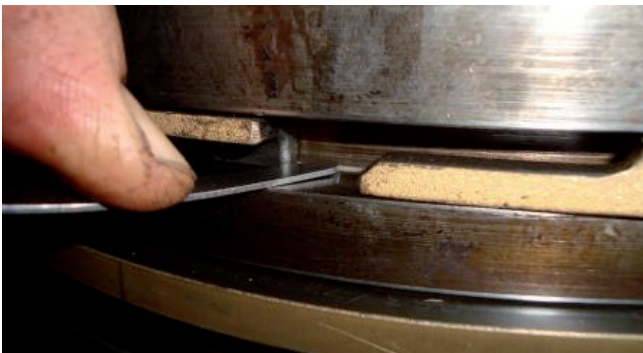
The Figs. 2 and 3 show the effect of running with an excessive ring groove clearance.

Fig. 2: Excessive ring groove wear and gap in the gas-tight lock

If the piston crown ring groove wear exceeds the figures given in the manual, the crown must be replaced by either a reconditioned or a new crown.

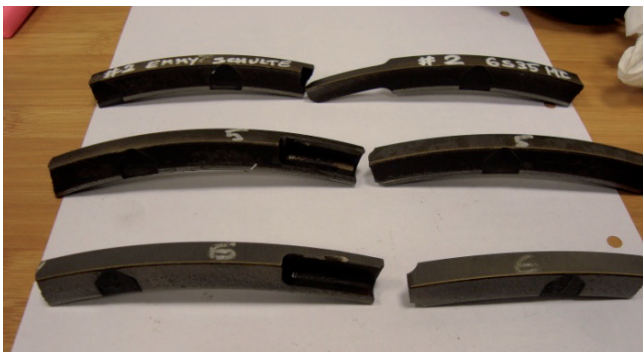
Fig. 3: Excessive ring groove wear and missing contact between groove and ring resulted in worn-out piston rings with gaps in the gas-tight lock
