# YANMAR SERVICE NEWS

Subject	Corrosion of Intake Valve	No. : 12-2-G-01-001-O Jan. 2012
Engine Model	6EY18(A)L(W)	Use
		Engine Nos.

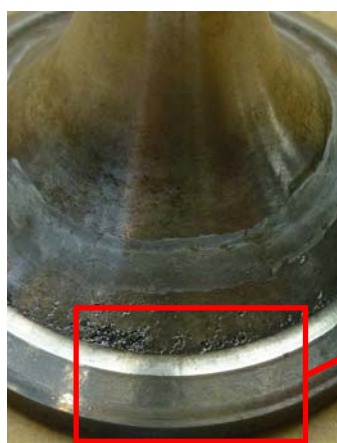
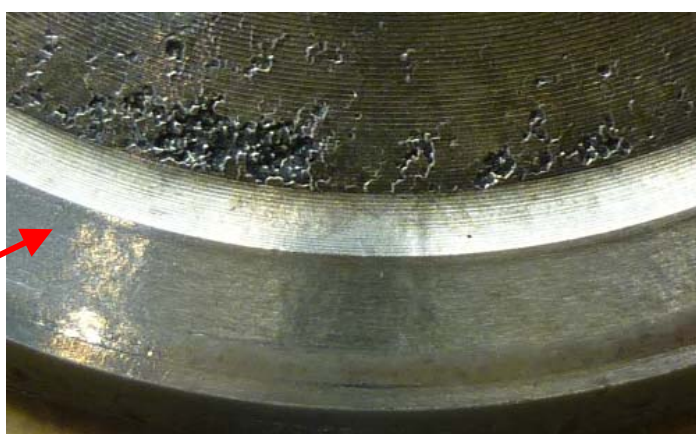
Upon inspection, the low temp. side CW inlet temperature was found to be low at about 22°C, which made it impossible to raise temperature even after adjusting the hull-side temp. regulating valve. This lowered the engine's low temp.-side CW intercooler inlet temp. and the boost temperature, (35~40°C), and caused the engine to be operated under excessively cooled state. As a result, condensed water was produced in the boost air, which reacted with sulfur contained in exhaust gas and sulfuric acid was produced, which caused the intake valve head to be corroded.

Corroded Intake Valve

- Check if or not the temp. setting of the hull-side temp. regulating valve is as per the completion drawing, (36°C or 38°C)  
→If temperature won't be raised even after adjusting or raising the temperature setting, ask improvement to the shipyard.
- Check if or not the engine's low temp-side CW intercooler inlet temperature is appropriate. (Hull-side temp. regulating valve setting: approx. -2~0°C)  
→When temp. drop was excessive, check if or not the piping was cooled.  
→When the by-pass valve is installed at the engine side, adjust the valve.
- Check if or not the intake valve head has been corroded while servicing the cylinder head, (see photos below).  
→ Replace the valve if corrosion, cracks, etc. was found.
