# YE SERVICE NEWS

Subject	<b>Judgement for replacement of plunger of Fuel oil injection pump</b>		No. : YEN-CM-22861-3 Date: 2019/03/19
Engine Model	6EY17W, 6EY18(A)L(W) 6EY22(A)(L)(W) 6,8EY26(L)(W), 6,8EY33(L)W	Use	Marine Main&Aux
		Engine No.	-

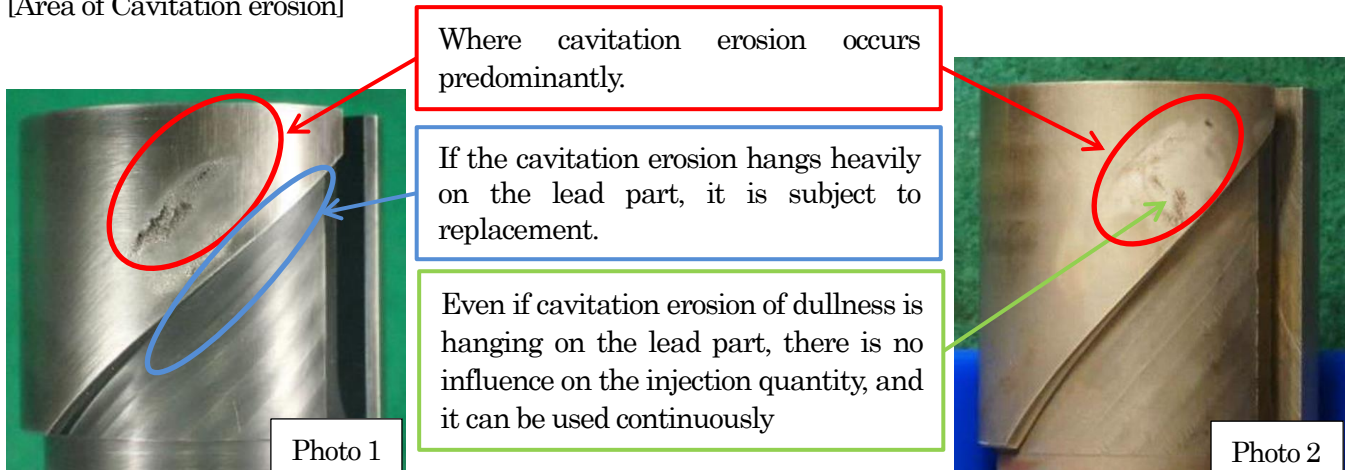
[Area of Cavitation erosion]

Photo 1 and 2 show the cases of actual cavitation erosion.

As you will find in the photos, cavitation erosion in most cases appears, structurally, in parallel along the upper lead part.

We surveyed plungers having cavitation erosion. As a result, we found that the light or somber cavitation erosion (Photo2) over the lead part, gives almost no influence on the injection performance and on the engine starting and operation performance. Accordingly, the plunger can be used continuously.

However, if P-max or exhaust temperature is fluctuated or engine performance is changed, we recommend to replace the plunger to new one at that timing.
