YANMAR SERVICE NEWS

Subject	Inlet Temp. Setting of LT F.W. Engine (Rev.2 : Precaution statement edit)	No.: 13-2-G-04-003-L-Rev2 Date: Jun. 2013
Engine Model	All Models	Use
		Engine Nos.
		Marine Aux. Engines

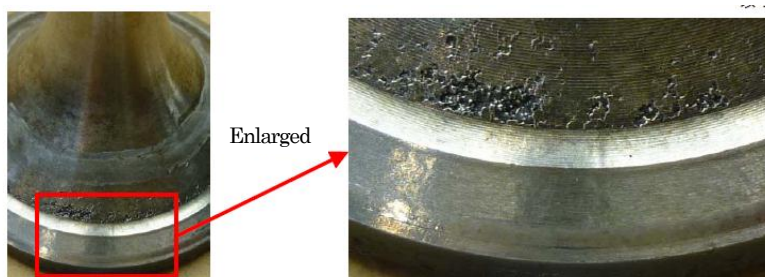
Condensed water is produced when the charged air passes through the intercooler. Condensed water combines with nitrous acid gas, (SO₂), that is produced by burning sulfur content (S) in fuel oil. This causes corrosion of the intake valve surface. (For details, please refer to our Service News, 12-2-G-01-001-O, already distributed.)

Photo 1. Intake Valve Corroded

Check that F.W. temperature is adjusted to **36°C (or 38°C)** by the hull-side temp. regulating valve.

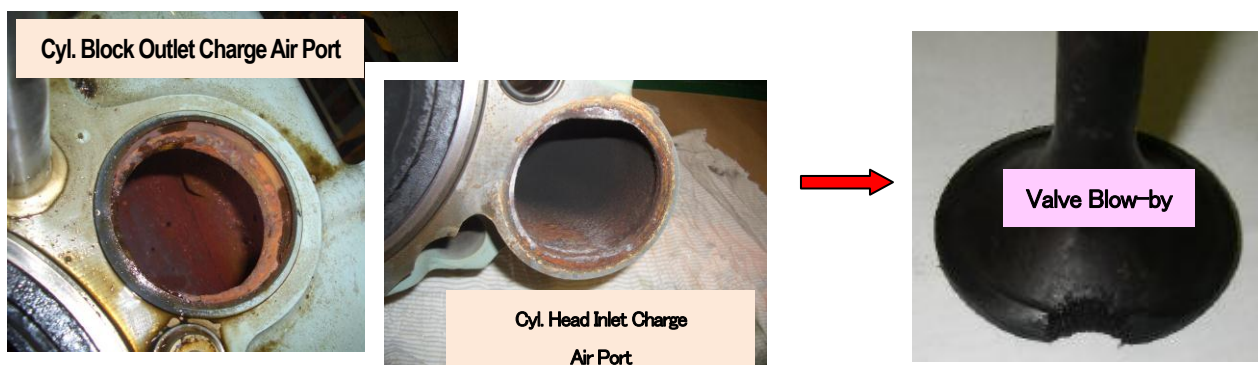
Condensed water produced in the intercooler is trapped in the bottom of the charge air chamber, which causes the charge air chamber interior wall to rust. Further, when the rusted fragments flowed into the combustion chamber together with the charged air and were embedded in the intake/exhaust valve seat, intake/exhaust valve blow-by is caused.

In addition, rusting of the cylinder block outlet charge air port or the cylinder inlet port can accelerate the leakage of air or condensed water through the clearance of V-packing during engine operation.

Photo 2. Valve blow-by caused by embedding rusted fragments in valve seat

Even when the LT F.W. temperature is 36°C, condensed water can be produced depending on the condition of ambient air or boost pressure, especially under the high-temperature and humidity environment. When the production of condensed water is excessive, operate the engine with opening the drain cock so that no condensed water may be trapped inside the charge air chamber.
