YANMAR SERVICE NEWS

Subject	MET18 Turbocharger LO Leakage	No.: 16-2-G-08-012-O Aug. 2016	
Engine Model	6EY18(A)L(W)	Use	Marine Aux. Engines, Industrial
		Engine Nos.	_____

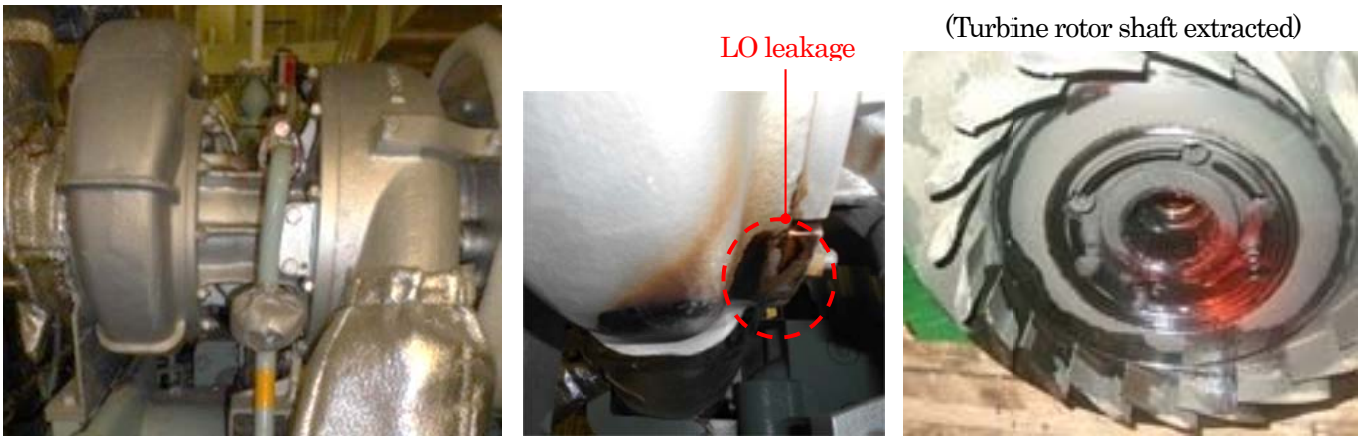
Photo 1. LO Leakage

In the 6EY18 engines, LO leaked from the joint face of the MET18 turbocharger exhaust casing and the center cartridge.

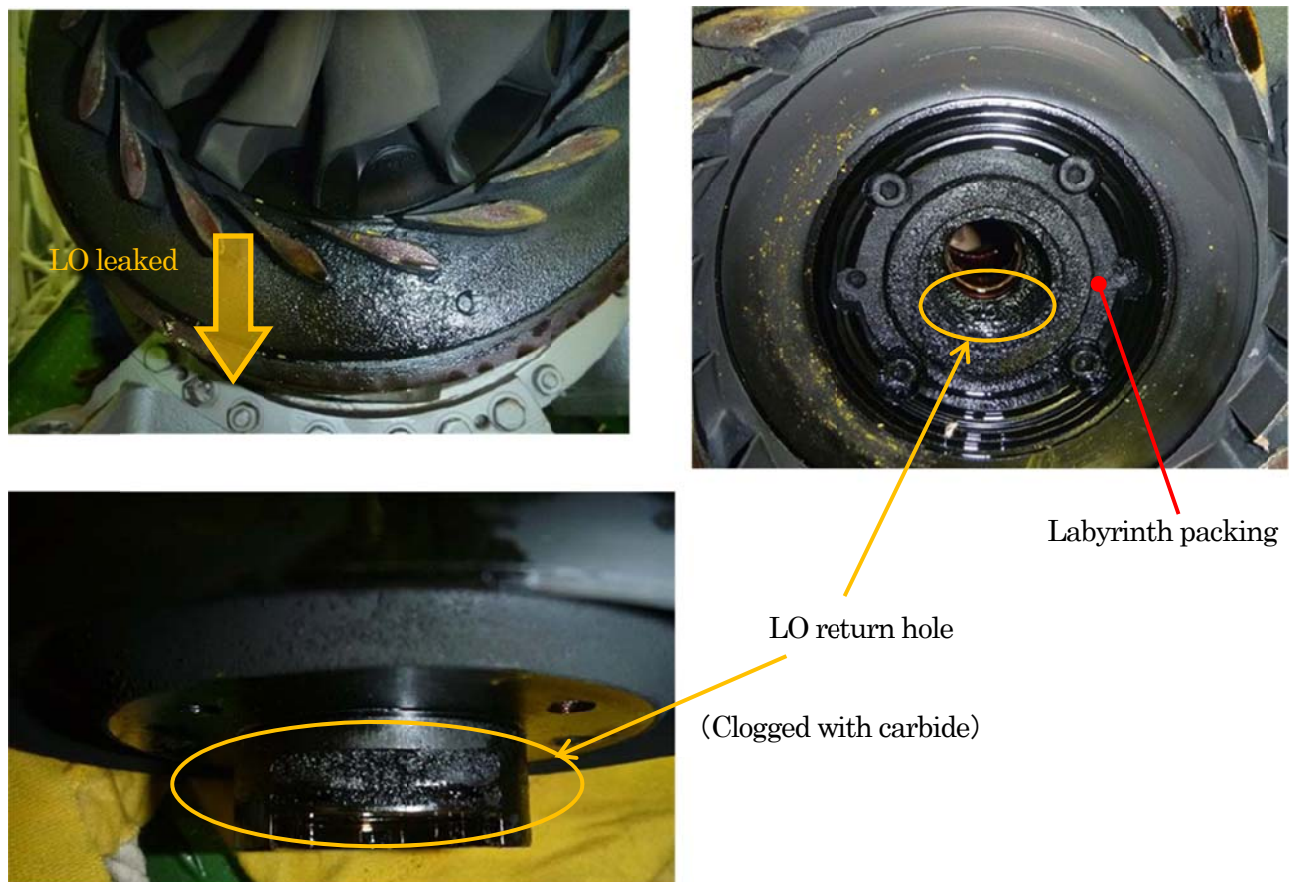
Photo 2. Interior of Turbocharger

Upon inspection, we found that lube oil leaked from the turbine-side rotor shaft seal,(labyrinth packing).

We noted that lube oil seemed to have leaked more heavily downward. This suggests that lube oil continued to leak while the engine was being stopped, too. This is because of the draft effect of the exhaust pipe of the engine being stopped.

As you will find in Photo 2, LO leaked downward. This suggests that LO continued to leak while the engine was being stopped, too. This tends to be caused when the engine was stopped and the pressure inside the exhaust pipe turned to negative pressure due to draft effect.

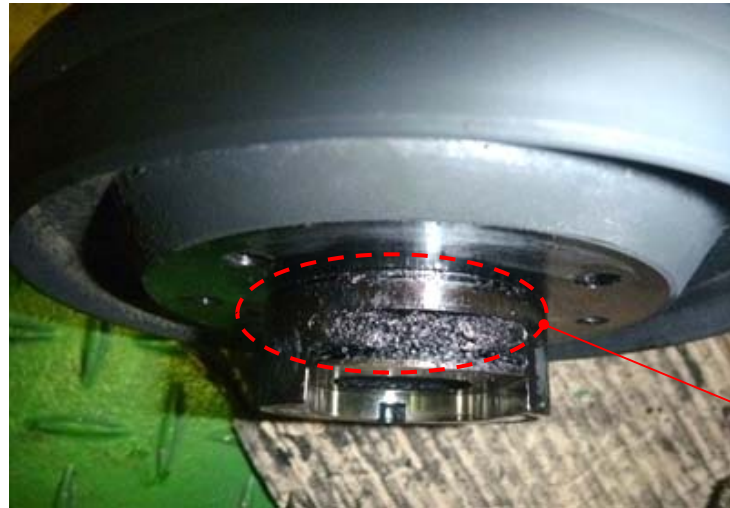
Photo 3. Clogging of Labyrinth Packing LO Return Hole

We checked that the labyrinth packing LO return hole was clogged with carbonized lube oil. This caused lube oil to be trapped inside and to overflow from the labyrinth groove.

We checked that the labyrinth packing LO return hole was clogged with carbide in a very short time. This suggests that the sealing performance had lowered already. In usual cases, carbide would deposit and accumulate in this LO return hole according to time. It is necessary to remove carbide and clean the hole on a periodic overhaul timing, (every 2~3 years or every 8000 ~ 12000 hrs.)

Clogged with carbide

In the case of insufficient engine cooling, following steps must be implemented as instructed in the operation manual. Check the status quo and implement the followings if necessary:

- Preparing for stopping the engine, interrupt the load and operate the engine at no load for about 10 minutes.
- Immediately after stopping the engine, operate the LO standby pump or electric LO priming pump for over 15 minutes.

It is generally known that water content and pentane insoluble content in LO influence carbonization of LO. LO needs to be controlled to satisfy the control standard as instructed in the operation manual. Check the present status and use LO with appropriate properties if necessary.
