YANMAR SERVICE NEWS

Subject	Rise of Exhaust Gas Temperature	No.: 16-2-G-08-001-O-rev.1 Aug. 2016	
Engine Model	6EY18(A)L(W)	Use	Marine Aux. Engines, Industrial
		Engine Nos.	_____

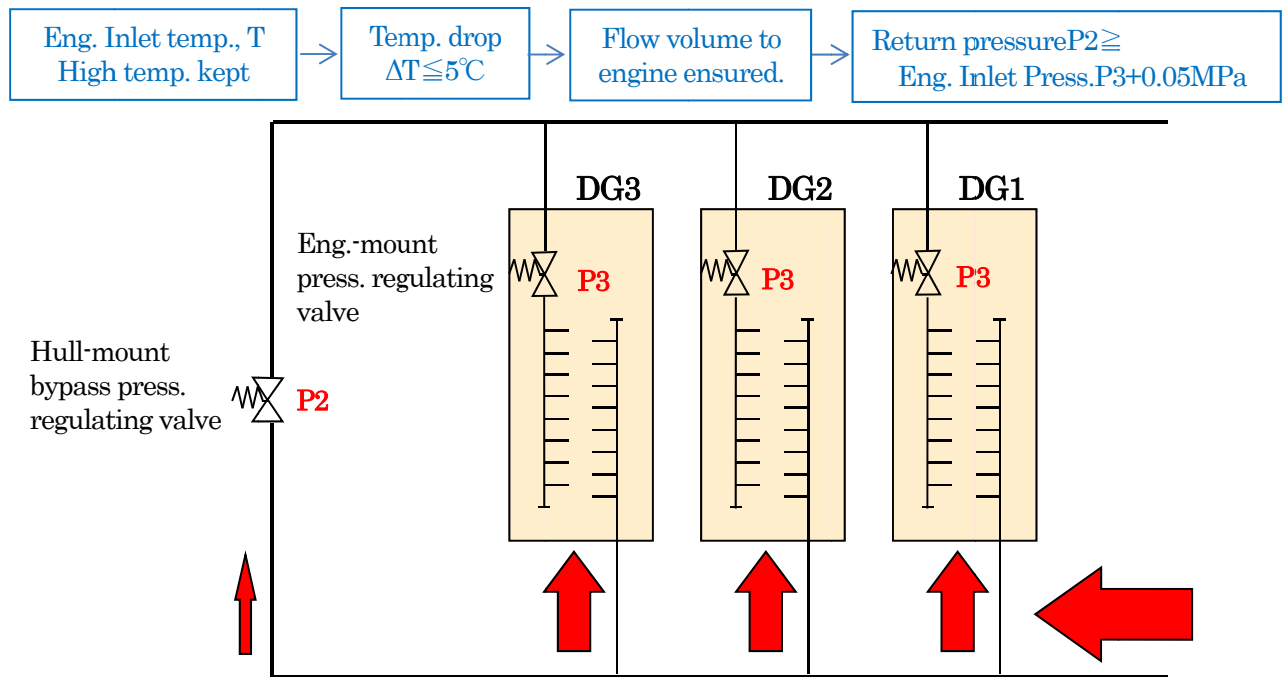
Fig.1 FO System Pressure Balance

If the engine inlet temperature can't be improved with the adjustment of the setting, it is possible that the balance between the engine inlet pressure, P1, and the return pressure, P2, has collapsed, which has caused the fuel flow volume to the engine to be insufficient, (see Fig.1 below). In this case, adjust the respective pressure regulating valve to obtain the following pressure:

Pressure Setting of Hull-mount Pressure Regulating Valve, P2 \geq Engine Inlet Pressure, P3+0.05MPa

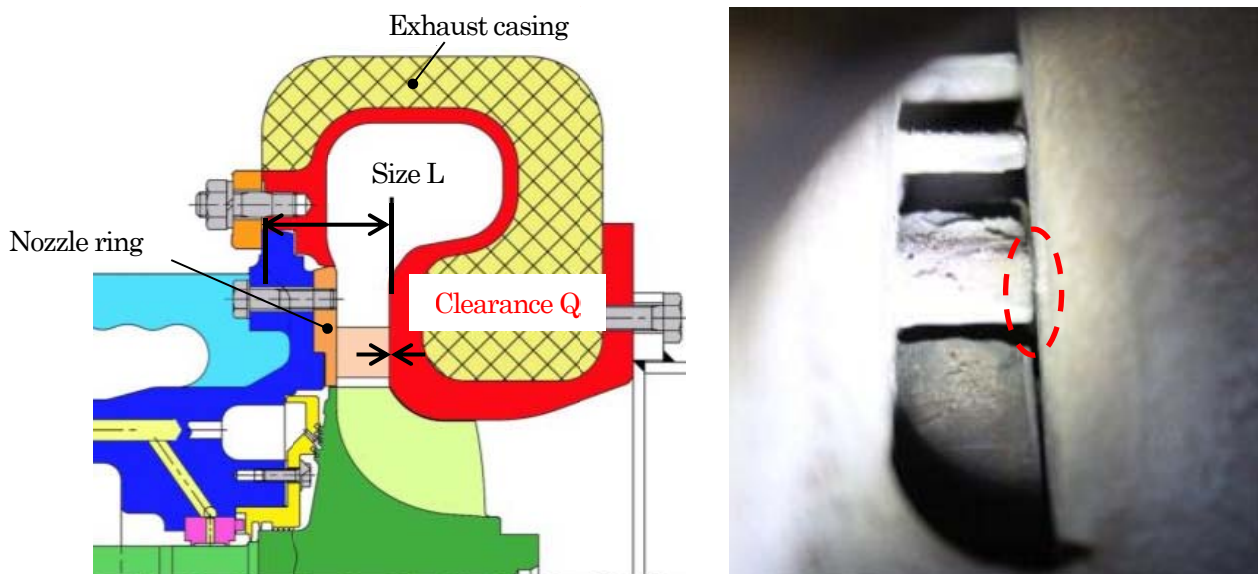
Fig.2 Increase of Clearance between Nozzle Ring & Exhaust Casing (Clearance Q)

In the MET18 turbocharger, though after overhaul, exhaust gas temperature rose. The turbocharger manufacturer, Mitsubishi Heavy Industries Marine Machinery & Engine Co., Ltd, as a result of their survey on this problem, reported to us that the turbocharger performance dropped due to the increase of clearance between the nozzle ring and exhaust casing, (Clearance Q). Carbon was removed by the maintenance cleaning and the increased Q-clearance was exposed as a result. We project that this caused the exhaust temperature to rise soon after conducting maintenance.

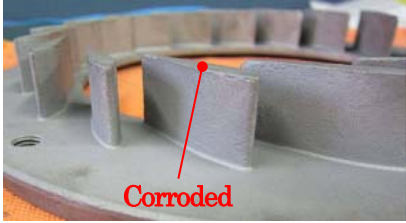
Cause	Improvement
<p>【Corrosion Wastage of Nozzle Ring】 Nozzle ring caused corrosion wastage due to high oxidation corrosion, which contributed to increase the Clearance Q.</p>

<p>【Nozzle Ring Material and External Diameter Change】</p> <ul style="list-style-type: none"> · In order to increase acid resistance, heat resistance and extreme temperature strength, the material was changed as follows: SS400(machined) → SCS1(casted) · In an aim to avoid interference caused by thermal expansion, the external diameter was diminished by 0.2mm. <p>【Discrimination】 Check the mfg. number punched on the nozzle ring surface and the rear casting surface.</p>
<p>【Nozzle ring rolled back】 As a result of FEM analysis, we found that the exhaust casing interfered with the nozzle ring outer circumference due to thermal expansion to cause distortion. However, this failure is corrected upon installing the exhaust casing. Accordingly, this factor gives only very small effect to the turbocharger performance drop.</p>

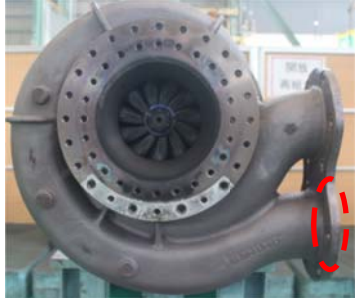
<p>【Distortion of Exhaust Casing】 We found that the distance between the installation flange face and the opposing nozzle face, (Size L in Fig.2), is distorted due to thermal stress for deformation, which contributed to increase the Q-clearance. However, the distortion was extremely small. Accordingly, this factor gives only very small effect to the turbocharger performance drop</p>	<p>【Exhaust Casing Material Change】 To increase strength against thermal stress, the material was changed as follows: FCD450 → Hi-Si ductile</p> <p>【Discrimination】 Check the mfg. number punched on casing.</p> <p>(Example) 15S-1257H ↓ Improved type</p>

The exhaust casing needs not be replaced since the distortion was extremely small as mentioned above.
