**Excessive wear on the locking keys of crankshaft thrust bearing**

SL2022-721/JNN  
January 2022

Owners and operators of  
MAN four-stroke engines.

Marine: L27/38

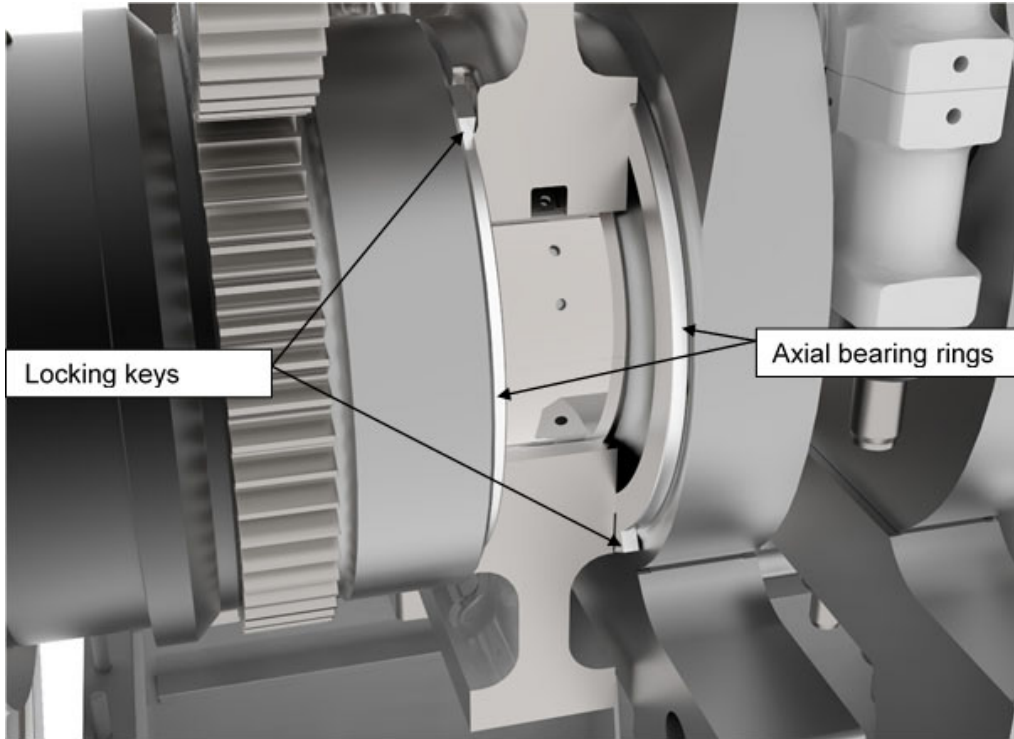
Figure 1.

As is shown in Figure 1 on page two, the thrust bearings are positioned on each side of the aft end main bearing, and the inspection can be done easily via the crankcase doors.

We recommend to carry out a visual inspection of the locking keys on the thrust bearing rings at the first opportunity.

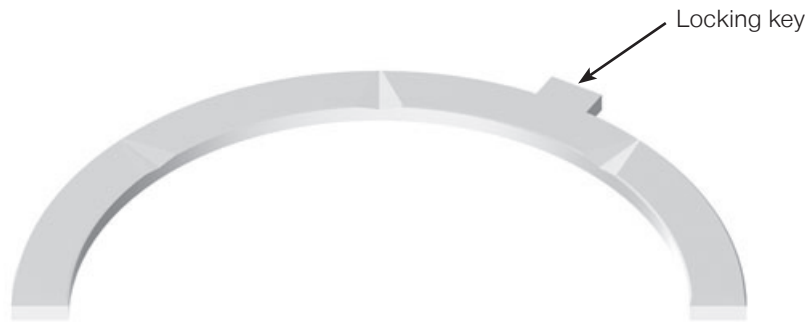
Figure 2. Axial thrust bearing with undamaged locking key

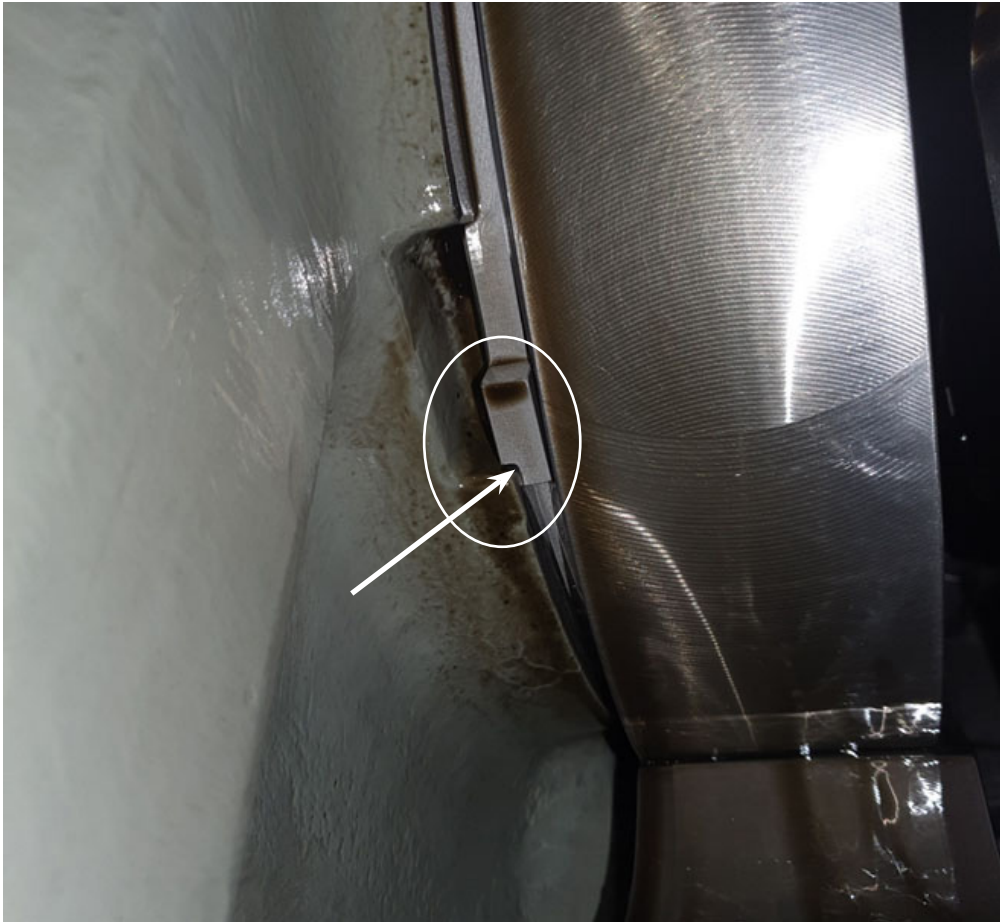
Service experience has shown a number of cases with excessive wear on the locking key of the crankshaft thrust bearing. In case this issue is not attended, the locking key may over time be worn to an extent where the fixation of the thrust bearing will be lost, and the thrust bearing ring will be able to turn in the bearing saddle. So far this has not caused any major breakdowns. However, operation in such a condition is not desired and may lead to major thrust bearing issues and, in the worst case, affect the engine frame and thrust bearing surface of the crankshaft.

Figure 3. Inspection of locking key, wear is clearly visible

As the present design of the thrust bearing assembly allows some free movement of the thrust bearing rings during operation, variation in engine installations and propeller designs etc. may lead to difference in the vibration/resonance level in service; causing the excessive wear.

- Wear below 25% of the locking key width  
Operation can be continued, but the next inspection must be scheduled according to the actual running hours and the observed wear rate (mm/1000 running hours).
- Wear below 50% of the locking key width  
Prepare for a replacement and upgrade to the new design.
- Wear beyond 50% of the locking key width  
Replace or upgrade the axial bearing immediately.

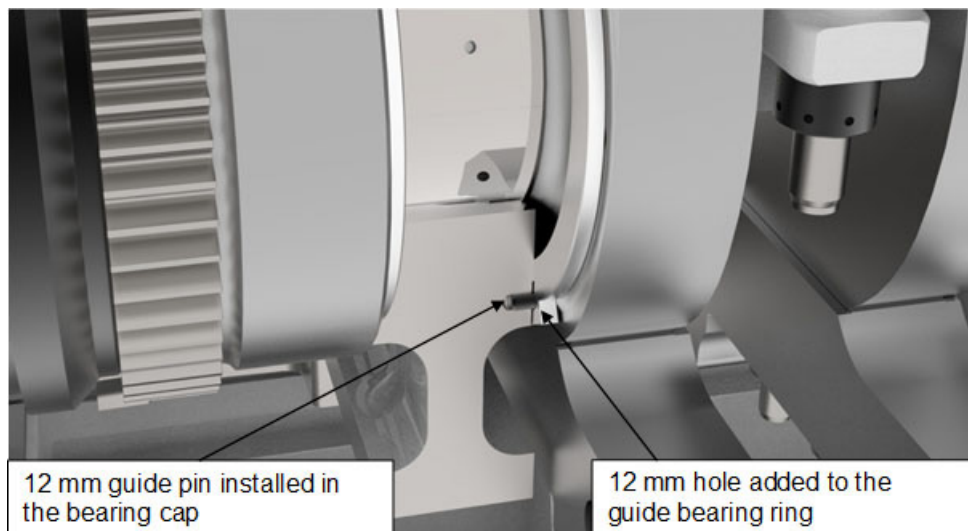
Figure 4. View of the application with guide pin and hole in the guide bearing ring

In order to reduce possible influence of vibrations/resonance on the thrust bearing system, a stronger fixation of these has been introduced as the standard for all newbuildings and is also available as a retrofit for engines in service.

The new design adds two 12 mm guide pins to the bearing cap, and 12 mm holes for fixation of the guide pins have been added to the thrust bearings.

In case wear is observed on the axial bearings, a service kit for introduction of the new fixation is available through out our PrimeServ organisation.
