Fleet Advisory 2023-01 (Accumulated)

Fleet Advisory 2022-02

PSC deficiencies at Osaka, Japan on 05th Jan 2022

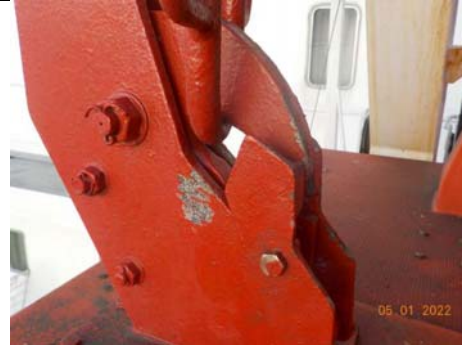
- Starboard side lifeboat link stoppers were recently painted due to which it was stuck. Movable parts should be not painted. Please ensure whenever a device is painted around a moving part, it is exercised to move free.

Stbd side L/B forward part link stopper stuck due to paint.

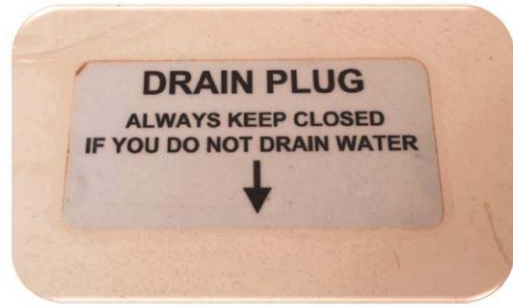
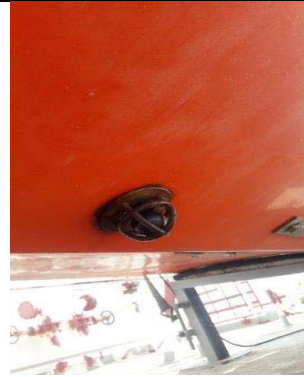
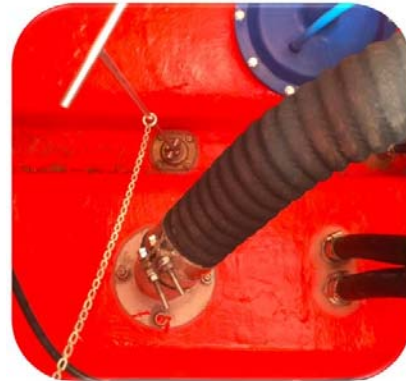
- Bottom plug for the stbd lifeboat was fitted in place but the chain connecting the plug to the boat was found missing during the inspection. Refer SOLAS regulation:

- Drain plug is marked as per above photo "ALWAYS KEEP CLOSED IF YOU DO NOT DRAIN WATER" (Laminate and post if not provided)
- Drain plug is fitted with chain / wire
- Drain plug is kept closed at all times except while draining water.
- Drain ball is in good condition and not seized/damaged/ worn out
- Crutch is attached to lifeboat by chain
- Adjacent lifeboat seat belts are of different colour (contrasting). If not please inform us and make requisition.
