## Fleet Advisory 2024-01 (Accumulated advisories of last years)

Fleet advisory 2023-02: AMSA PSC deficiencies at Fremantle on 03 Feb

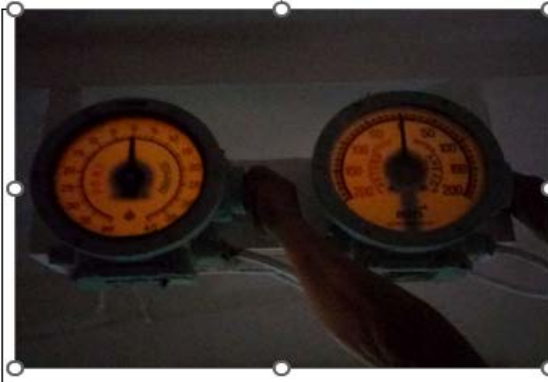
Code	Description
3.10	<p>Is navigation equipment in good order? (V)</p> <p><b>Finding description</b> The illumination for the bridge wing tachometers and rudder angle indicators was not functional at the time of inspection. Rectified during inspection. The dimmer controls on all of these units were seized.</p> <p><b>Root cause:</b></p> <ul style="list-style-type: none"> <li>Inadequate inspection and maintenance of dimmer controls</li> <li>Lack of compliance with Company SMS requirements – The Company's "NAVB22 - DAILY CHECKS" form clearly specifies that buzzer / lamp tests / dimmer lights on each equipment shall be tested which was not complied with in true spirit by the OOW</li> </ul> <p><b>Preventive action:</b></p> <ul style="list-style-type: none"> <li>Ensure strict compliance with all the bridge checklists paying attention in detail to each item.</li> <li>Ensure that each bridge equipment including indicators ,dimmers and associated controls are operational. Any defect identified shall be promptly reported through the defect list and rectified at the earliest opportunity.</li> <li>The Master shall also make random checks on the operational status of the bridge equipment and its controls during daily bridge rounds and during navigational audit.</li> </ul> <div style="display: flex; justify-content: space-around;"> <div style="text-align: center;">

<p><b>Starboard</b> Rudder Angle Indicator and Propeller Shaft revolution Indicator <b>DIMMER ON</b></p> </div> <div style="text-align: center;">

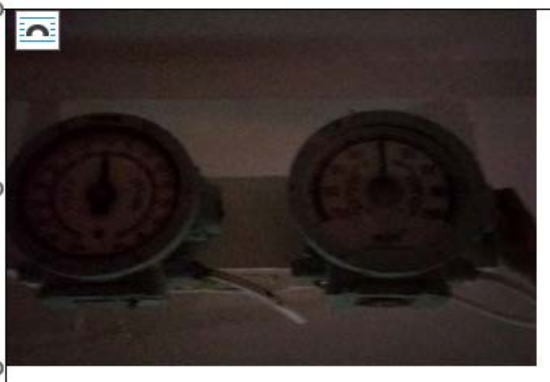
<p><b>Starboard</b> Rudder Angle Indicator and Propeller Shaft revolution Indicator <b>DIMMER OFF</b></p> </div> </div>

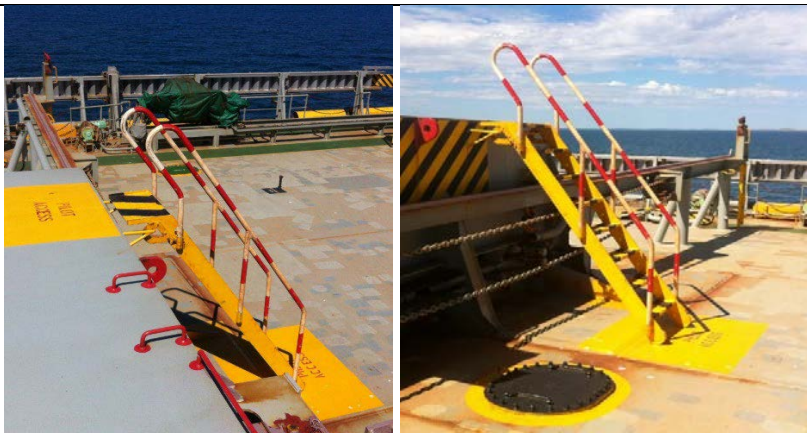
4.39	<p>If the vessel is provided with a helicopter operating area, does the area comply with the requirements of ICS guidelines, and is there a safe access from the hatch cover to deck? (V)</p> <p><b>Findings:</b> The helicopter operating area was said to be "winch only" but was not marked accordingly. The access ladder was not fitted with a front platform with operational load for two persons 150 kg. There was only one access / egress route provided for embarking / disembarking passengers.</p> <p><b>Root cause:</b></p> <ul style="list-style-type: none"> <li>• Inadequate record keeping – The Class approved helicopter landing certificate was not filed onboard in BASSNET system as per Company requirements</li> <li>• Lack of familiarization – The Master was not aware that the vessel hatch No 5 was certified for helicopter landing</li> <li>• Lack of compliance with SMS – The SMS procedures regarding the access ladder requirements from hatch cover to deck was not complied with by the ship staff.</li> </ul> <p><b>Preventive action:</b></p> <p>The Master shall ensure that all certificates are filed promptly in BASSNET once received from the Company. If any certificate is missing or if there are any doubts , the Company shall be consulted.</p> <p>The Master shall also ensure the following SMS requirements regarding helicopter operations:</p> <ul style="list-style-type: none"> <li>• Strength confirmation letter from the classification society shall be available for the helicopter landing hatch ( if hatch is certified for landing)</li> <li>• The access from hatch cover to deck should be a fixed height inclined ladder with fixed handrails and front platform with operational load for two persons (150 KG). The ladder must have “<b>two persons up 150 kg</b>” marked on it. The steps and platforms should be made of non-slip materials. (a set of steps that will at all times provide the user with three points of contact two hands, one foot / two feet, one hand) . The platform shall be painted as per below photos.</li> </ul>

- Master should ensure that, a minimum of two access/egress routes to and from the landing area is available to ensure that, in the event of an incident on the landing area, helicopter passengers and crew can escape upwind of the incident

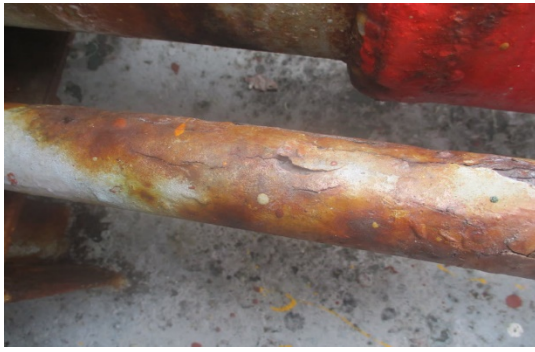
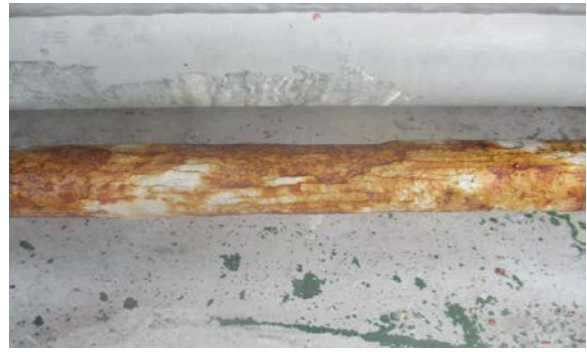
**Before maintenance:**

**Findings:** The pneumatic line on the starboard side upper deck was severely corroded over approximately 30% of its length. Wastage of approximately 25% was noted over extended sections

- Lack of maintenance
- Inadequate planning/preparation - Ship staff did not plan and complete the maintenance of the pneumatic line in a timely manner.

- The Chief officer shall pay attention in detail and look out for excessive corroded areas while taking routine rounds on deck .
- A maintenance plan shall be prepared by the Chief officer and the deck crew shall be instructed to carry out maintenance of these areas in a timely manner.
- Sufficient stock of paints shall be always kept on board.
- The ship Manager shall be informed if any materials are required for repair.

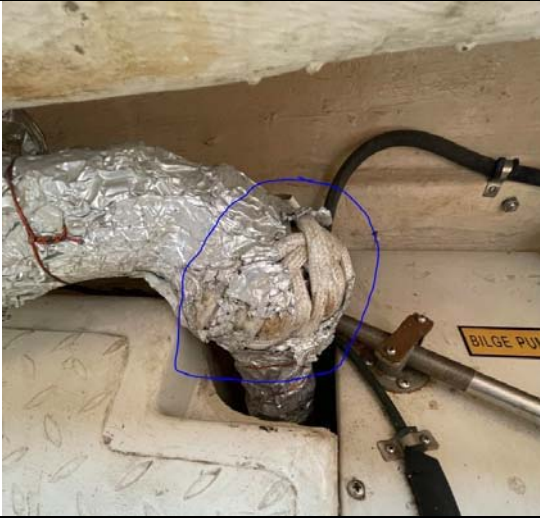
S.No. / Code	Description
1/ 11104	<p>Rescue boat operation instruction ingress broken.</p> <p><b>Comments:</b></p> <ul style="list-style-type: none"> <li>• Rescue boat operation instruction in the plastic enclosure displayed on bulkhead had moisture inside. Water had seeped through the cracked plastic sheet.</li> <li>• Check the Lifeboat and Rescue boat operating instructions posted on board your vessel is legible, unfaded and free from the moisture. Replace if required. Use laminated sheet in place of plastic case.</li> <li>• Ensure that operating instructions are posted under the emergency light.</li> </ul>
2/ 1110 1	<p>The smoke exhaust pipe for free fall lifeboat lack of some fire isolation material.</p> <p><b>Comments:</b></p> <ul style="list-style-type: none"> <li>• The insulation around the exhaust pipe was intact, it was the superficial covering/foil around the insulation material at small section of the smoke exhaust pipe, which was missing.</li> <li>• The superficial covering around insulation was immediately installed after pointing out of the deficiency by inspector.</li> <li>• Check and ensure that the smoke exhaust pipe in your lifeboat is covered with the insulation material for protecting persons from coming with hot parts accidentally.</li> </ul> <p><b>Refer LSA Code 4.4.6.9</b>  The lifeboat engine, transmission and engine accessories shall be enclosed in a fire-retardant casing or other suitable arrangements providing similar protection. Such arrangements shall also protect persons from coming into accidental contact with hot or moving parts and protect the engine from exposure to weather and sea.</p> <p><b>Photo of the insulation</b></p> <div>

</div> <div> <p>Before Inspection</p> <p>After covered by foil</p> </div>

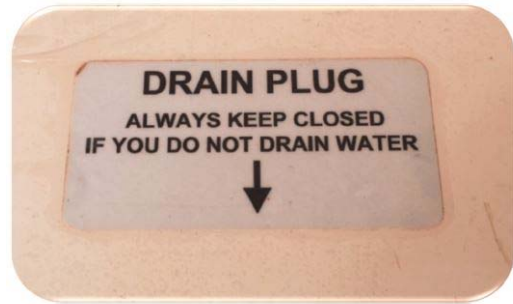
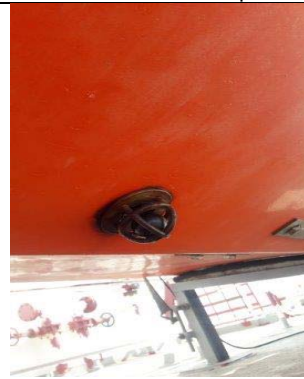
- Bottom plug for the stbd lifeboat was fitted in place but the chain connecting the plug to the boat was found missing during the inspection. Refer SOLAS regulation:

- Drain plug is marked as per above photo "ALWAYS KEEP CLOSED IF YOU DO NOT DRAIN WATER" (Laminate and post if not provided)
- Drain plug is fitted with chain / wire
- Drain plug is kept closed at all times except while draining water.
- Drain ball is in good condition and not seized/damaged/ worn out
- Crutch is attached to lifeboat by chain
- Adjacent lifeboat seat belts are of different colour (contrasting). If not please inform us and make requisition.
