Fleet Advisory 2024-07

PSC deficiencies at Ortona, Italy on 30 Aug 2024

PSC deficiencies at Porto Marghera, Italy on 17 Oct 2024

PSC deficiencies at Zhenjiang, China on 18 Oct 2024

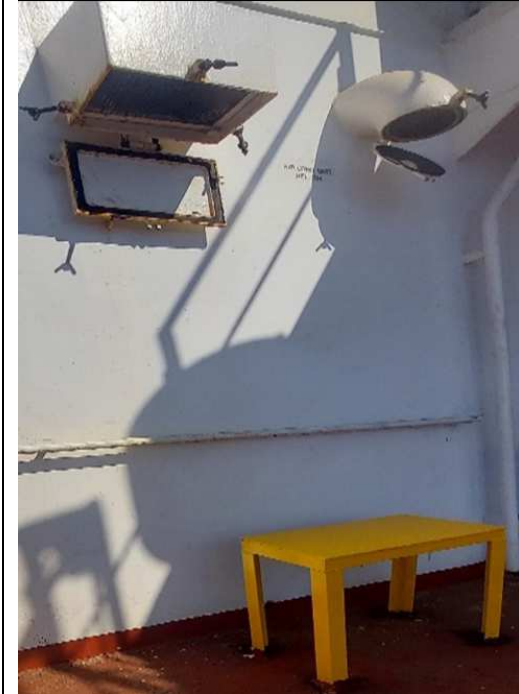
4/18327	<p>Some opening /closing devices of ventilation on outside decks are put in too high position that cannot be reached in safely because steps are missing.</p>

Step installed on deck

- If the air vents around accommodation are not reachable safely from the deck level, please inform your Ship Manager/Superintendent for installing the step below the air vent.

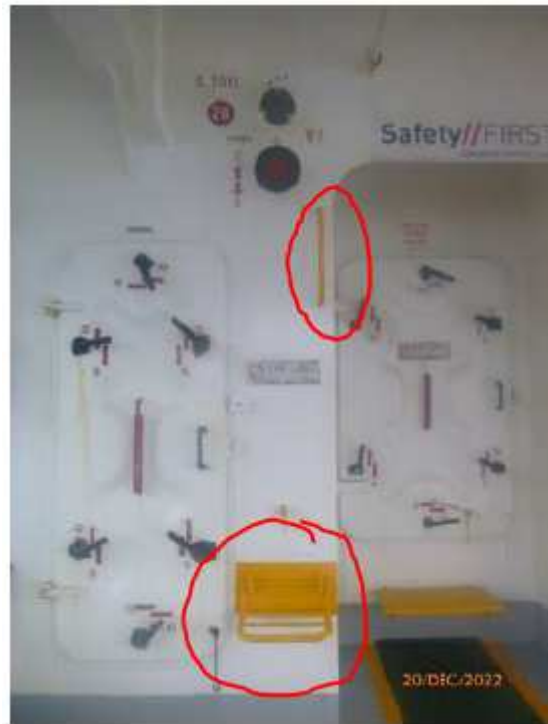
Step and hand hold installed on bulkhead

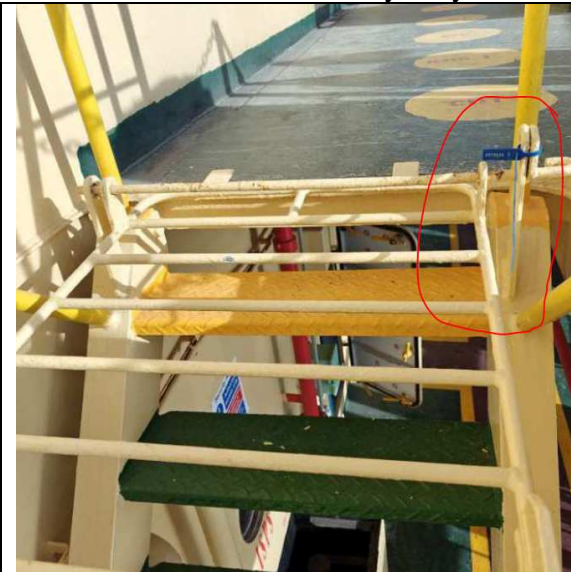
S.No./ Code	Description
1/ 16101	<p>One port side, a padlock has been found used to close a gate for security purposes along with a means of escape.</p> <p>Comments:</p> <ul style="list-style-type: none"> • The plastic security seal is to be preferred for locking the accommodation external ladders in place of a padlock in ports where there is a negligible security risk of theft, stowaways, contraband etc. • The accommodation external ladders are to be padlocked in ports where there is a security risk of piracy, robbery, theft & stowaway/contraband and during transit of high-risk areas. • In port: If external ladder is locked using a padlock, the key is to be kept at the gangway security desk and another key is to be kept in ship's office. • At sea: During high-risk transit area when external ladder is locked using padlock, the key is to be kept in wheelhouse and another key is to be kept in ship's office. • All crew is to be made aware of the locations of the keys keeping in mind that safety of the crew overrides the security. Keys are to be properly marked for the location. <div style="display: flex; justify-content: space-around;"> <div data-bbox="343 1272 917 1841">

</div> </div> <div style="display: flex; justify-content: space-around; margin-top: 5px;"> <div data-bbox="343 1841 917 1877">Plastic seal in use</div> <div data-bbox="954 1841 1385 1877">Pad lock in use</div> </div>

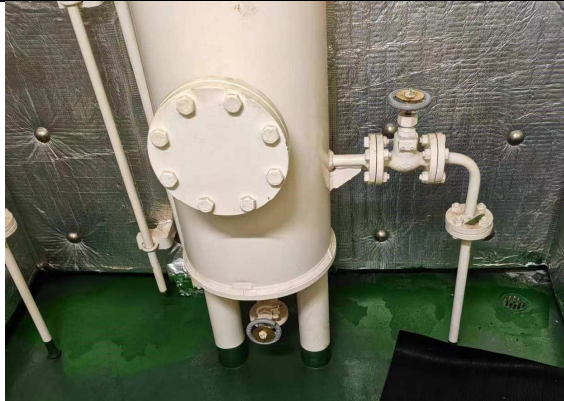
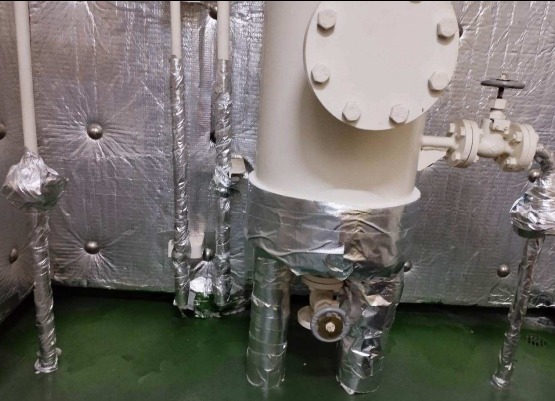
S.No. / Code	Description
1/ 0710 1	<p>Decks bulkheads and penetrations - Insulation materials for pipes from E/R to fire station on A-60 deck not extended 450mm.</p> <p>Comments:</p> <ul style="list-style-type: none"> • The insulation was not installed on the two compressed air pipes passing through the A Class floor to the fire station. • All other pipes, ducts and penetrations passing through the A-Class protection deck are to be insulated up to 450 mm. • Check pipes penetrating the A-Class division are insulated until length of 450mm. <div style="display: flex; justify-content: space-around;"> <div data-bbox="316 898 898 1305">

</div> </div> <div style="display: flex; justify-content: space-around; margin-top: 5px;"> Before - without insulation After - with insulation </div>
<p>Following ClassNK Guidance Part R Annex R9.3.1 Fig.2.1.3-1 for quick reference in accordance with SOLAS II-2 / Reg.9.3.</p>

1 Where a pipe penetrates in a deck or a bulkhead which is required to be insulated, the insulation is to be carried past the penetration for a distance at least 450 mm. (See Fig. 2.1.3-1)

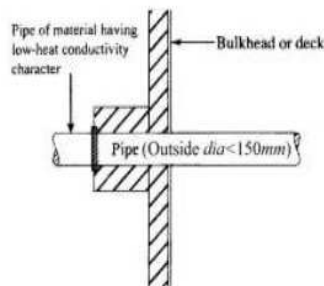
Fig. 2.1.3-2

2 Notwithstanding 1 above, for a penetration of a pipe made of material having low-heat conductivity character (e.g. a metallic pipe) and an outside diameter of less than 150 mm in a "B" class division, the insulation may be terminated at the end of penetration piece or sleeve as required. (See Fig. 2.1.3-2)

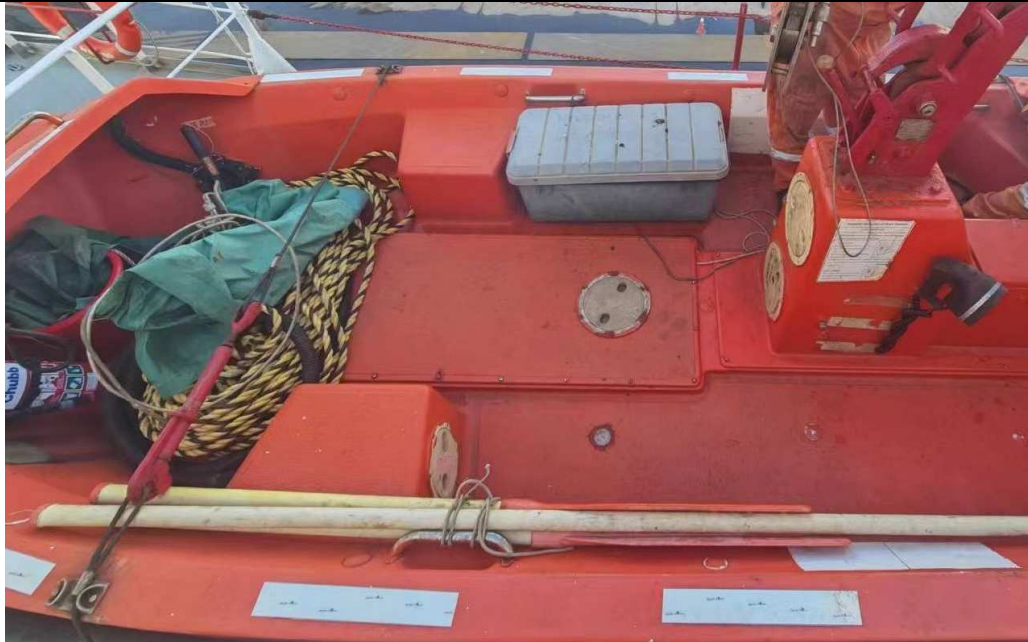
Rescue boat - Seating position of R/B not marked.

Before – without marking the seat

- If the rescue boat seats are not marked, please mark the seats in accordance with the maker's manual and send the photo to your Ship Manager/Technical Superintendent for verification.

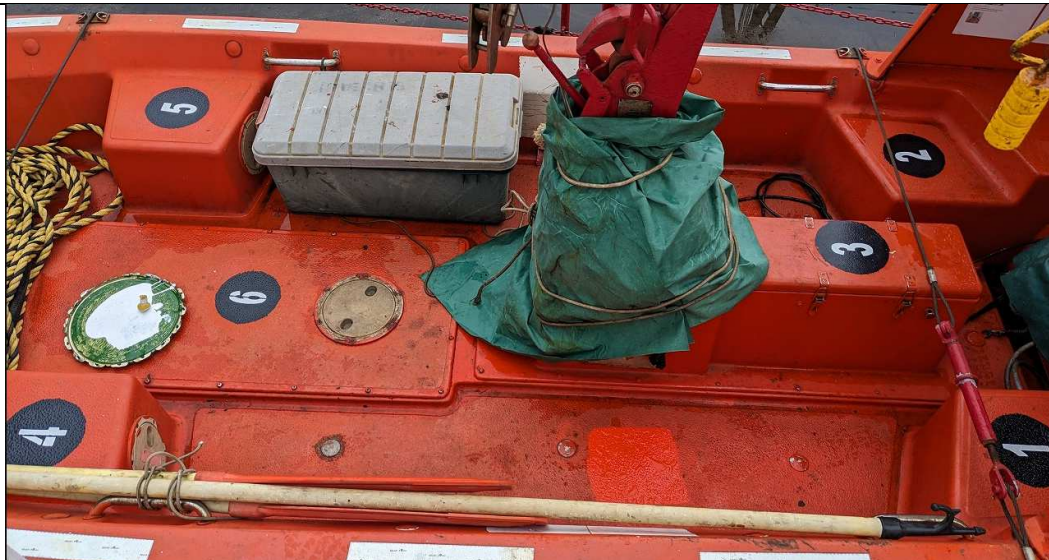
After – seat marked
