Date: 02 DEC 2024

Fleet Advisory 2024-08

PSC deficiencies

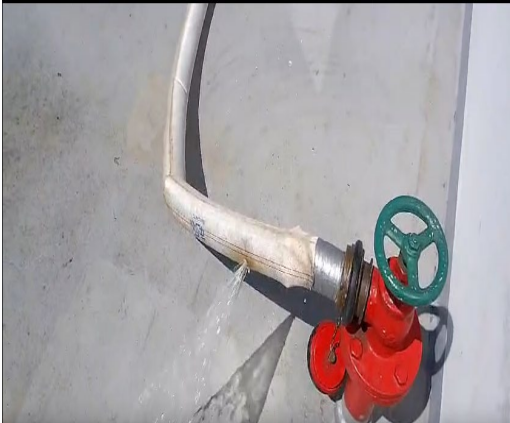
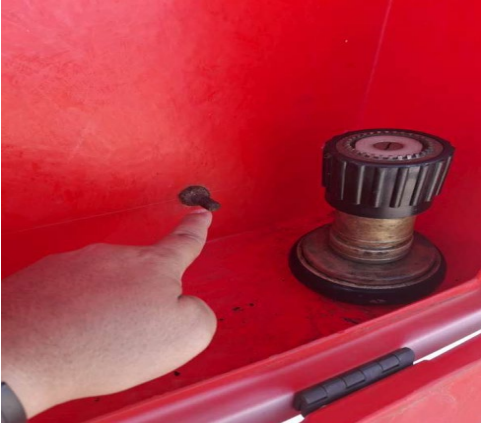
07113	<p>Deficiency - Bridge wing stbd side fire hose punctured and leaking</p> <p>Root Cause: Lack of situational awareness / risk perception / risk awareness Upon investigation, it was observed that the hose box was mounted with a bolt protruding inside the hose box. The hose was tightly stowed in direct contact with the bolt (which was rusted and sharp) and due to ships vibration the bolt had punctured the hose. Refer below photo.</p> <div data-bbox="261 1541 772 1962">

</div> <p>Preventive Actions Check for protruding objects in the hose box and take necessary actions like renewing the corroded bolts , cutting excess length and applying Denso tape so that the hose is stowed in a safe manner.</p> <p>Compliance shall be verified by the safety officer onboard.</p>
