**Fleet Advisory 2025-02**

RightShip inspection findings, Chittagong on 31Jan2025

## Fleet Advisory 2025-03

## Fleet Advisory 2025-04

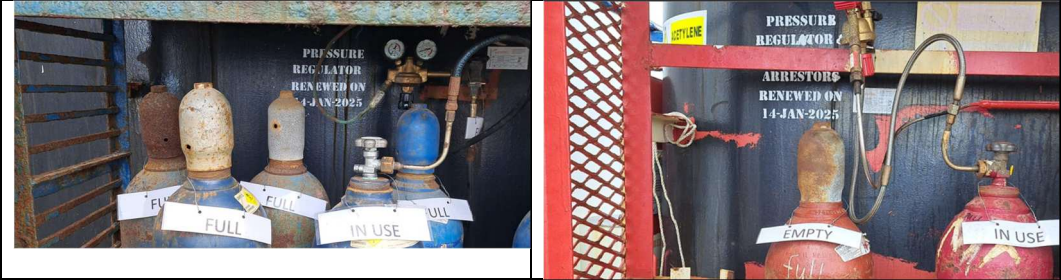
| 4.17 | <p><b>Checks made on the oxygen-acetylene bottles of welding equipment/ installation on board and the following noted: 1) Some of the bottles were not marked/missing empty/Full and some safety caps were missing. 2) Gas burning installation pressure regulators were not being replaced every five years or as indicated by the manufacturer, no records were available.</b></p> <p><b>Company comments:</b></p> <ul style="list-style-type: none"> <li>The pressure regulator is replaced every five years as per company PMS, please mark the date of change of pressure regulators in Oxygen/Acetylene room in addition to recording in PMS.</li> <li>Ensure caps are to remain on cylinders not connected for use.</li> <li>Ensure bottles are appropriately identified Empty/Full.</li> </ul> <p>Sample of marking regulator renewal date and Empty/Full/In Use tags :</p> |

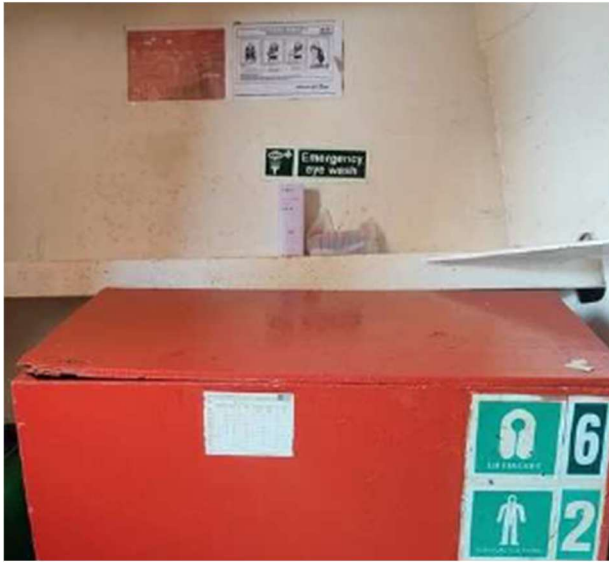
| 4.20 | <p>Life jackets and immersion suits were kept in forward store, however no donning instructions were posted around there.</p> <p><b>Comments:</b></p> <ul style="list-style-type: none"> <li>• Ensure life jacket and immersion suit donning instructions are posted near the storage box in the forward store.</li> </ul> |

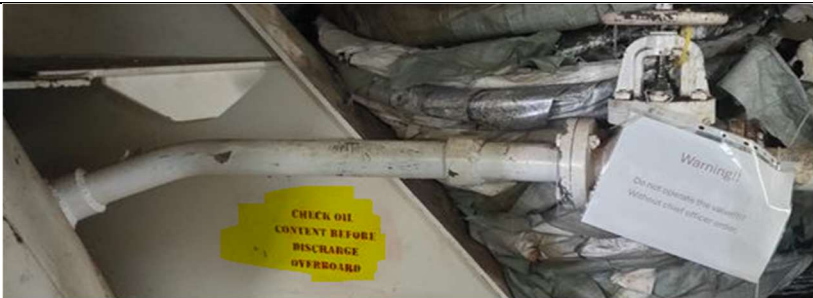
| 5.9 | <p><b>Warning poster/measures were not in place near the overboard discharge valve to prevent the accidental discharge of oil from forward store D'watering system.</b></p> <p><b>Company Comments:</b></p> <ul style="list-style-type: none"> <li>• Pollution prevention notice was posted near the bilge suction valve. However, it was missing at the overboard discharge valve.</li> <li>• Mark 'Check oil content before discharging overboard' near the overboard discharge valve in forward store.</li> </ul> <p>Sample photo:</p> |

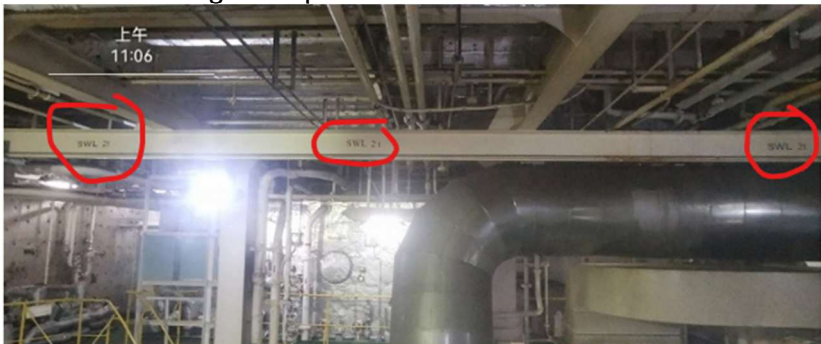
| 13.27 | <p><b>Is the engine room crane and other lifting gear regularly inspected, tested, and maintained? (V &amp; M)</b></p> <p><b>Findings:</b> The engine room overhead transverse crane's beam and the internal fore and aft 'I' beam were not clearly marked with SWL in several locations to make visible from all standing positions. (Mark found at one place and only one side of the beams and not at both sides).</p> <p><b>Company comments:</b></p> <ul style="list-style-type: none"> <li>The engine room transverse crane beam should be clearly marked in several locations – not only on the travelling beam itself and, on the hook, but also on the internal fore and aft 'I' beam – so that no matter where you are standing on the engine room top plates the SWL of the equipment is clearly visible. (RISQ Guide to Inspection)</li> <li>Check the SWL markings is clearly marked at several locations visible from any location on E/R top plate, mark SWL where required.</li> </ul> <p>SWL marking example:</p> |

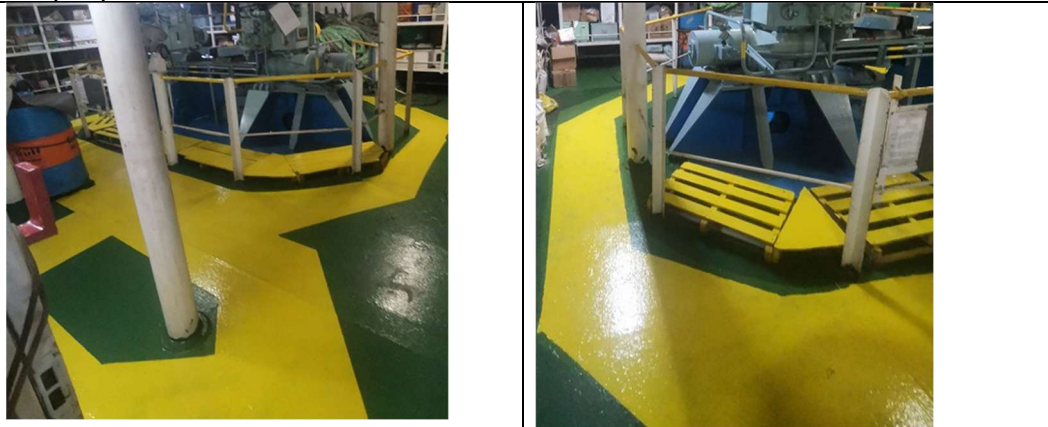
| 13.45 | <p><b>Steering gears compartment outer walkways were found slippery and the surfaces were not provided with non-slip paints or with gratings.</b></p> <p><b>Comments:</b></p> <ul style="list-style-type: none"> <li>The steering gear compartment shall be provided with suitable arrangements to ensure working access to steering gear machinery and controls. These arrangements shall include handrails and <b>gratings or other non-slip surfaces</b> to ensure suitable working conditions in the event of hydraulic fluid leakage. (SOLAS II-1/29.13.2)</li> </ul> |

| | <ul style="list-style-type: none"> <li>Check the condition of non-slip paint coating (not applicable where gratings are provided), plan painting non-slip coat if required. If required add sand to make the paint non-slip.</li> </ul> <p>Sample photo:</p> <div data-bbox="311 280 1364 705"> </div> |

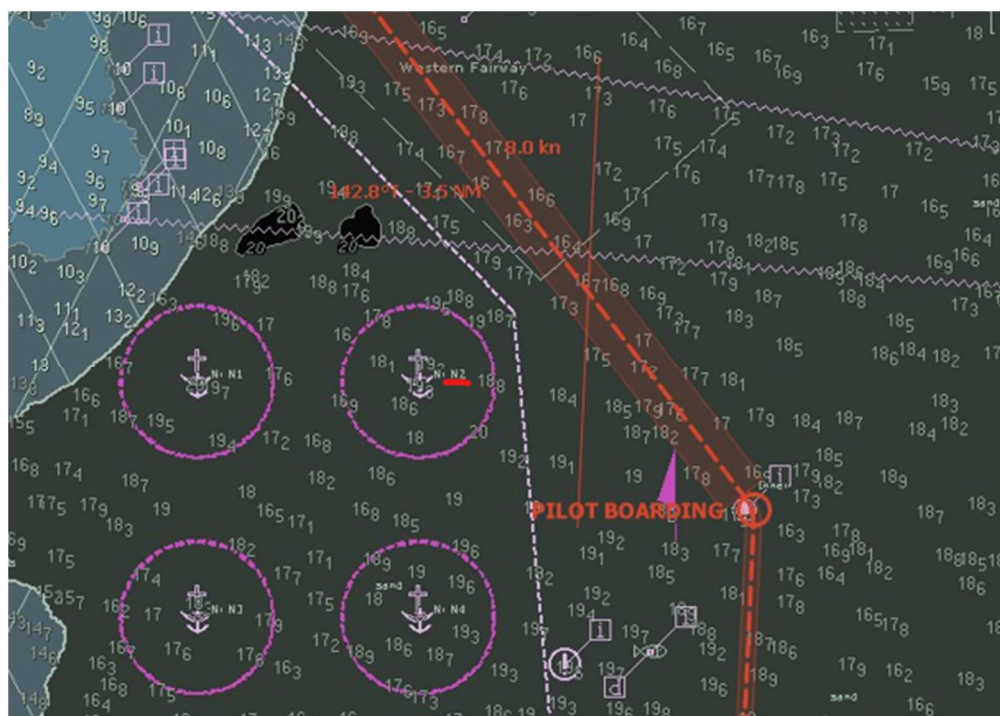
### **Anchorage waypoint not included for in bound Kwinana passage plan.**

- As usual vessel's original passage plan was prepared from berth to berth. However, vessel was required to anchor prior berthing at designated anchorage N2 which was about 0.4 NM from the vessel's route, refer below ECDIS screenshot but the passage plan was not revised for the deviation waypoint.

- Refer 'Nautical Manual/9.0 Passage Planning/11. Passage plan changes/Deviation' requires the original passage plan to amend in case of any change/deviation. We have added a clear para as highlighted in yellow when vessel needs to anchor prior berthing.

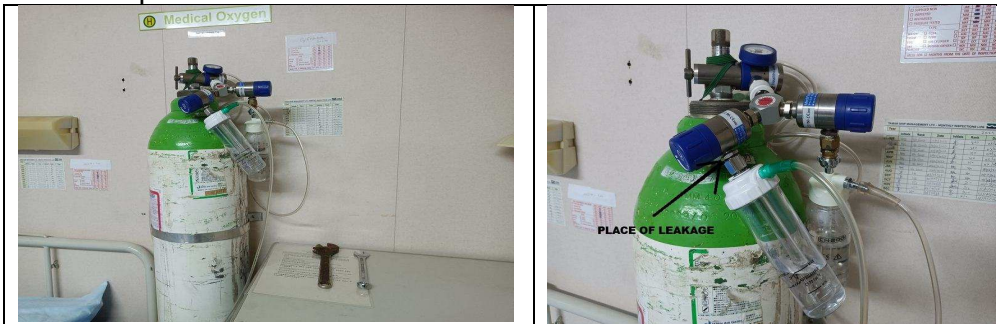
| <p>Code<br/>18401</p> | <p><b>The oxygen cylinder of the oxygen resuscitator in the ship's infirmary leakage.</b></p> <p><b>Comments:</b></p> <ul style="list-style-type: none"> <li>Minor air leak was noticed between the air regulator and humidifier bottle when cylinder valve (40 litre) for checking the air pressure was opened. Probably the nut connecting the humidifier bottle and air regulator was not properly tightened after last filling up of the water in the bottle during last routine inspection.</li> </ul> <div data-bbox="368 638 1369 960"> </div> <ul style="list-style-type: none"> <li>Ensure fittings/connections are properly tightened after routine inspection/maintenance.</li> <li>Check for any air leakage after completion of the maintenance by opening the air cylinder valve.</li> </ul> |

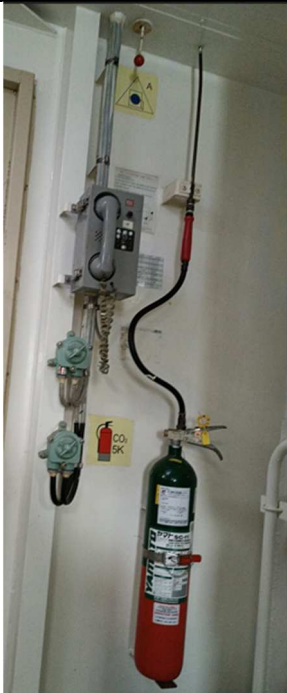
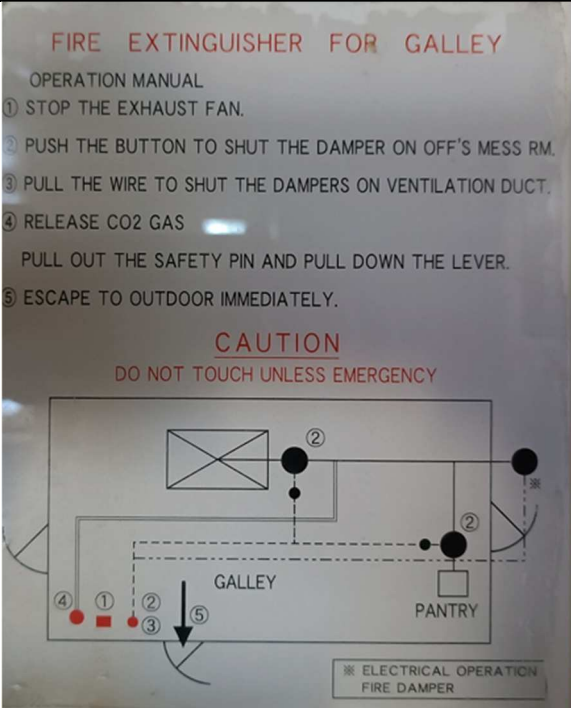
| No./Code | Description |
|---|---|
| 1/07123 | <div>Crew in charge was not familiar with CO2 fire extinguishing system in Galley.</div> <div> Comments: <ul style="list-style-type: none"> <li>Please assess the knowledge of the crew members on the operation of fixed CO2 fire extinguishing system in Galley (where fitted). If required, conduct the familiarization training of the crew members on the operation of fixed CO2 fire extinguishing system.</li> <li>Ensure clear operation instructions are posted near the CO<sub>2</sub> fire extinguishing system.</li> <li>Crew should be familiar with the operation of all fire extinguishing systems fitted on board the vessel.</li> <li>During monthly training as required by company Form 3.2.1, please ensure the training session is kept interactive with the crew members and assess their knowledge with the operation of fixed firefighting system.</li> </ul> </div> <div>Refer fixed CO2 fire extinguishing system fitted in Galley on inspected vessel with operation instructions.</div> <div> <div> </div> <div> </div> </div> |

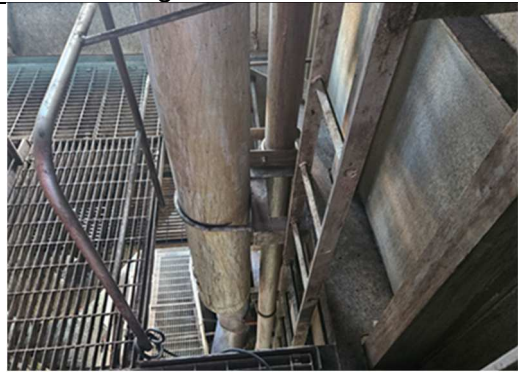
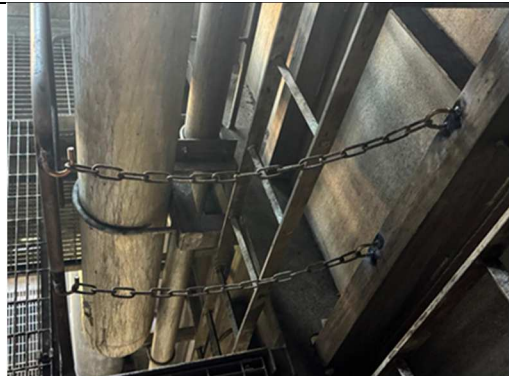
| S.No./ Code | Description |
|---|---|
| 2/<br>18499 | <p>ER – Upper platform in ER casing – Safety chain to prevent crew falling not present.</p> <p><b><u>Comments:</u></b></p> <ul style="list-style-type: none"> <li>The yard design did not include a safety chain/barrier at the ER upper platform in the casing.</li> </ul> <div style="display: flex; justify-content: space-around;"> <div style="text-align: center;"> <p>Photo before installing chains</p> </div> <div style="text-align: center;"> <p>Photo after installing the chains</p> </div> </div> <ul style="list-style-type: none"> <li>Check all different platforms in the E/R for the openings which may pose fall hazard and inform office if any opening with fall hazards is not provided the safety chains.</li> </ul> |

| | <ul style="list-style-type: none"><li>• Please pay attention to details on fall hazards while carrying out routine safety inspection.</li></ul> |
