## Fleet Advisory 2026-06

### PSC deficiency at Yangpu, China on 12 May 2026

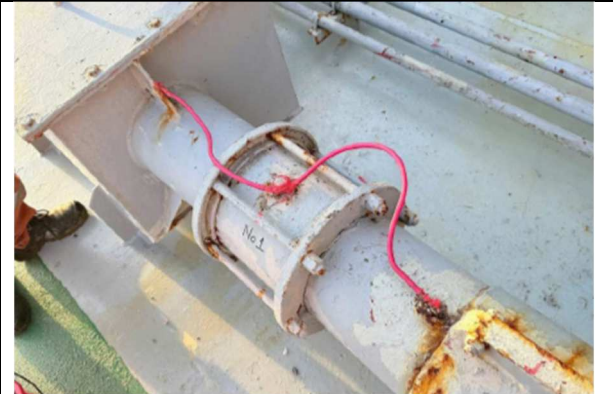
| S.No./ Code | Description |
|---|---|
| 1/<br>18322 | <p>Disconnected ground wire at foremost end of cable conduit on port side of main deck.</p> <p><b>Comments:</b><br/>This deficiency resulted due to disconnected ground wire on conduit pipe expansion joint.</p> <p>Installed new ground wire</p> <p>Please note as following:</p> <ul style="list-style-type: none"> <li>• Check the ground wire is installed across expansion joints of the pipes on deck.</li> <li>• Check after each heavy weather transit for any detachment of ground wire</li> <li>• The purpose of the grounding wire is as following: <ul style="list-style-type: none"> <li>➢ Ensures that all metallic parts of the conduit remain at the same electrical potential, preventing stray currents or shock hazards.</li> <li>➢ Provides a path for static electricity or fault currents to safely dissipate to the ship's hull/earth</li> <li>➢ Equalizing potential reduces galvanic corrosion between dissimilar metals in the conduit system.</li> <li>➢ This movement can break the metallic continuity of the conduit, so the dedicated earthing strap/wire ensures grounding is not lost.</li> </ul> </li> </ul> |

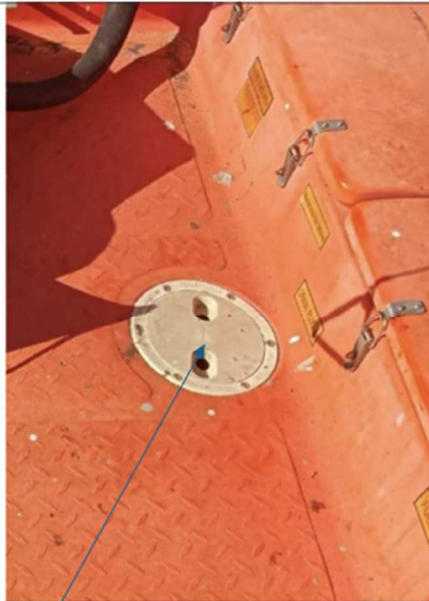
| S.No./ Code | Description |
|---|---|
| 3/11104 | <p>Damage to drain plug hatch of rescue boat on starboard side of boat deck.</p> <p><b>Comments:</b><br/>It was the access cover for the equipment storage space of rescue boat (not the drain plug), which had a hairline crack as following:</p> |

Hairline crack

- Check access cover for the equipment storage space of Rescue boat/lifeboat for any defect/crack
- Carry out routine inspection of lifesaving appliances and its equipment diligently
- Any minor defect is to be immediately reported and rectified.

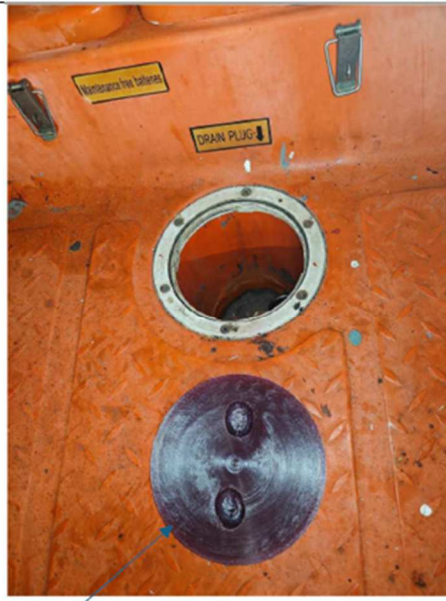
New lid
