## Fleet Advisory 2026-09

RightShip inspection findings, Kobe, Japan on 19 June 2026

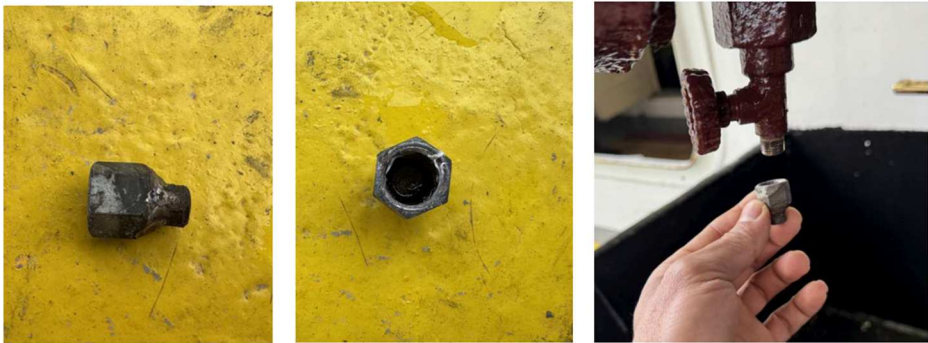
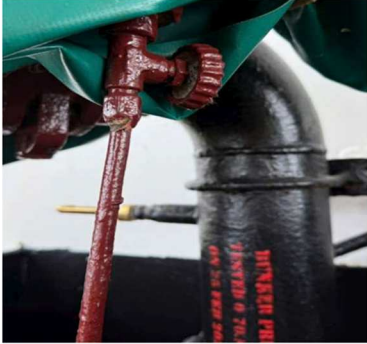
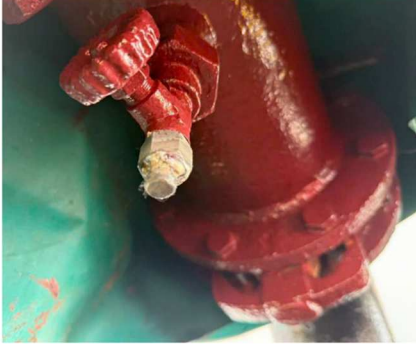
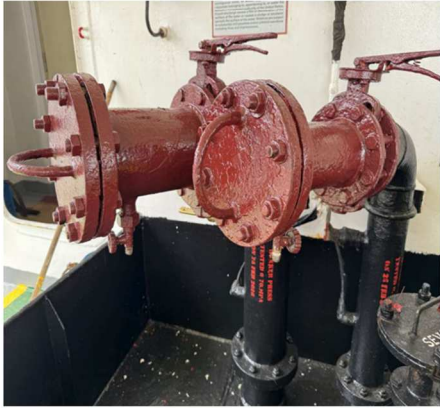
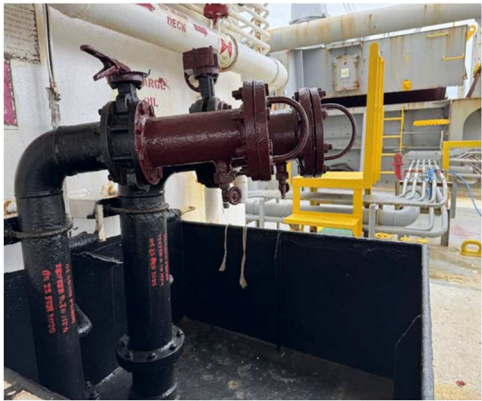
| 7A.3 | <p><b>Both drain lines on port and starboard bunker manifolds were fitted with a single valve without blanking.</b></p> <p><b>Comments:</b></p> <ul style="list-style-type: none"> <li>• Bunker manifold drain lines are to be blanked/capped/plugged (as applicable) where drain lines are provided with single valve.</li> <li>• Check metallic caps/plugs are tight-fitting and leak-proof</li> <li>• Blanking is to be checked prior to bunkering.</li> <li>• Please send the photographic evidence to your Ship Manager of blanked/capped/plugged (as applicable) manifold drain lines.</li> <li>• Refer following photos for your guidance.</li> </ul> <div data-bbox="400 1361 1332 1702"> </div> <div data-bbox="400 1787 1337 1816"> <p>Fabricated Plugs for Bunker Manifold (P,S)</p> </div> |

| | <div style="display: flex; justify-content: space-around;"> </div> <div style="display: flex; justify-content: space-around; margin-top: 10px;"> <p>Before</p> <p>After</p> </div> <div style="display: flex; justify-content: space-around; margin-top: 10px;"> </div> <div style="display: flex; justify-content: space-around; margin-top: 5px;"> <p>Bunker Manifold Port side</p> <p>Bunker Manifold Starboard side</p> </div> |
