Fleet Advisory 2024-02

PSC deficiencies in Tianjin, China on 08 April 2024

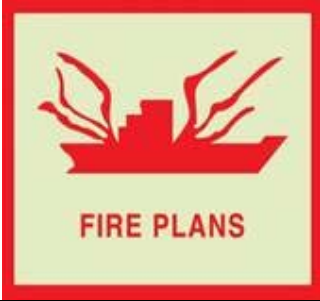
<p>IMO SYMBOL as per fire plan</p>	<p>SYMBOL as required by MSC/Circ. 451</p>

- Ensure both symbols IMO and symbol required by MSC/Circular.451 showing fire on ship are posted near the fire plan enclosure on both side of the accommodation.

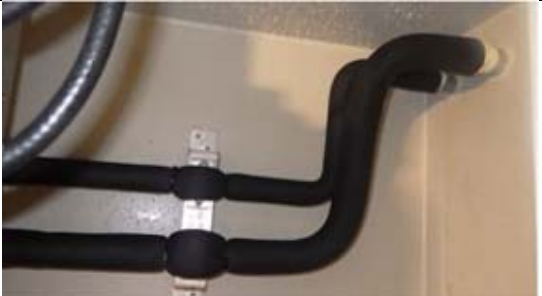
The refrigeration line in the meat room iced seriously.

- The line found frosted by the PSC inspector was the gas return line after the evaporator which does not require lagging as per the maker and will automatically defrost during the set defrost cycle. There was no requirement from the maker to insert lagging on this line.
- Refer to the maker drawings and ensure that the refrigeration room pipelines are covered with appropriate lagging material (if applicable) to prevent icing of the pipeline.

<p>Before without lagging</p>	<p>After installing lagging</p>

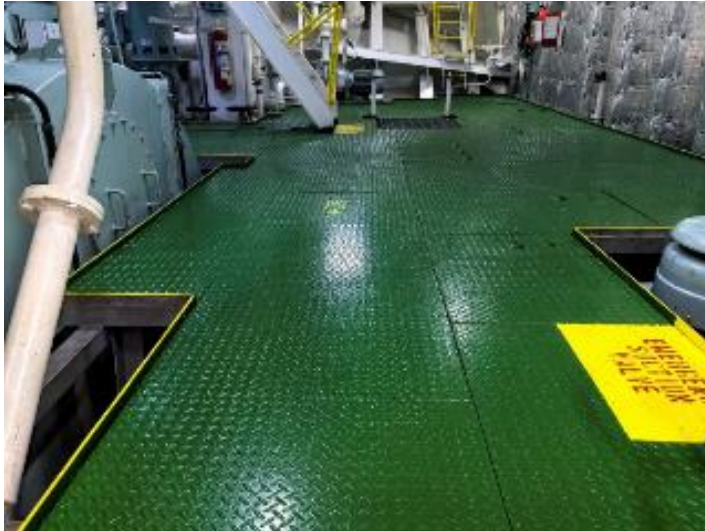
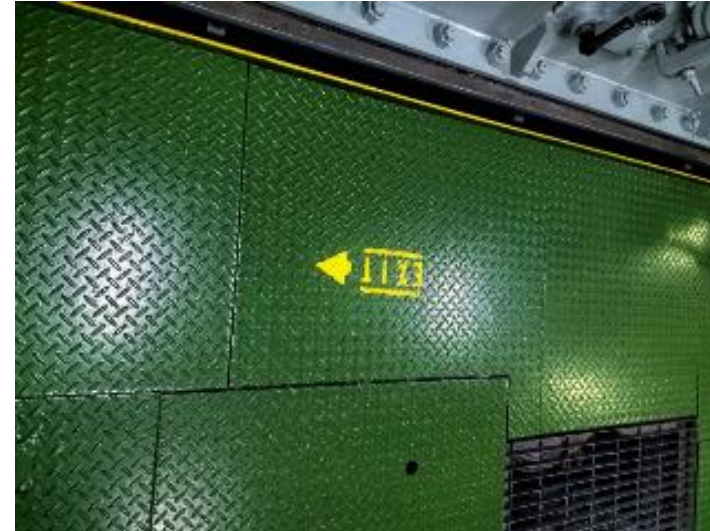
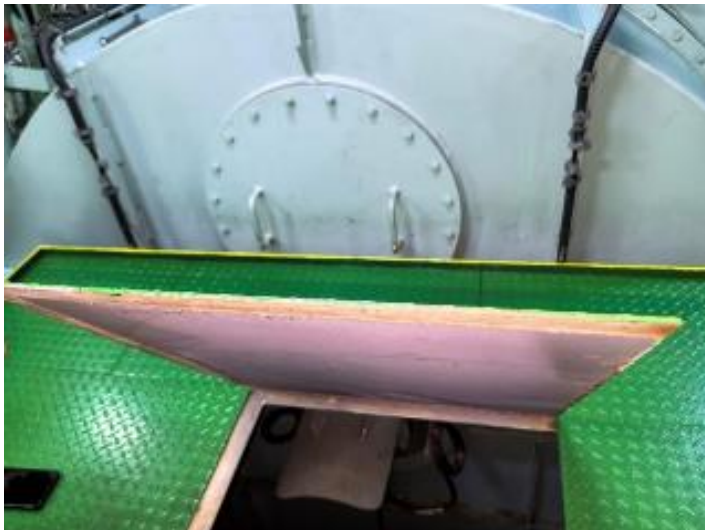
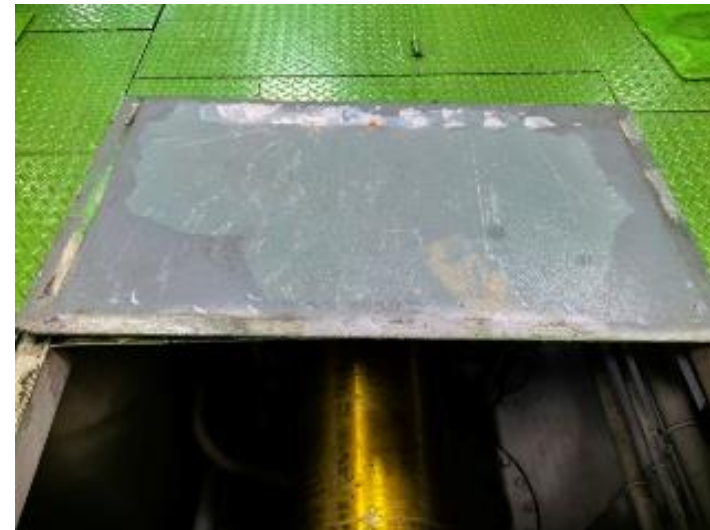
As per PSCO requirement, the floor plates in ER should be secured on the frame to avoid shifting in case of ship rolling & pitching at sea / listing / flooding.

At delivery from shipyard, the floor plates are not secured.

Drill holes in the plates and supporting frames with straight twist drill
(Drill Φ : 9mm)

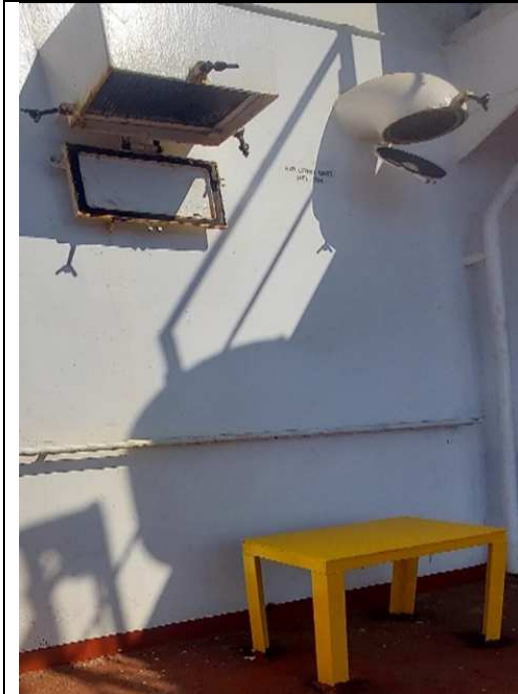
4/18327	<p>Some opening /closing devices of ventilation on outside decks are put in too high position that cannot be reached in safely because steps are missing.</p>

Step installed on deck

- If the air vents around accommodation are not reachable safely from the deck level, please inform your Ship Manager/Superintendent for installing the step below the air vent.

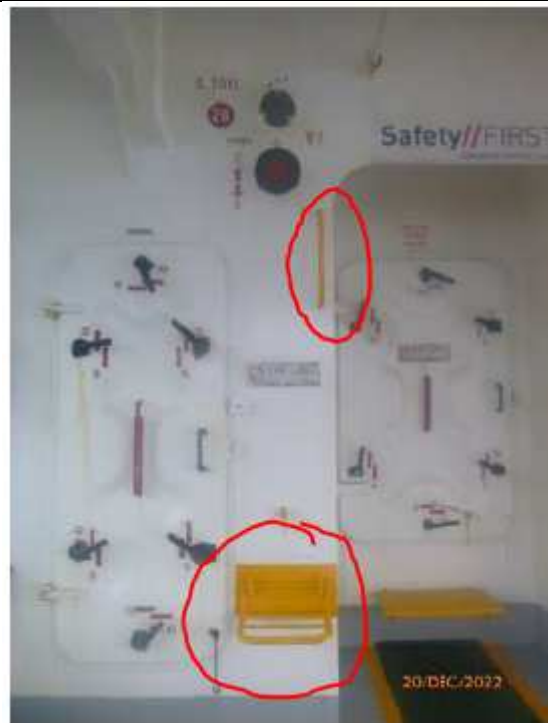
Step and hand hold installed on bulkhead

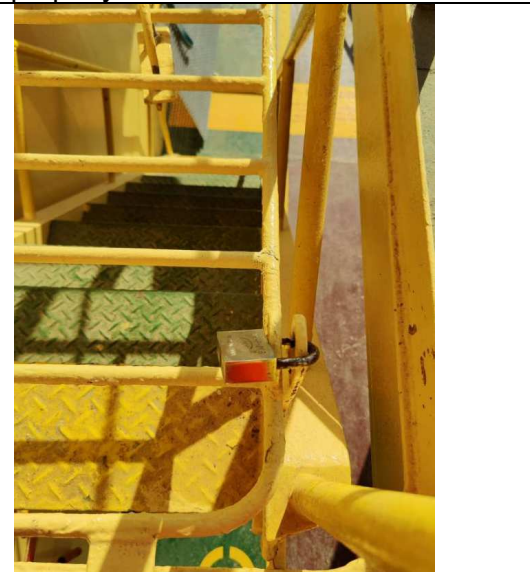
S.No./ Code	Description
1/ 16101	<p>One port side, a padlock has been found used to close a gate for security purposes along with a means of escape.</p> <p>Comments:</p> <ul style="list-style-type: none"> • The plastic security seal is to be preferred for locking the accommodation external ladders in place of a padlock in ports where there is a negligible security risk of theft, stowaways, contraband etc. • The accommodation external ladders are to be padlocked in ports where there is a security risk of piracy, robbery, theft & stowaway/contraband and during transit of high-risk areas. • In port: If external ladder is locked using a padlock, the key is to be kept at the gangway security desk and another key is to be kept in ship's office. • At sea: During high-risk transit area when external ladder is locked using padlock, the key is to be kept in wheelhouse and another key is to be kept in ship's office. • All crew is to be made aware of the locations of the keys keeping in mind that safety of the crew overrides the security. Keys are to be properly marked for the location. <div style="display: flex; justify-content: space-around;"> <div data-bbox="343 1272 917 1841">

</div> </div> <div style="display: flex; justify-content: space-around; margin-top: 5px;"> <div data-bbox="343 1841 917 1877">Plastic seal in use</div> <div data-bbox="949 1841 1481 1877">Pad lock in use</div> </div>

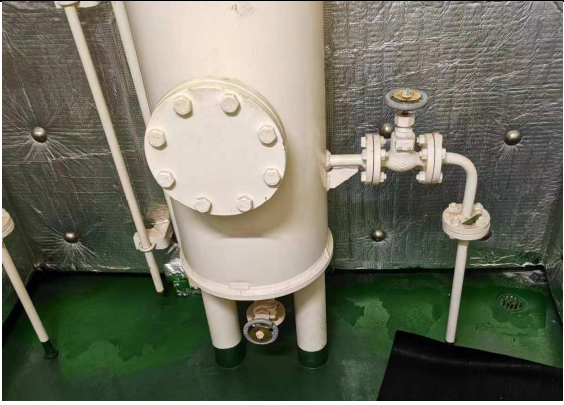
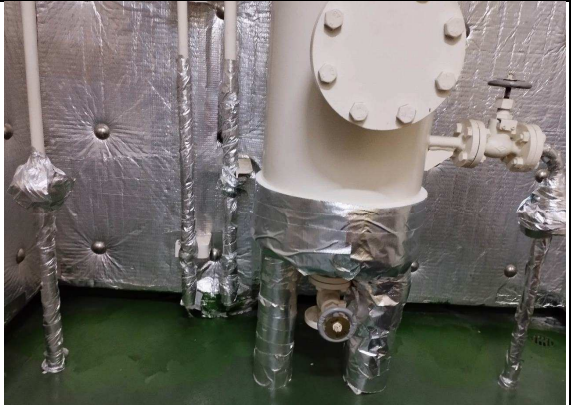
S.No. / Code	Description
1/ 0710 1	<p>Decks bulkheads and penetrations - Insulation materials for pipes from E/R to fire station on A-60 deck not extended 450mm.</p> <p>Comments:</p> <ul style="list-style-type: none"> • The insulation was not installed on the two compressed air pipes passing through the A Class floor to the fire station. • All other pipes, ducts and penetrations passing through the A-Class protection deck are to be insulated up to 450 mm. • Check pipes penetrating the A-Class division are insulated until length of 450mm. <div style="display: flex; justify-content: space-around;"> <div data-bbox="317 902 898 1305">

</div> </div> <div style="display: flex; justify-content: space-around; margin-top: 5px;"> Before - without insulation After - with insulation </div> <p>Following ClassNK Guidance Part R Annex R9.3.1 Fig.2.1.3-1 for quick reference in accordance with SOLAS II-2 / Reg.9.3.</p>

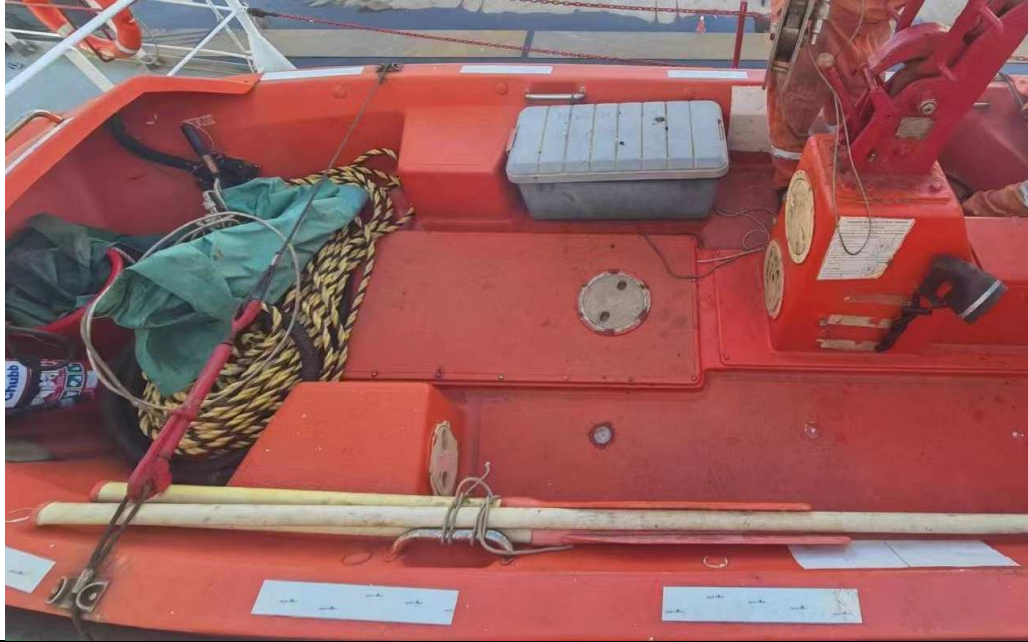
Rescue boat - Seating position of R/B not marked.

Before – without marking the seat

- If the rescue boat seats are not marked, please mark the seats in accordance with the maker's manual and send the photo to your Ship Manager/Technical Superintendent for verification.
