AREA / LOCATION : Cable penetrations on fire resistant divisions ( bulk heads/ deck)

**Note : Please recheck all penetrations on board especially where security cameras and WIFI installations have been recently installed. Ineffective sealing will affect fire integrity of vessel and will also result in PSC deficiencies.**

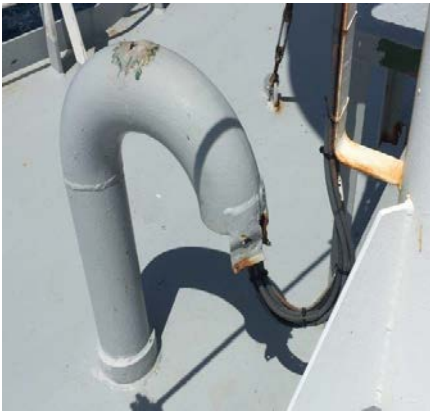
Monkey island Sealing not done using fire retardant material

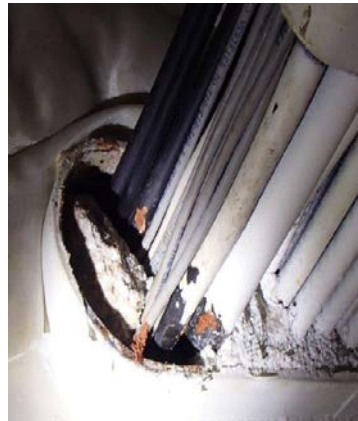
Sealing not done using fire retardant material

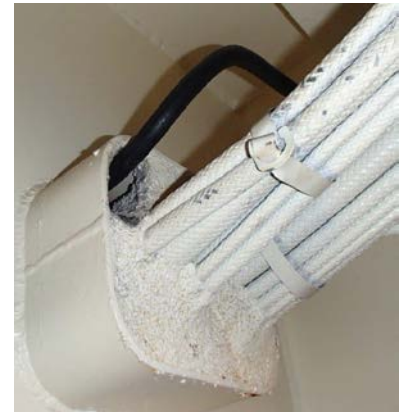
Sealing not done using fire retardant material

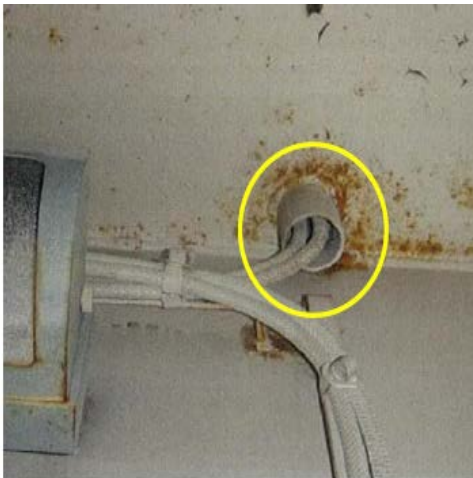
Sealing not done using fire retardant material

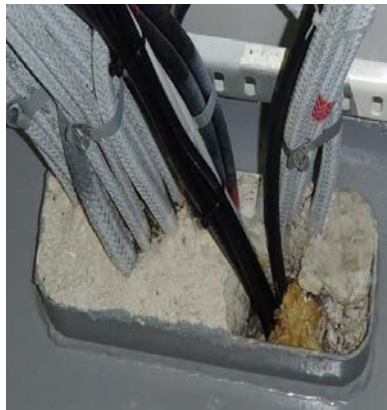
Sealing not done using fire retardant material

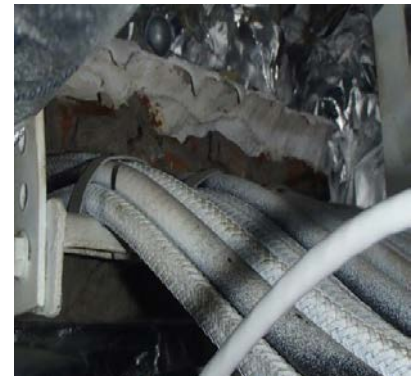
Sealing not done using fire retardant material

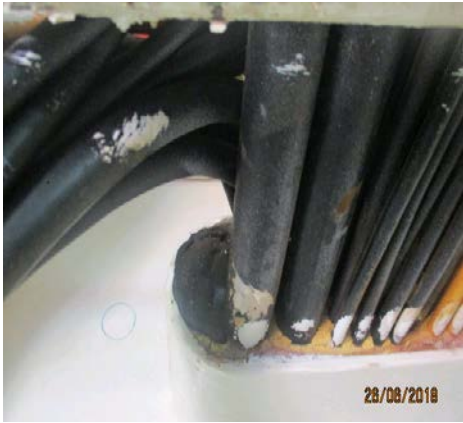
Fire retardant compound inserted on bosun store cable penetration

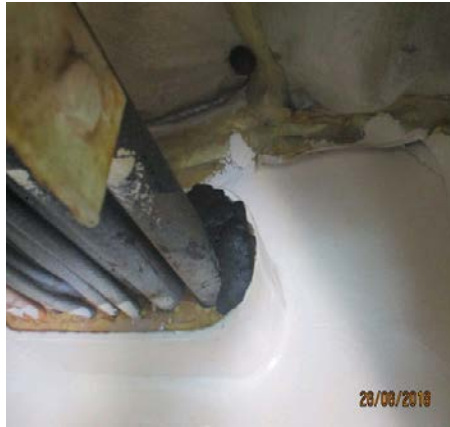
Fire retardant compound inserted on carpenter store cable penetration

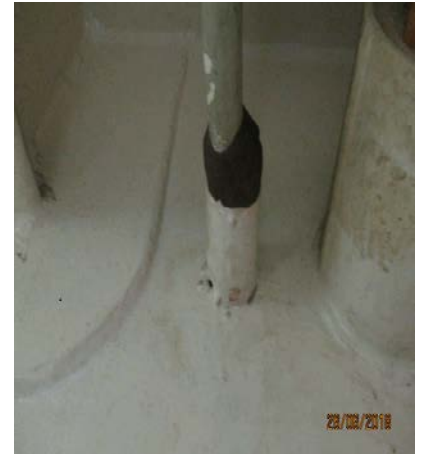
Fire retardant compound inserted on pump room cable penetration
