AREA / LOCATION : **FFA – POOR PRACTICES RESULTING IN PSC DEFICIENCIES/ DETENTION**

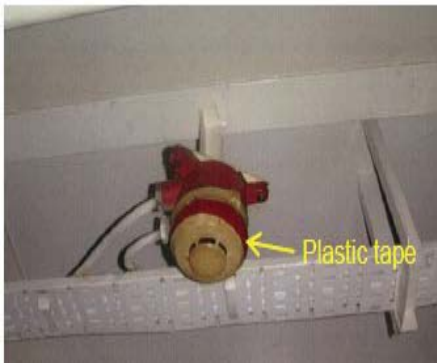
Fire detector covered with plastic tape

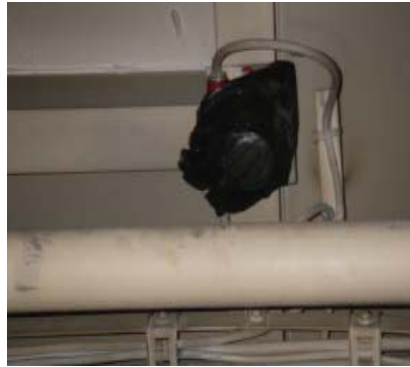
Smoke detector covered with plastic bag

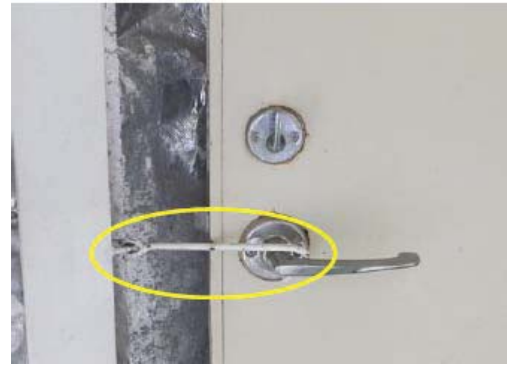
Hold back hook - Unacceptable

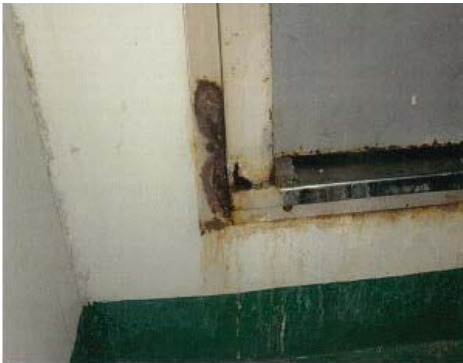
Worn out and wasted fire door frame

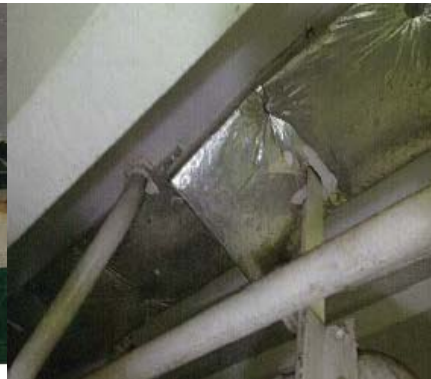
Deteriorated insulation

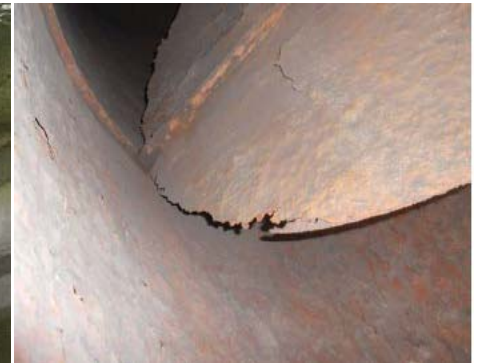
Fire damper flap wasted

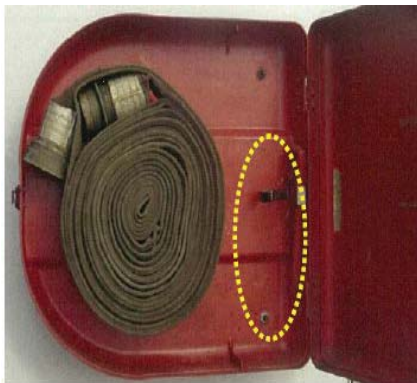
Nozzle missing

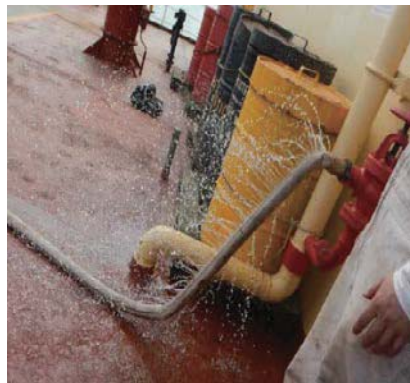
Leaking fire hoses

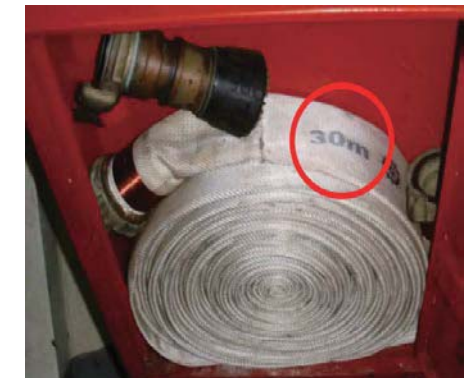
Length of fire hose in Engine room more than 15 M

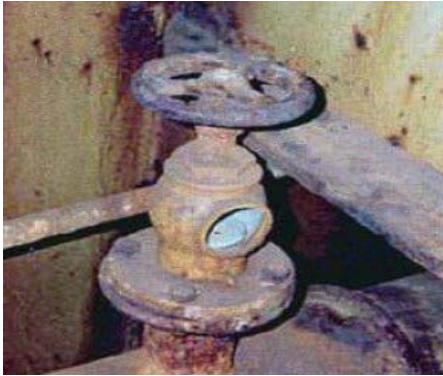
Corroded hydrant and missing coupling

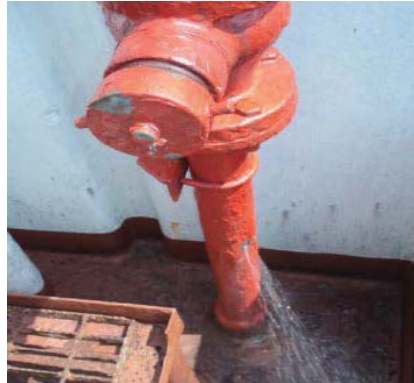
Leaking fire line

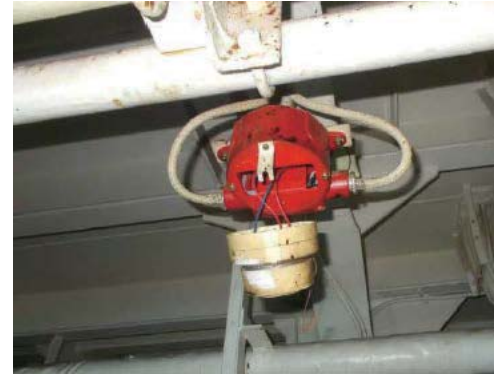
Defective fire detector

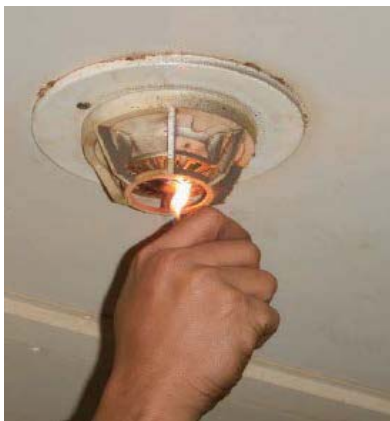
Improper test method

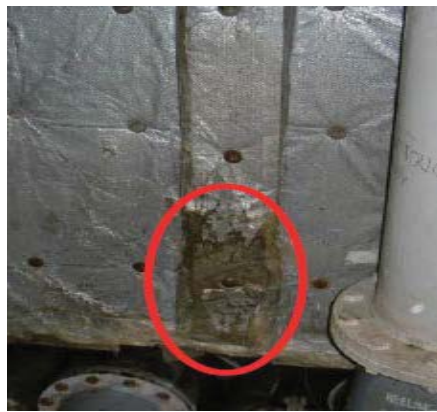
Partly missing Class A insulation

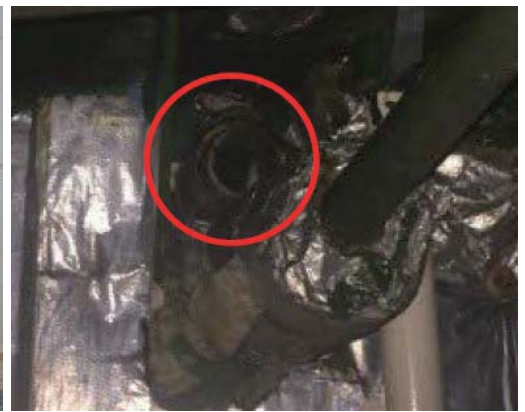
Hole in A-60 class Bulk head

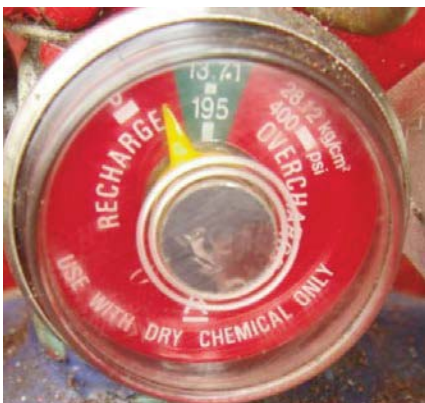
Fire extinguisher not charged

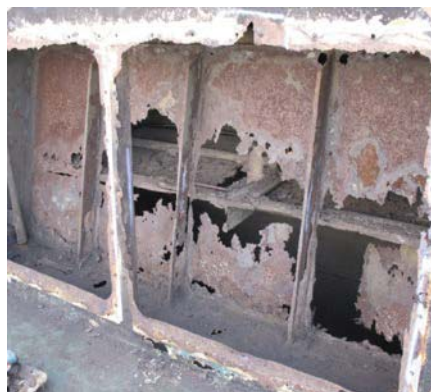
Fire damper wastage found after removing cover

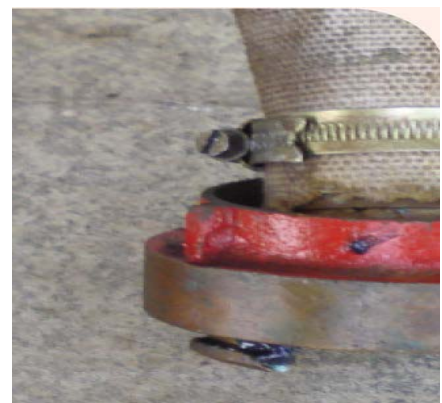
Fire hose end secured using unapproved method
