# INTERIM REPORT

## MARINE CASUALTY SAFETY INVESTIGATION

Death of one seafarer, one stevedore and serious injury of one stevedore

#### M/V IONIC

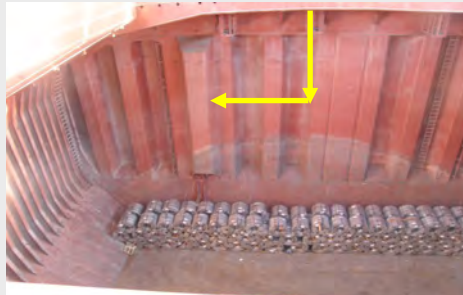
Cargo Hold No 1 showed from fore section. Duct is pointed in yellow.

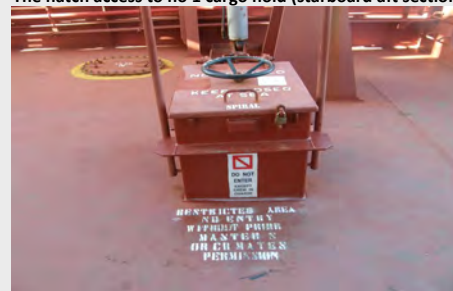
The hatch access to no 1 cargo hold (starboard aft section)

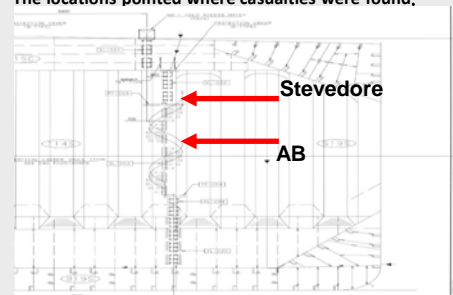
The locations pointed where casualties were found.
