MARINE SAFETY ALERT

Safety Alert 07-22

UNEXPECTED DANGERS: LIFEBOAT REMOTE CONTROL WIRES

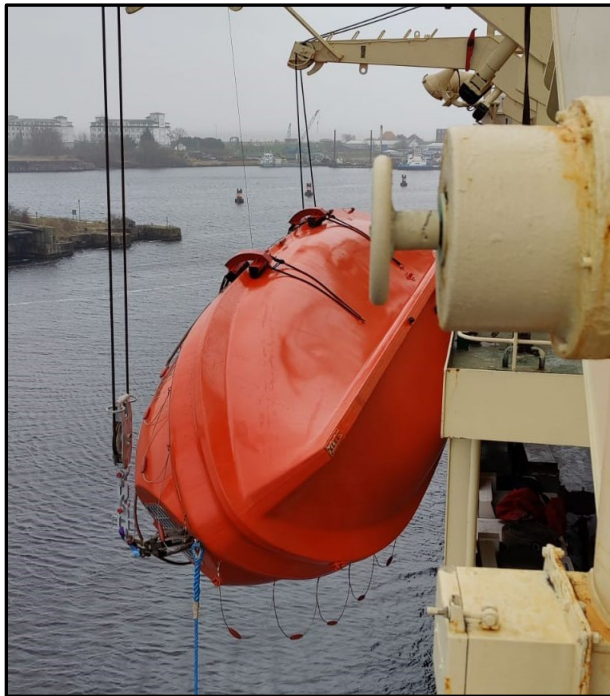
- (2) The second occurred a day later after the replacement remote control wire was hand spooled from extra wire found on board. While testing with crew on board using the remote control wire to lift the brake, an unexpected pay out of wire led to the winch brake prematurely engaging, which made the lifeboat stop lowering and swing erratically above the embarkation deck. Seconds later, the movement caused the wire to regain tension, which lifted the winch brake arm and caused the lifeboat to lower again. While lowering in a swinging motion, the skeg of the lifeboat caught on the knife-edge of the ship's deck, causing the lifeboat to list more than 90 degrees. Without the quick action of a crewmember who activated the winch brake lever from the deck, the lifeboat could have inverted further and led to catastrophic outcomes.

Figure 3 - Lifeboat listing more than 90 degrees w/ crew inside.

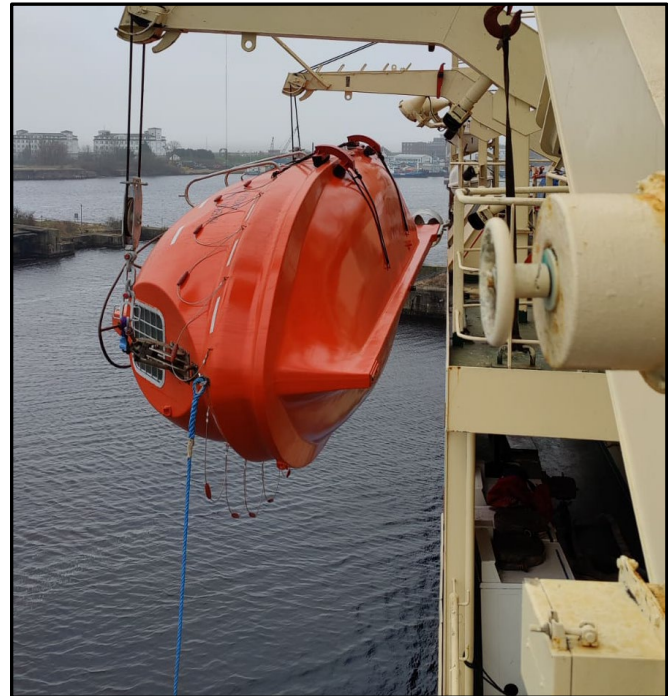
Figure 4 - Lifeboat skeg caught on deck edge.
