Marine Inspection Detachment Singapore

August 11, 2022
Singapore

Findings of Concern 009-22

AUTHORIZED MAINTENANCE OF LIFESAVING SYSTEMS

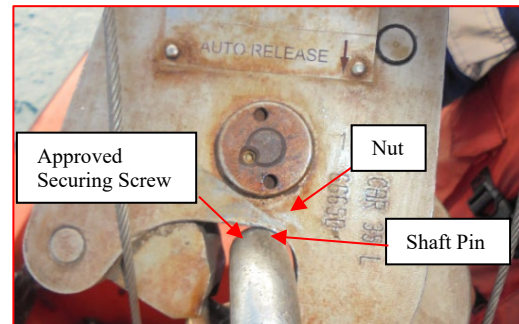
Figure 1

Causal Factors and Analysis. The primary cause of this casualty was improper release gear configuration (see figure 1 for basic nomenclature). Specific causal factors were determined to be an improper securing screw replacement, thread wear on the shaft pin, and the addition of two shackles between the spliced cable eye and the release gear (see figures 2 and 3).

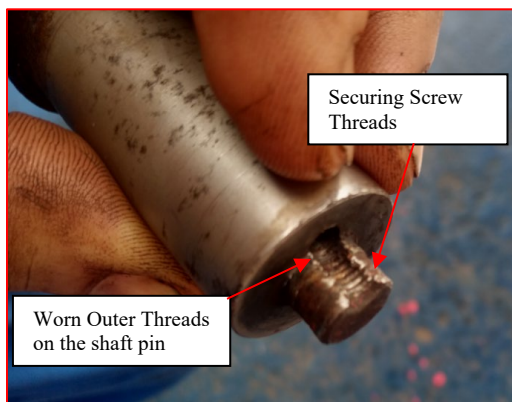
Figure 2

- Objective evidence indicates that the securing set screw was a generic aftermarket machine screw and not approved by the Original Equipment Manufacturer (OEM).
- The most recent release gear servicing was not completed by an authorized service provider¹.
- Objective evidence indicates that two shackles were added at some point between the spliced cable eye and the release gear shaft pin. According to the OEM, the release gear was designed to be directly connected to the shaft pin with the spliced cable eye without the use of shackles.

- The Company should ensure that servicing of lifesaving appliances is completed by an authorized service provider for the specified lifesaving appliance.
- There should be no modifications to lifesaving appliances without consulting the OEM or an authorized service provider (e.g., components, configuration, complex repairs, etc).
- The Company's Safety Management System (SMS) should contain provisions for thorough risk assessments and equipment inspections prior to use of lifesaving appliances, particularly after servicing is performed.

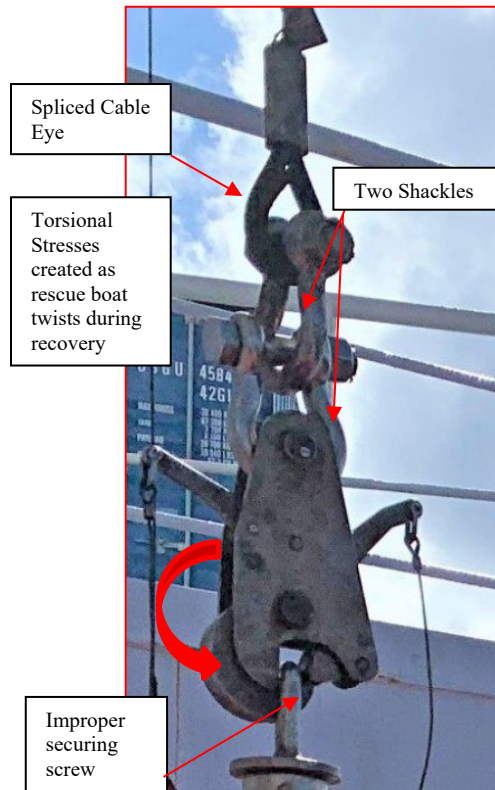
Figure 3

The torsional stresses created during the rescue boat recovery combined with the two shackle configuration created sufficient outward force on the release gear side plates to cause mechanical failure of the nut that secures the shaft pin to the release gear. Subsequently, the dynamic forces in play during the rescue boat recovery caused the shaft pin to back out of one of the release gear side plates. This created an uneven loading condition causing the side plate to deflect outward and the rescue boat to hang from the release gear at an unconventional angle. As the angle continued to open (i.e., the shaft pin becomes parallel with the wire rope) and the side plate continued to

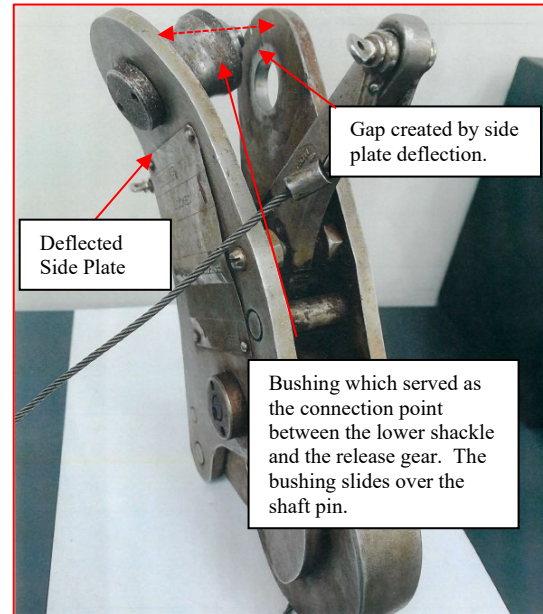
Figure 4

deflect, a sufficient gap was created to allow the cable and bushing to slip free of its connection point on the release gear. (see figure 4). Throughout the incident, the release gear hook never disengaged and remained firmly secured to the lifting stanchion of the rescue boat (see figure 5).
