Making waves IVSS CAMPAIGN APR 2025

Table of Contents

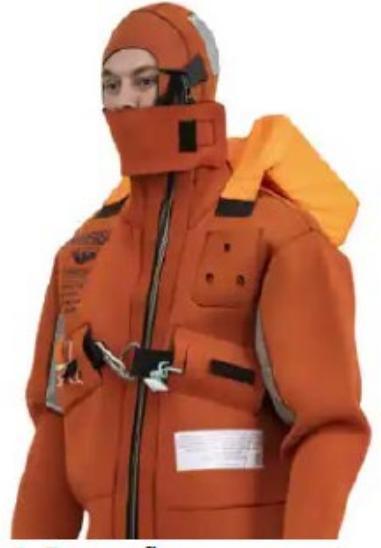
Image 1: Proper fit

The issue observed while attempting to don the suit is the hood's fabric and design may prevent the zipper from being fully zipped, allowing for water ingress. The photos below show the intended fit and the zipper malfunction.

The Master shall ensure that each crew try the immersion suit (regardless of the model) to check for proper donning and fit.

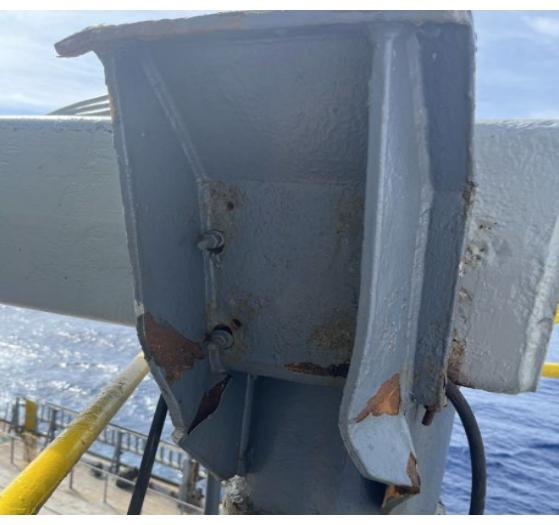
No. 3 Crane Jib Resting Post

On one of our vessels, the indentation damage to crane no.4 jib was reported to office by THE Superintendent on 7th Feb 25 during his visit to vessel in Port. The ship staff was unaware of the indentation. There was no report from the ship about the indentation on the jib.

- 4. Contact point of damage "No. 3 crane jib parking post "is not visible from No. 4 crane cabin, is in a blind spot.
- 5. Possible reason for contact damage

The crane was repaired as per the maker's repair plan and to the satisfaction of Class incurring huge cost and off hire of vessel.

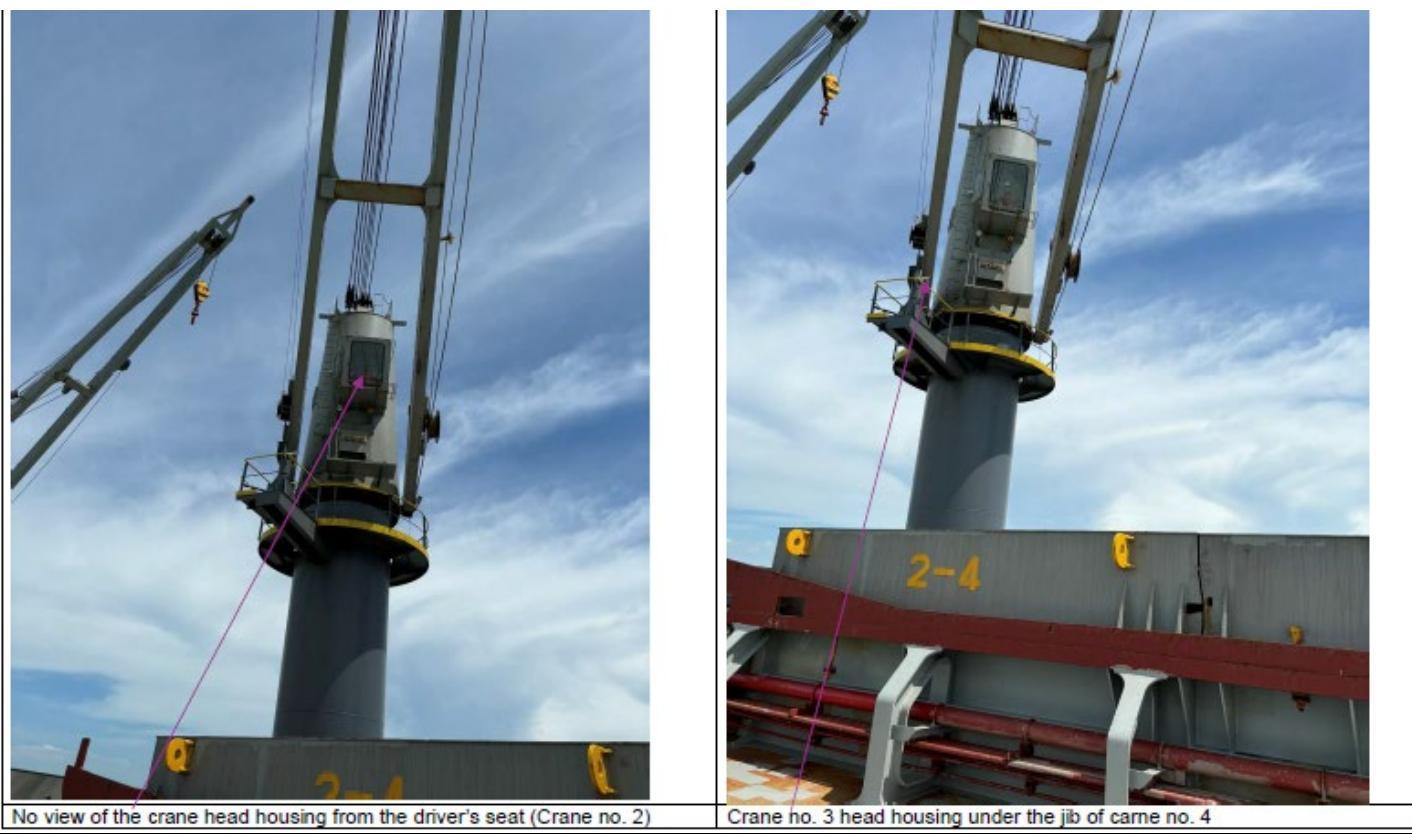
No view of the crane head housing from the driver's seat (Crane no. 2)

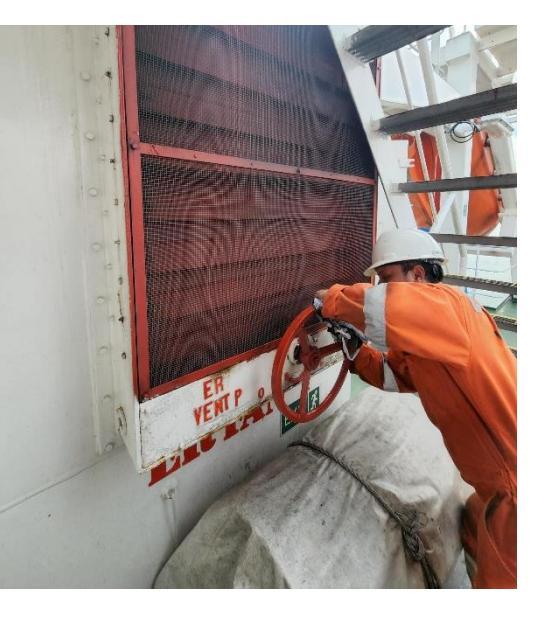
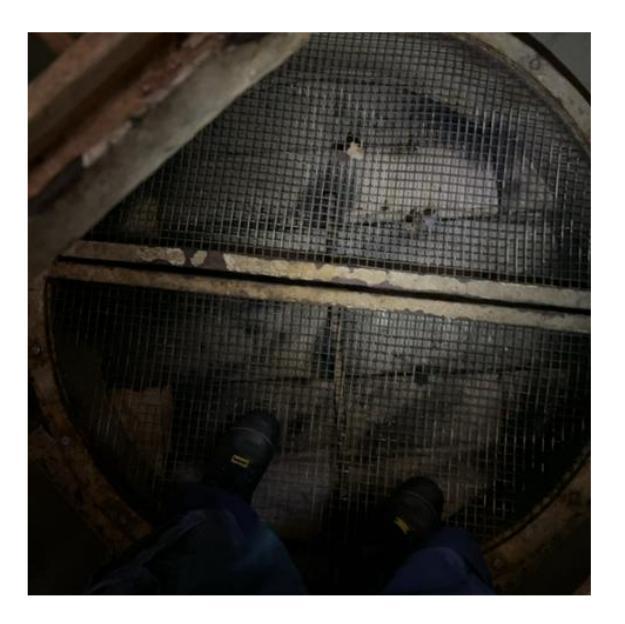
Fire dampers :

- All Engine Room ventilation fire dampers unable to be closed.
- Engine Room port side fire damper not operational.

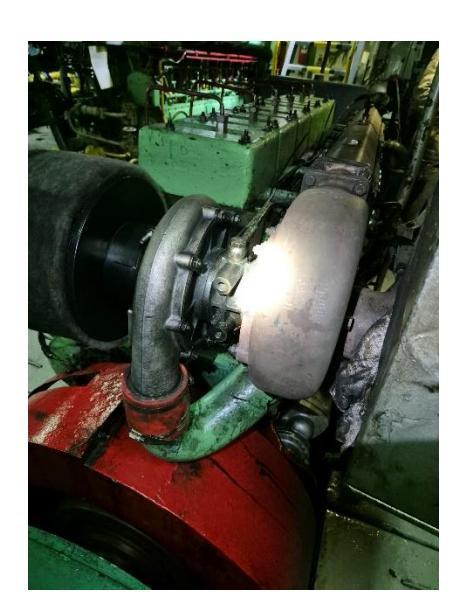
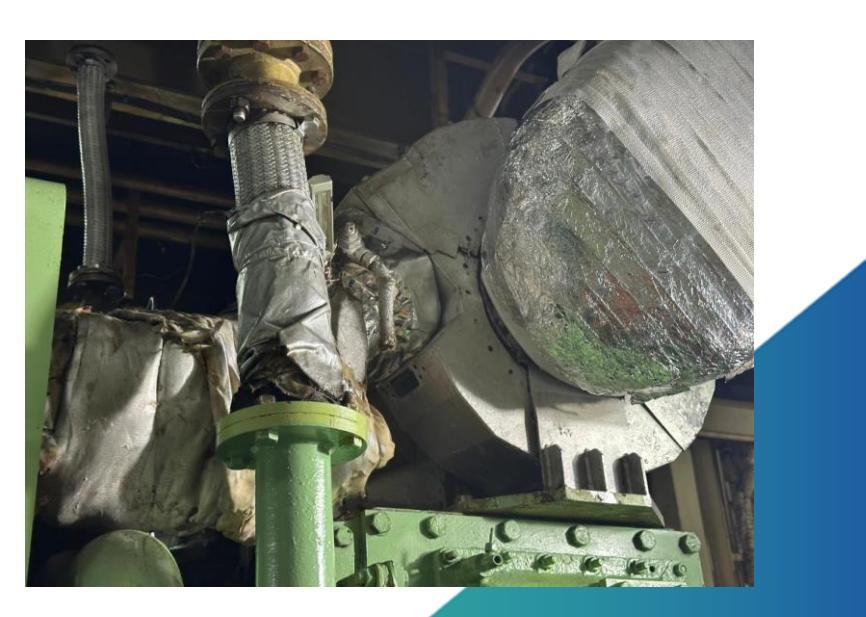
Other (Fire Safety):

Insulation fitted to high temperature surfaces of the following are defective: exhaust gas pipes and turbocharger casings on No.1, 2 and 3 auxiliary engines; exhaust gas inlet pipe to main engine turbocharger.

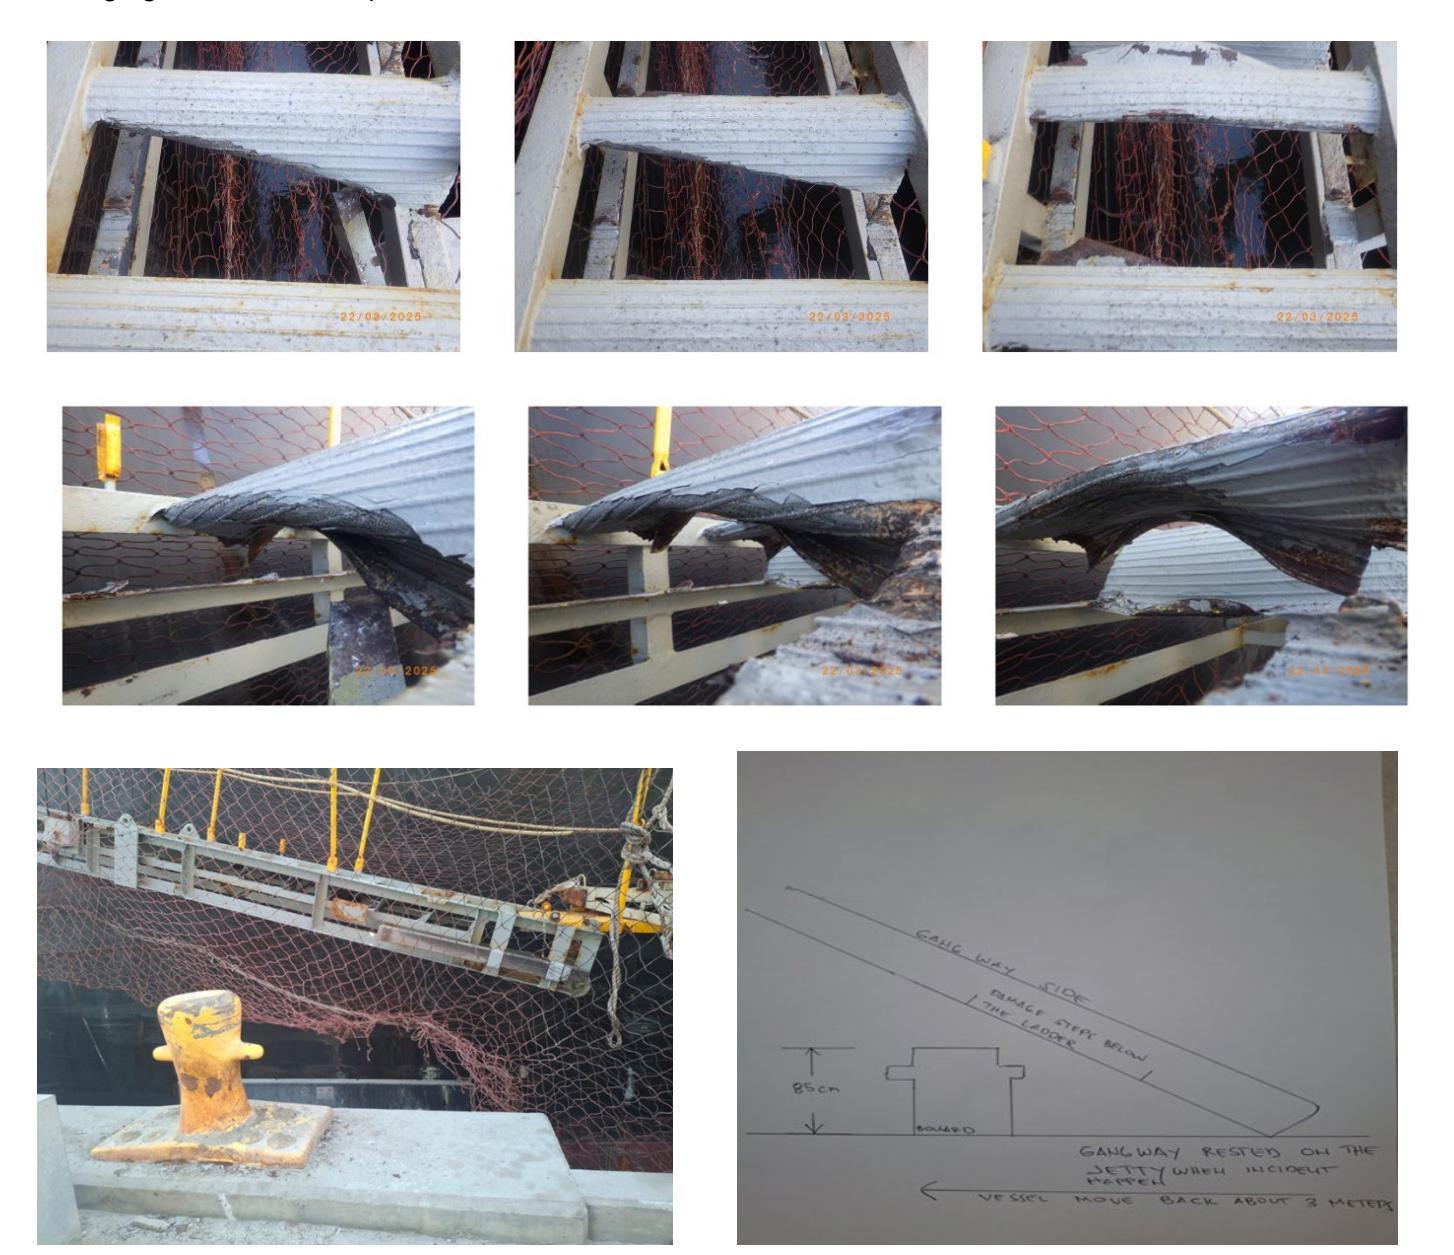
Damaged Steps of Stbd side Accommodation ladder

While the vessel was alongside, a container vessel passed on the port side causing the vessel to surge and move 3 meters aft which resulted in the accommodation ladder contacting the shore bollard and damaging the ladder 4 steps.

The ladder steps were temporarily repaired and made safe for use.

• The OOW and gangway watch keeper shall ensure that the gangway is monitored at frequent intervals especially when vessels are passing close by. The gangway shall be adjusted considering tides and draft change due to cargo operations. The gangway watch keeper shall ensure that under no circumstance, the gangway lands on the gap between the ship side and the berth to avoid crushing damage.

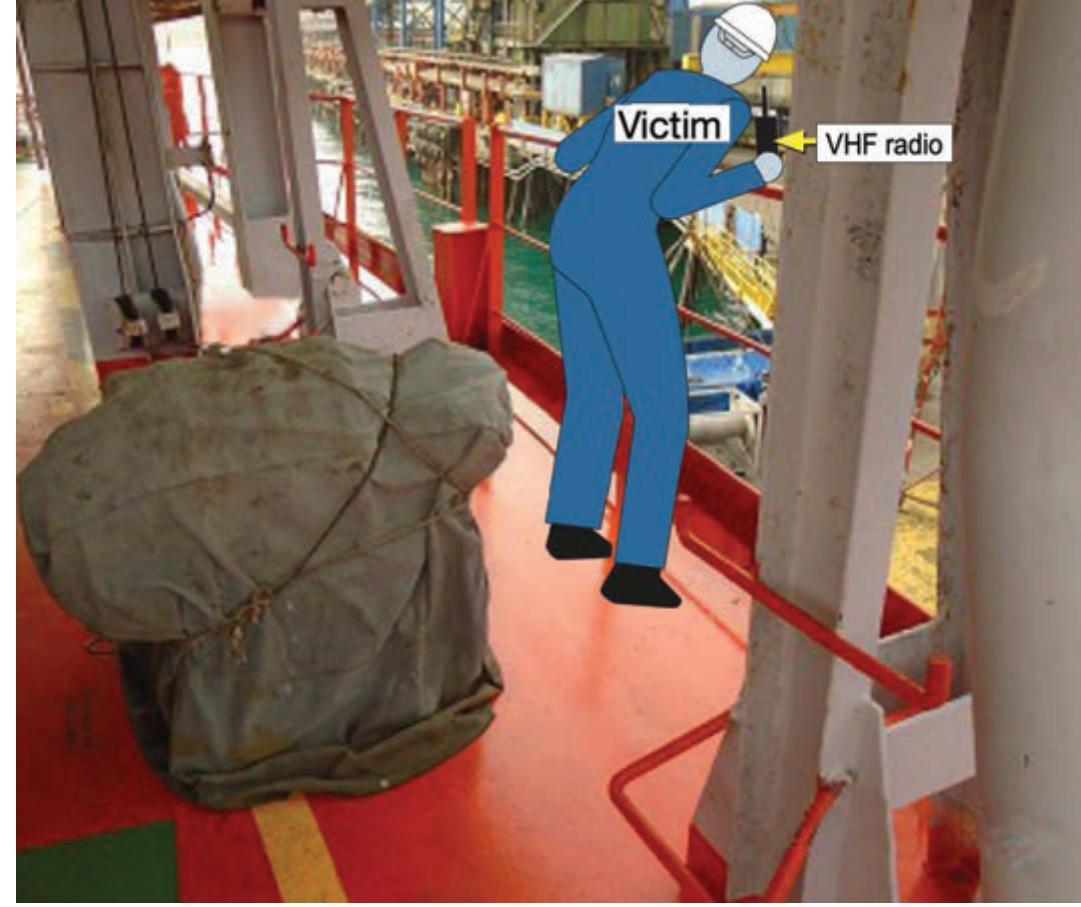
Position of victim just prior to spring line recoil

A few minutes later, the officer in charge of the aft mooring party positioned himself near the accommodation ladder and looked over the side rail directly above the slack spring line while using a VHF radio. At that moment, the spring line tightened, then slackened and then came under tension once more. A loud bang was heard as the line suddenly released and recoiled vertically upwards.
