**NEWSLETTER
& CAMPAIGN
JAN 2024**

ISLAND VIEW SHIPPING SERVICES
Authored by: IVSS Team

SUMMARY OF PSC DEFICIENCIES

Attached please find fleet advisory 2024 – 01 which contains all previous fleet advisories issued on the PSC/RightShip deficiencies/findings pointed out during last two years.

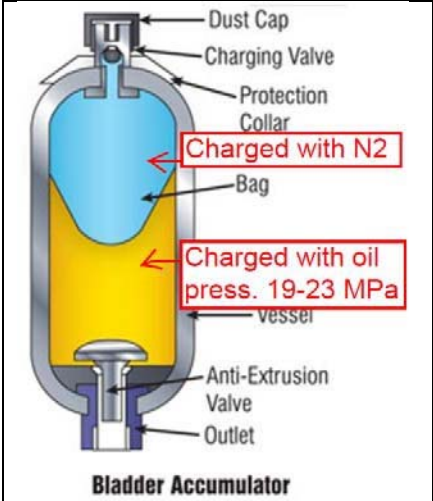
Code	Description
11113	<p>Rescue boat unable to be launched using accumulator.</p> <p>Comments:</p> <ul style="list-style-type: none"> • AMSA inspector instructed the crew to swing the rescue boat davit by means of accumulator. The davit only moved to about 30 degrees and the pressure from the accumulator dropped down to zero. The investigations revealed that there was no nitrogen gas in the cylinder as it ruptured the internal bladder. • New accumulator was ordered and installed in place. • Test rescue boat davit operation on all modes – electric/accumulator/manual handle during monthly drill and revert with the result to your Ship Manager. Ensure all three modes operating instructions are displayed and crew is trained to operate davit by all three modes. • Ensure accumulator pressure is maintained as per the manufacturer’s manual. Check maker’s manual of your vessel in this regard. • As per the inspected ship maker’s manual: <ul style="list-style-type: none"> ➤ The charging pressure of accumulator is to be kept 8 MPa (80 bar) and accumulator is to be charged with nitrogen if pressure falls below 8 MPa. There is a bladder (an elastic bag) inside the cylindrical unit which is charged with nitrogen gas. ➤ The accumulator pressure is to be kept in the range of 19 – 23 MPa (190-230 bar). This pressure in the accumulator is maintained by automatically controlled electric pump. When accumulator pressure falls below 19 MPa, pump charges the pressure to 23 MPa with the hydraulic oil. • There is to be always one 230 Bar 50 litre Nitrogen bottle ready for use. Please order if it is not on board. There is a specific fitting with gauge that is needed to fill Nitrogen. Ships are to order this from their manual. Stow this item in the safety locker properly labelled/marked. • The accumulator shall be serviced/bladder renewed ashore at 5 yearly intervals during dry docking. <p>Accumulator (General picture for understanding, not ship specific)</p>

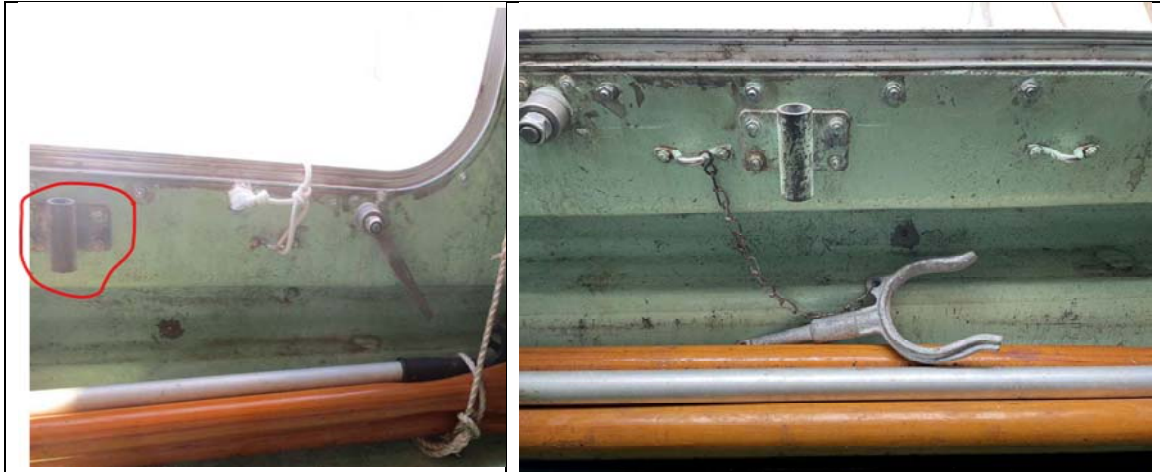
Code	Description
14101	<p>The solenoid valve for 2nd chamber of oily water separator – not worked because stuck and choked.</p> <p>Comments:</p> <ul style="list-style-type: none">• The 15PPM alarm test and function test of all other solenoid valves was demonstrated to the inspector, unfortunately the 2nd chamber valve would not open during function test.• Valve was dismantled, internals cleaned and performed function test in the presence of the inspector. Inspector closed the deficiency.• Carry out the function test of oil level solenoid valves and report to your Ship Manager if any malfunctioning.• The annual maintenance consisting complete overhauling of the solenoid valves (oil control valves) is being added in the PMS.
11101	<p>Oar crutches of lifeboats (both side) - not attached to hull lifeboat by lanyards or chains.</p> <p>Comments:</p> <ul style="list-style-type: none">• The lifeboats were provided with the oar crutches with chains attached to the boat hull. The ship staff had disconnected the oar crutches and chains as it was creating an obstruction for the crew entering through the lifeboat door and had safely kept them inside the lifeboat equipment locker.• The oar crutches of the lifeboats were immediately attached to the hull by chains.• LSA CODE 4.4.8.1, sufficient buoyant oars shall be provided to make headway in calm seas. Thole pins, crutches or equivalent arrangements shall be provided for each oar provided. Thole pins or crutches shall be attached to the boat by lanyards or chains;• Ensure that the lifeboat fittings are maintained as per the LSA code and not altered in any manner or removed from its location. Crutches are kept attached to the boat by lanyard or chain.

During PSC inspection, crutches were disconnected and kept in the L/B equipment locker	Crutches are to be kept connected to boat by lanyard or chain as above

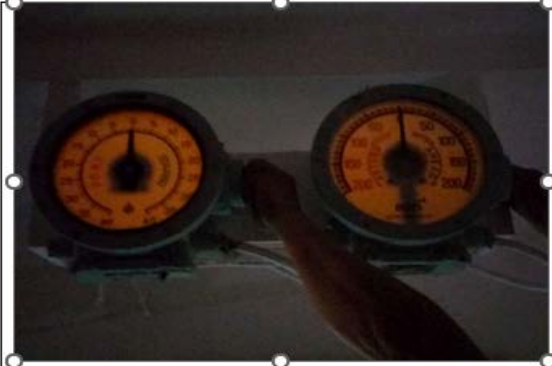
Code	Description
3.10	<p>Is navigation equipment in good order? (V)</p> <p>Finding description The illumination for the bridge wing tachometers and rudder angle indicators was not functional at the time of inspection. Rectified during inspection. The dimmer controls on all of these units were seized.</p> <p>Root cause:</p> <ul style="list-style-type: none"> • Inadequate inspection and maintenance of dimmer controls • Lack of compliance with Company SMS requirements – The Company’s “NAVB22 - DAILY CHECKS” form clearly specifies that buzzer / lamp tests / dimmer lights on each equipment shall be tested which was not complied with in true spirit by the OOW <p>Preventive action:</p> <ul style="list-style-type: none"> • Ensure strict compliance with all the bridge checklists paying attention in detail to each item. • Ensure that each bridge equipment including indicators ,dimmers and associated controls are operational. Any defect identified shall be promptly reported through the defect list and rectified at the earliest opportunity. • The Master shall also make random checks on the operational status of the bridge equipment and its controls during daily bridge rounds and during navigational audit. <div style="display: flex; justify-content: space-around;"> <div data-bbox="288 1317 842 1682">

<p>Starboard Rudder Angle Indicator and Propeller Shaft revolution Indicator DIMMER ON</p> </div> <div data-bbox="847 1317 1409 1682">

<p>Starboard Rudder Angle Indicator and Propeller Shaft revolution Indicator DIMMER OFF</p> </div> </div>

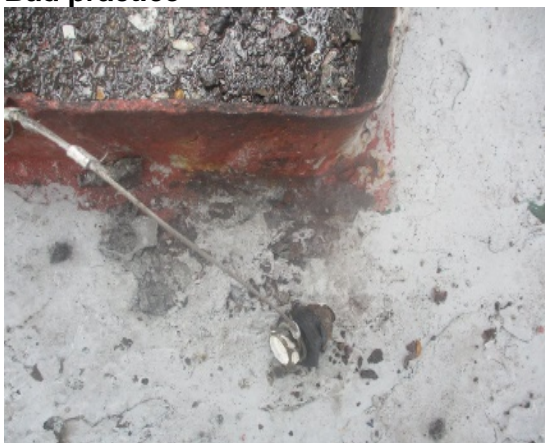
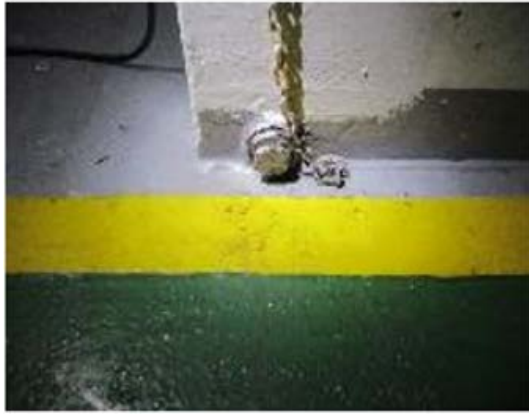
Bad practice

Good practice

- Ensure that all save-alls / containment arrangements are kept clean and empty of water , oil , rust , debris like ropes , rags etc and plugged in port (especially after draining any accumulated water) and the drain plug is secured with a strap chain to the save-all.
- The Chief officer shall carry checks as per the weekly deck inspection checklist paying attention in detail to each item.
- Compliance shall be verified by the Chief officer prior arrival each port before the hydraulics are activated.
- The OOW and ratings shall also periodically check the drain plugs of all save-alls as part of their watch keeping duties in port.

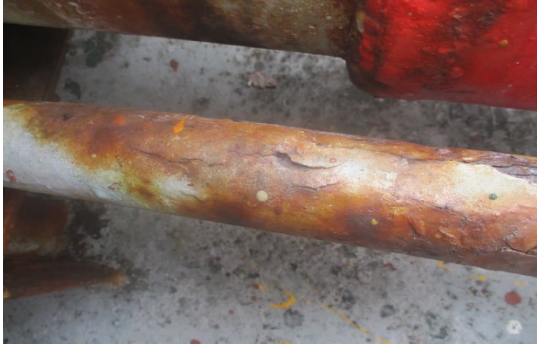
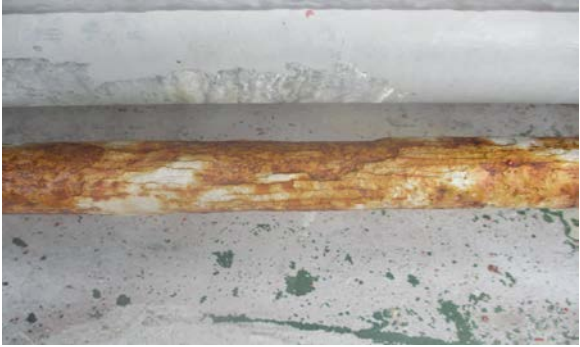
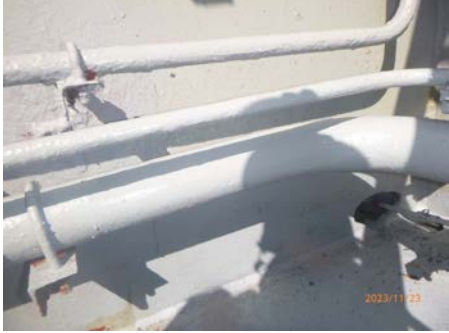
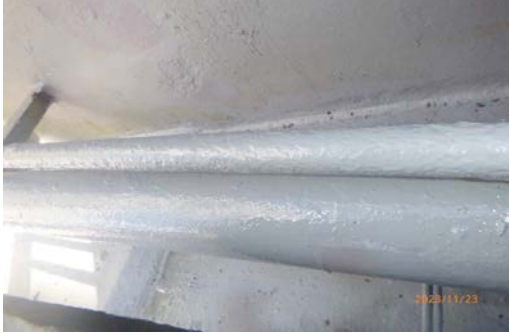
Findings: The pneumatic line on the starboard side upper deck was severely corroded over approximately 30% of its length. Wastage of approximately 25% was noted over extended sections

- Lack of maintenance
- Inadequate planning/preparation - Ship staff did not plan and complete the maintenance of the pneumatic line in a timely manner.

Before maintenance:

After maintenance:

- The Chief officer shall pay attention in detail and look out for excessive corroded areas while taking routine rounds on deck .
- A maintenance plan shall be prepared by the Chief officer and the deck crew shall be instructed to carry out maintenance of these areas in a timely manner.
- Sufficient stock of paints shall be always kept on board.
- The ship Manager shall be informed if any materials are required for repair.

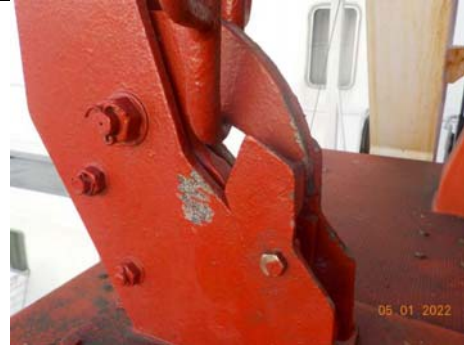
- Starboard side lifeboat link stoppers were recently painted due to which it was stuck. Movable parts should be not painted. Please ensure whenever a device is painted around a moving part, it is exercised to move free.

Stbd side L/B forward part link stopper stuck due to paint.

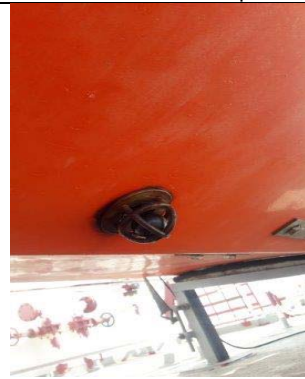
- Bottom plug for the stbd lifeboat was fitted in place but the chain connecting the plug to the boat was found missing during the inspection. Refer SOLAS regulation:

- Drain plug is marked as per above photo “ALWAYS KEEP CLOSED IF YOU DO NOT DRAIN WATER” (Laminate and post if not provided)
- Drain plug is fitted with chain / wire
- Drain plug is kept closed at all times except while draining water.
- Drain ball is in good condition and not seized/damaged/ worn out
- Crutch is attached to lifeboat by chain
- Adjacent lifeboat seat belts are of different colour (contrasting). If not please inform us and make requisition.
