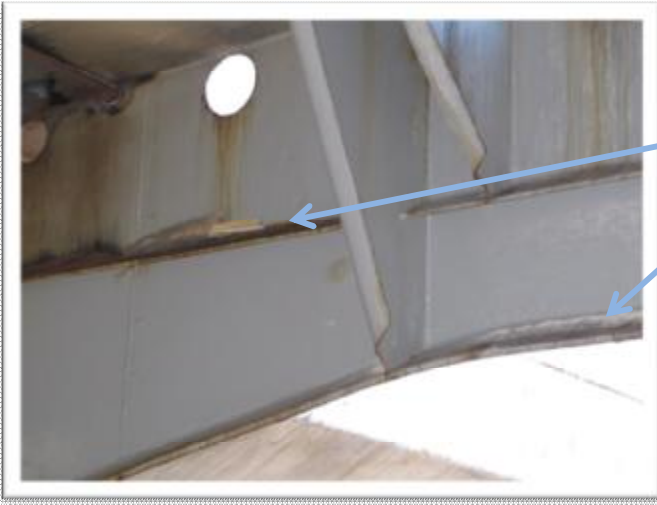
Under deck beam residues and foreign material must be removed.

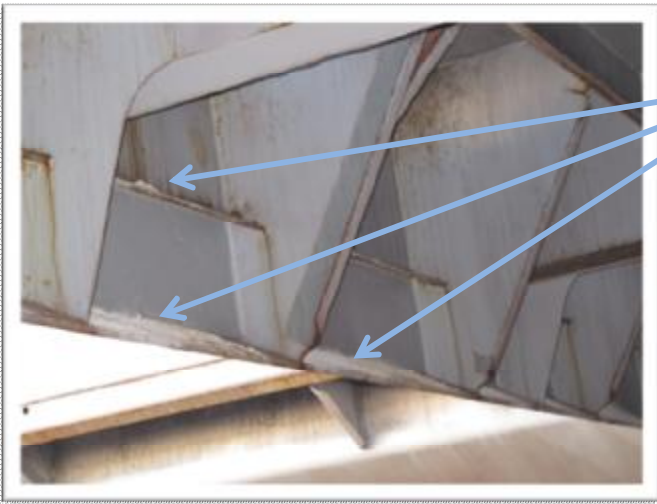
Under deck beam previous cargo residues must be removed.

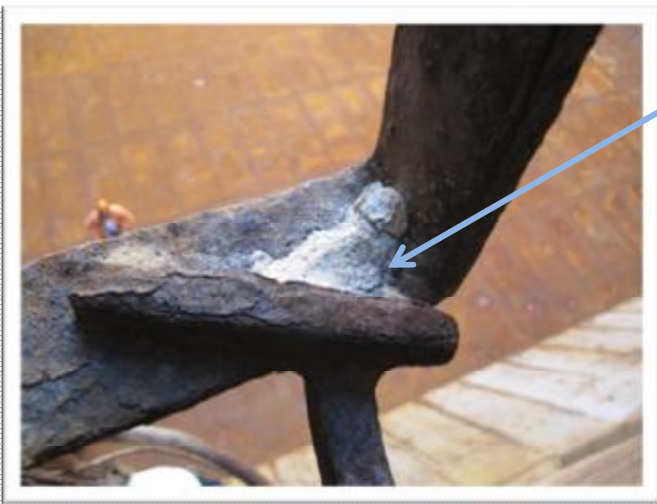
Residues on access ladder must be removed.

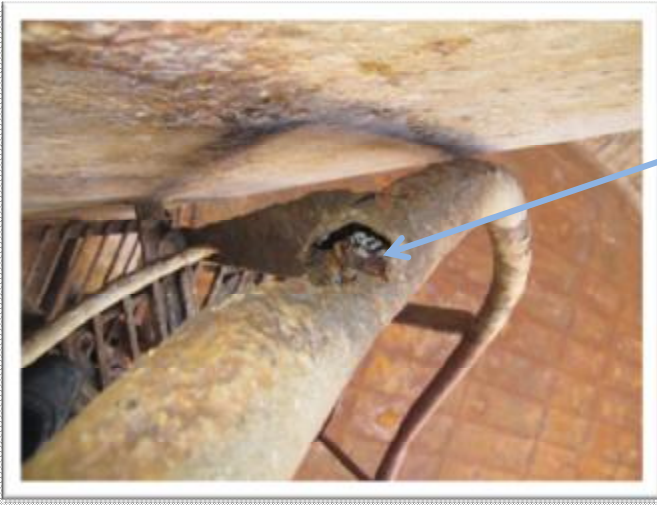
Broken ladder rails are collection points for previous cargo. These may become infested with insects if the cargo was a grain product. Smell the area to ensure there is no odor.

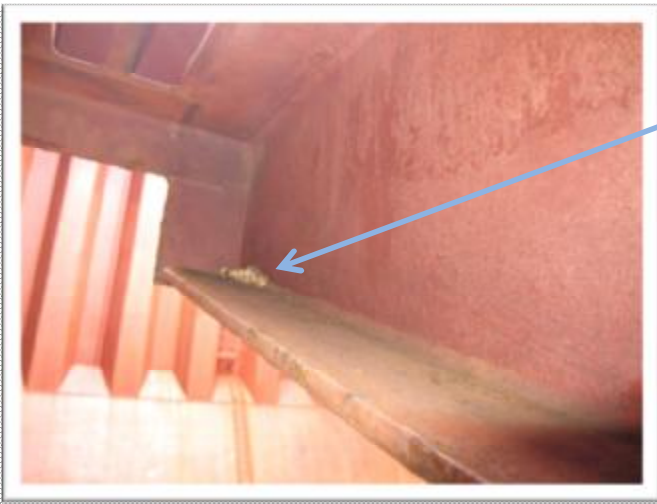
Previous cargo residues under ladder platform angles. Check under ladder structure for cargo / rust / loose paint.

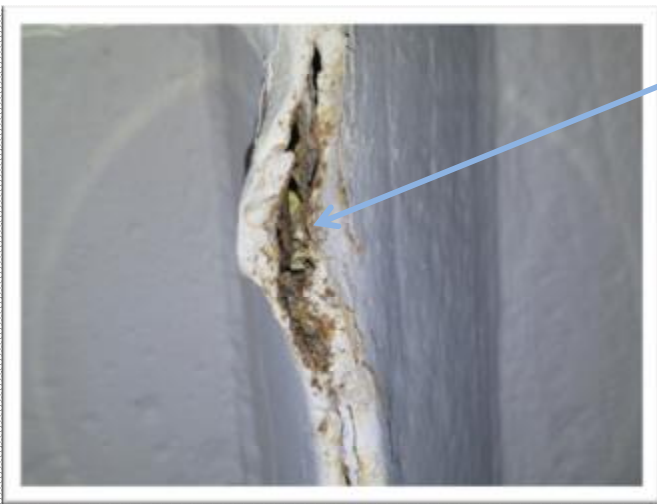
Split ladder stiles are catch points for previous cargo and possible infestation.

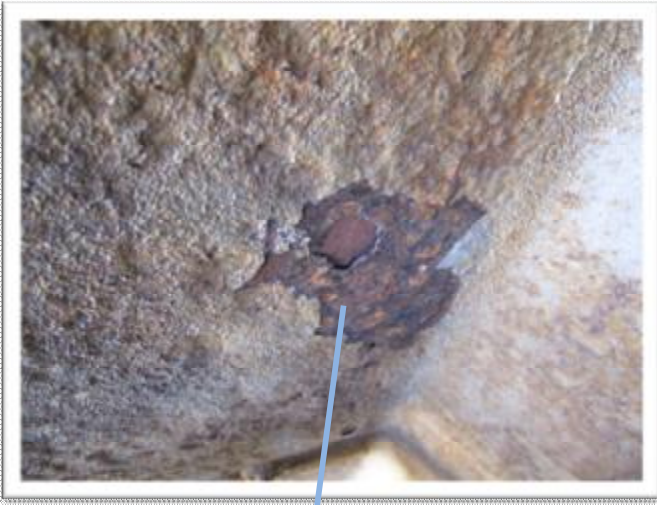
Bulkhead blisters that sound hollow should be chipped back. These are easy to identify by tapping with a paint scraper or chipping hammer.

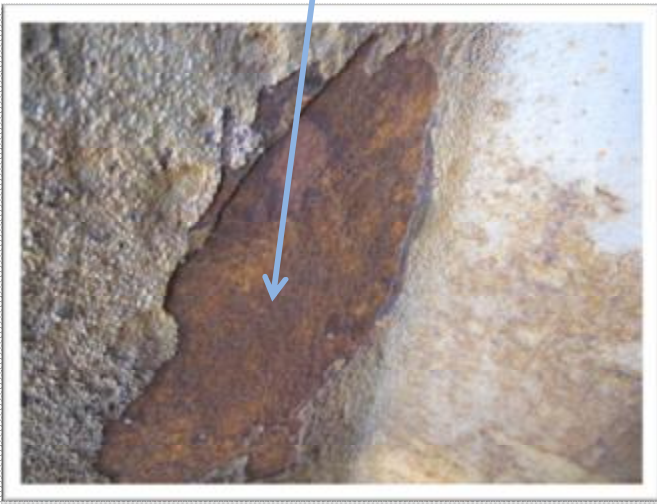
And end up coming back rusted plating

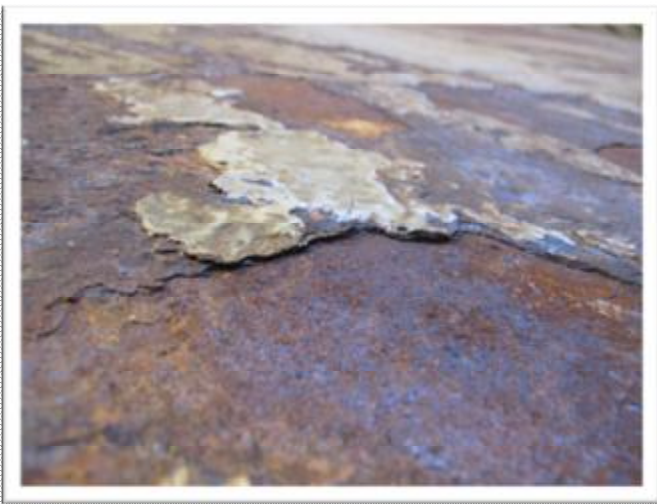
Hopper side paint and scale must be removed where edges are lifting and can be removed with a paint scraper.

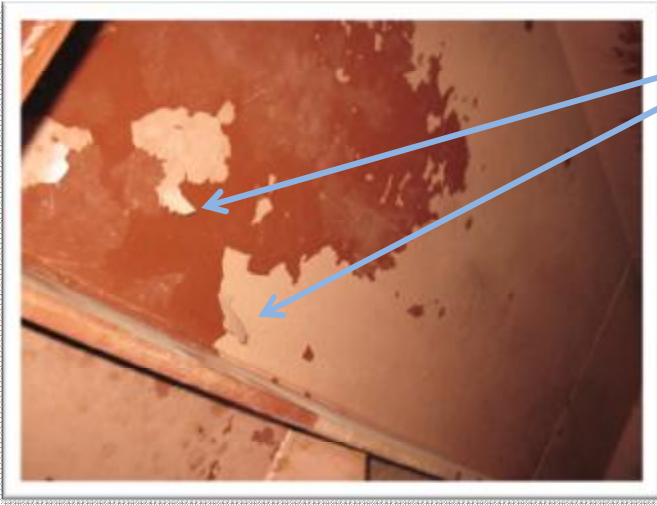
Example of poor paint coating where flaking paint must be removed.

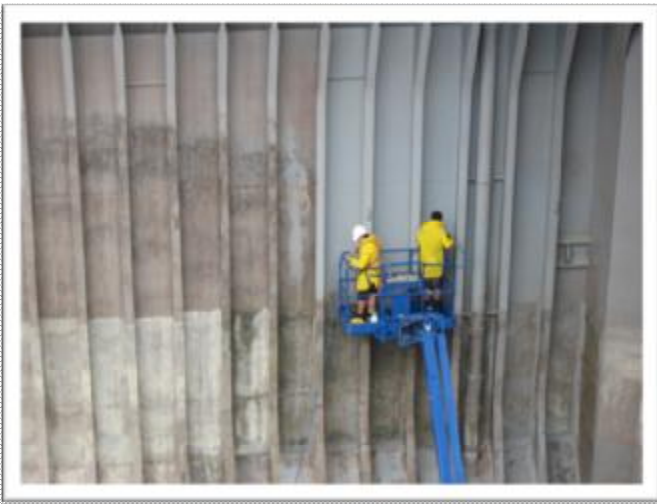
Side frames showing the difference between stained and cleaned plating. This type of staining requires cherry pickers and high pressure washing which can only be done safely alongside.

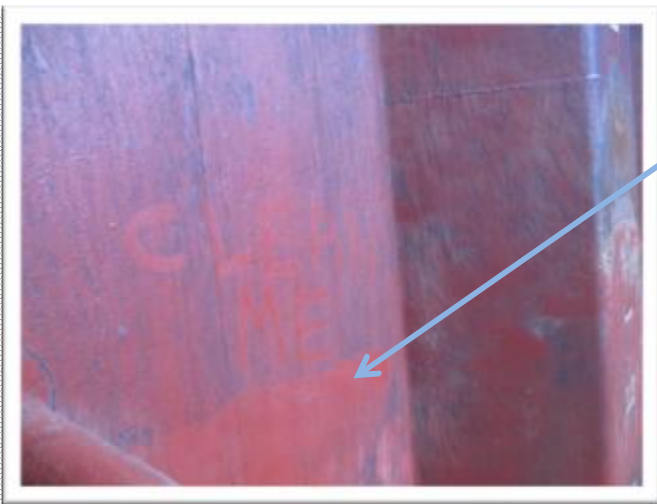
Coal stain on bulkhead that can be easily cleaned with a wet rag. Upper reaches of the holds are difficult to reach.

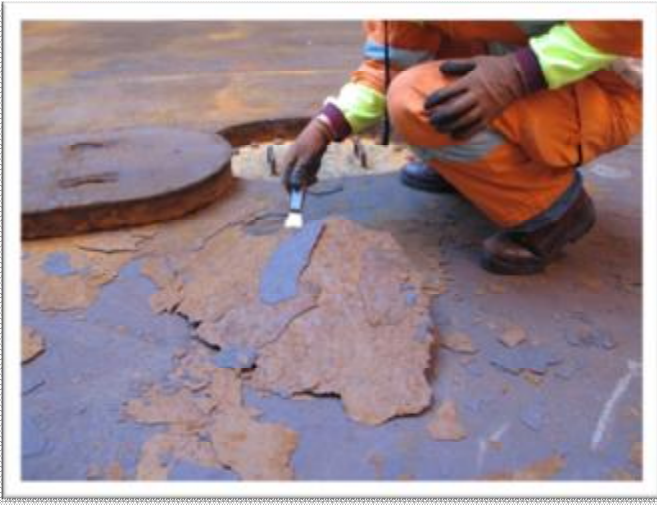
Tanktop sheet rust must be removed. In some cases a hammer or chipping machine may be required to ensure all loose rust is removed.

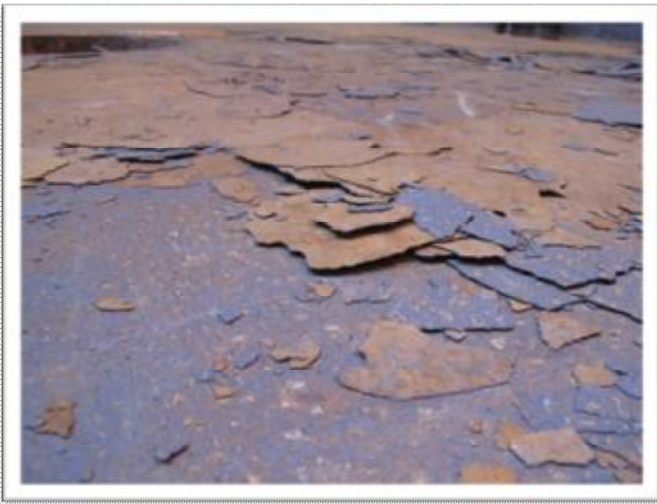
Tanktop sheet rust is best removed dry with chipping hammers and scrapers.

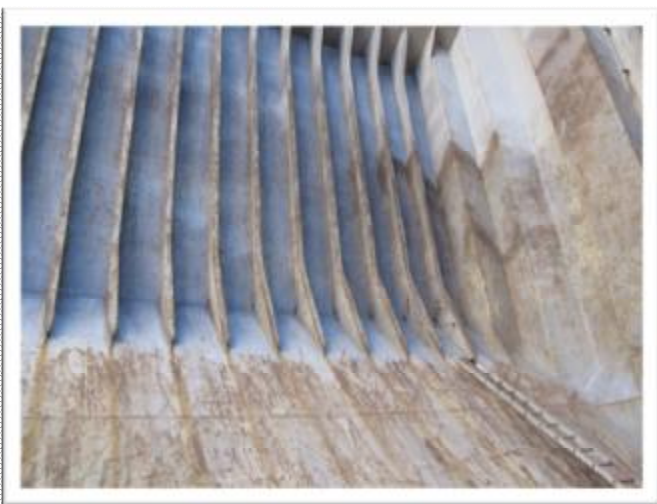
Side frames with stain mark from previous cargo.

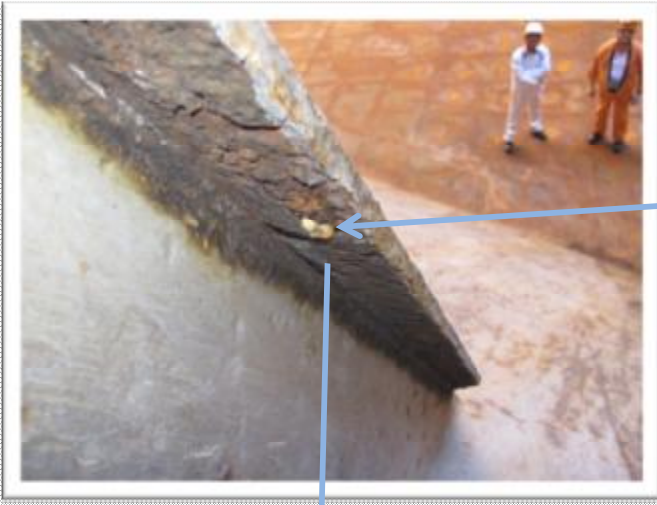
Always check behind frames for loose scale and also previous residues which may be lodged behind the rust scale.

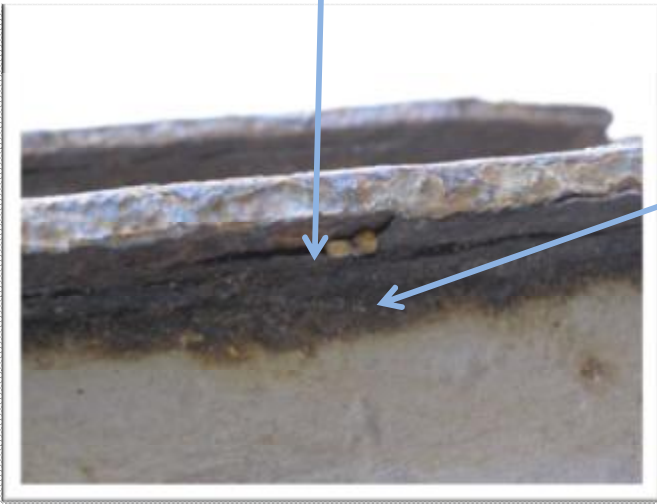
Some sheet rust behind frames may also extend to the angle section of the frame

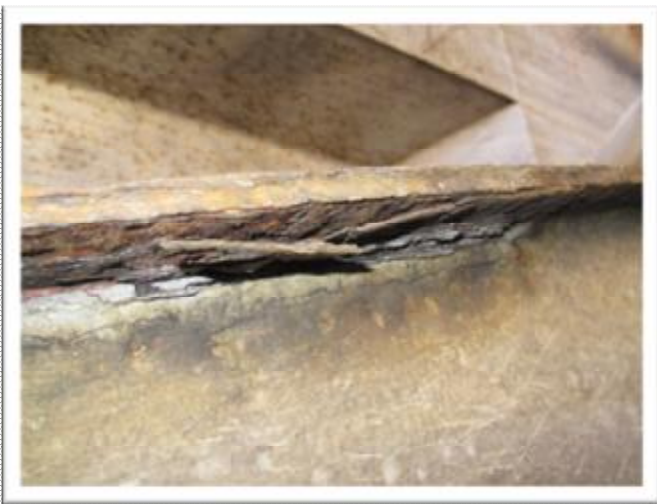
Sheet rust behind side frames may extend to upper reaches of frames. Check frames as high as possible particularly at the turn of the frames and in areas behind bent or damaged sections.

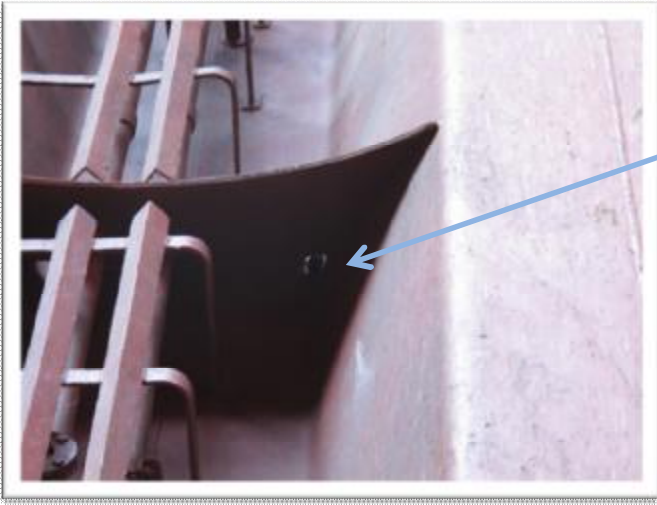
Cargo residue can get caught up in shedder plate holes.

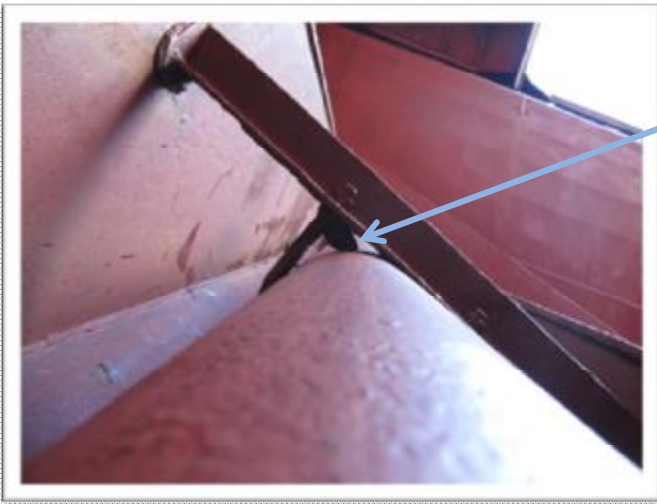
Pipe brackets are also catch points for lumps of residue.

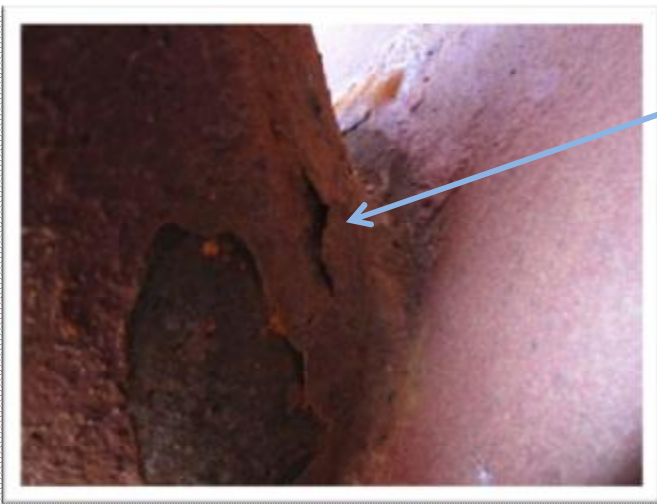
Behind pipework at the base is also a catch point for residues and rust scale.

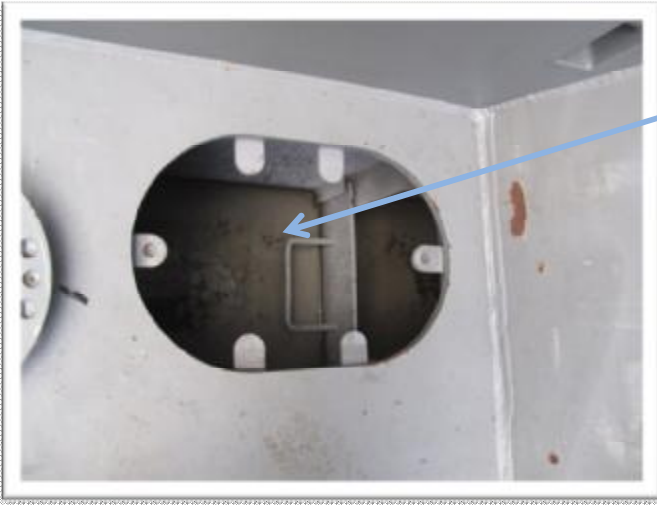
Ensure bilges are clean, dry and functional prior to coming alongside.

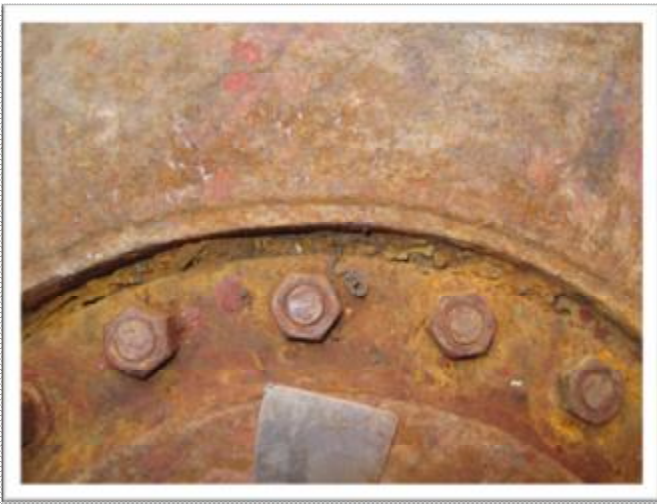
Manholes should be checked for rust and debris in the grooves.

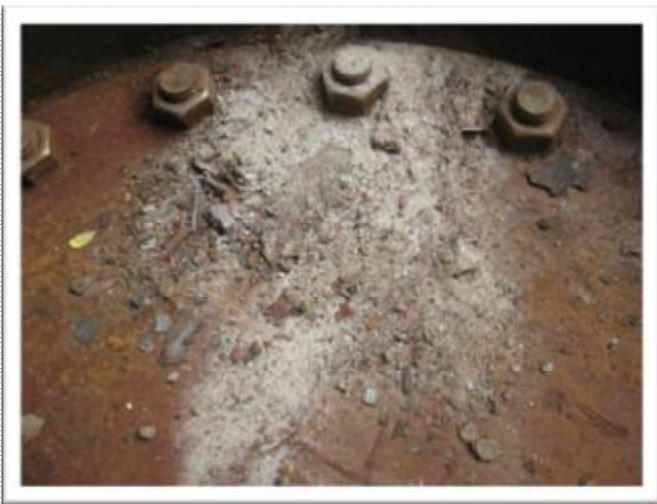
Cover plates over manholes should be removed and cleaned. All manholes covering ballast tanks must not have any evidence of water leaking through.

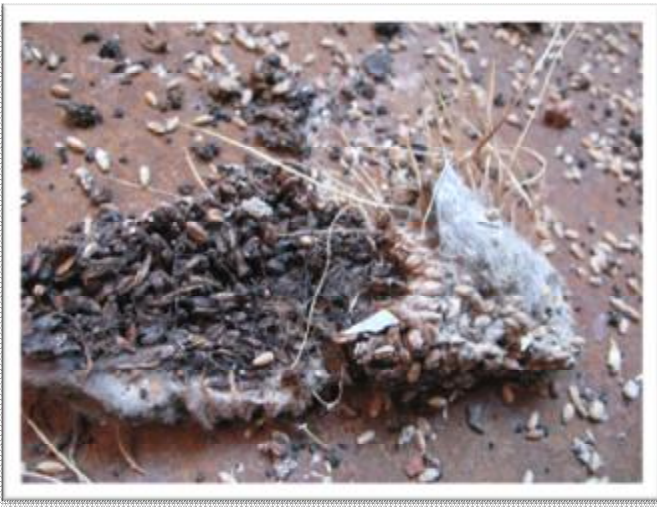
Previous grain cargo must be removed otherwise there is a risk of infestation and growth. This generally is found under deck beams which are hard to reach.

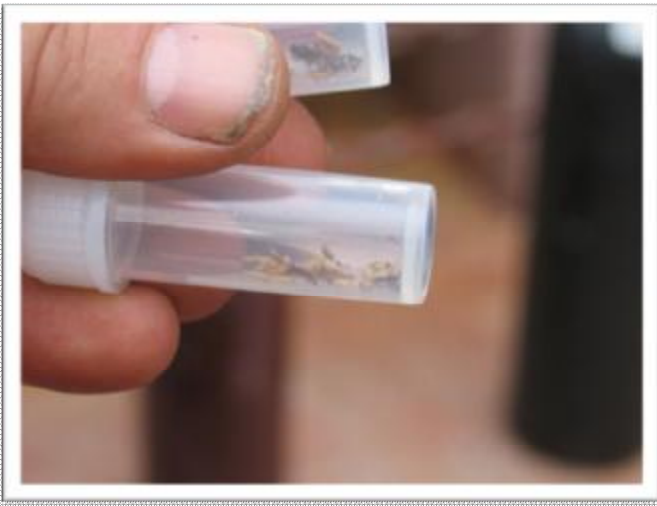
Bugs found in previous residues will generally require fumigation.

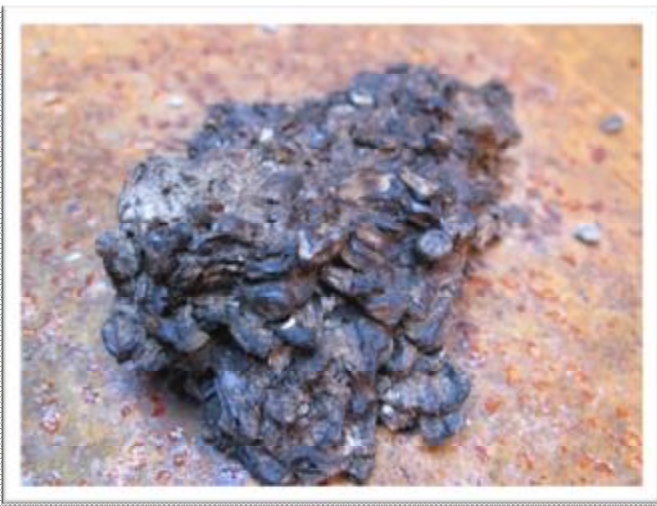
Another example of mouldy old grain. Ensure cleaning is thorough after each consumable cargo so that this type of residue is not onboard when presenting for a grain survey.

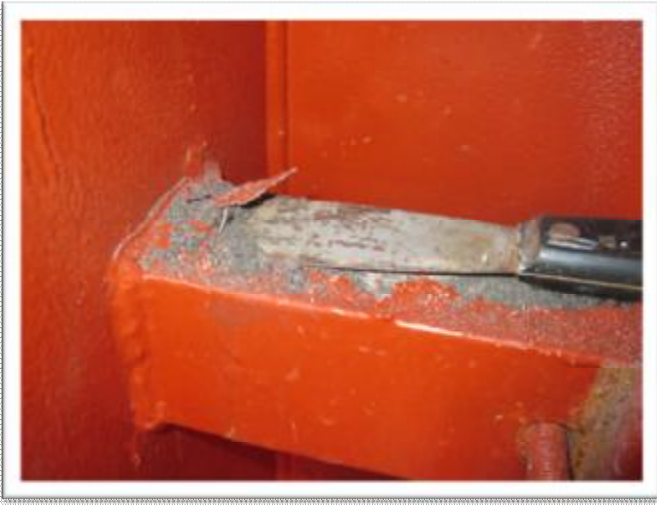
Paint scraper can get under loose paint / rust. In this case there is grit from blasting painted over.

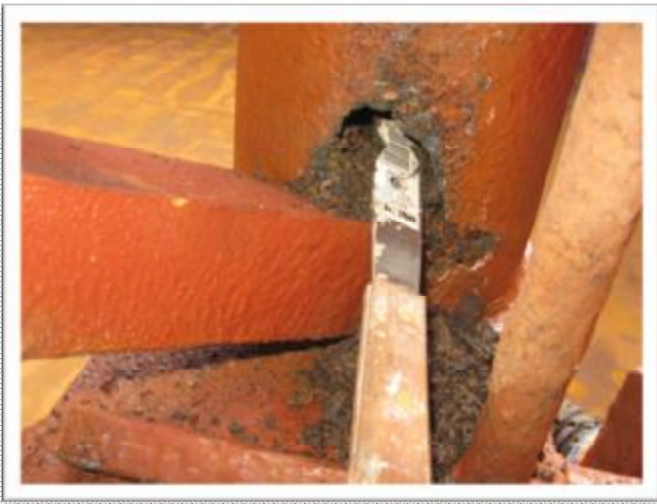
Rusted out structures like spiral ladder posts must be cleaned out carefully and repaired.

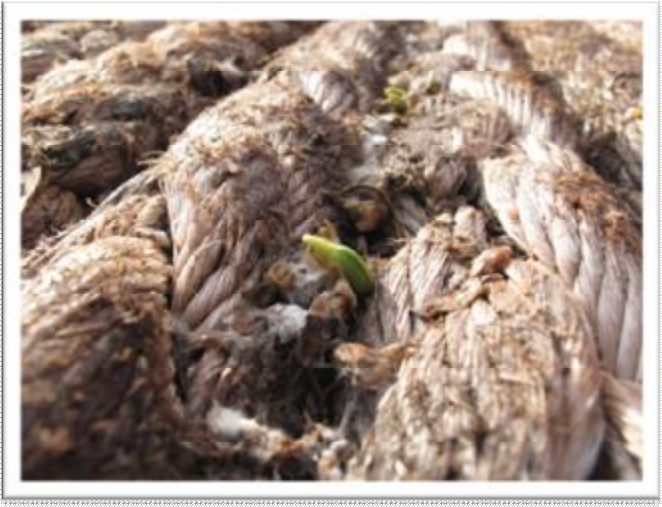
This example shows grain sprouting from a mooring line on deck. All this must be removed from the quarantine perspective.
