Potential Crack in Piston Crown

- in inner circular contact flange

SL2016-626/SBJ September 2016

Owners and operators of MAN B&W two-stroke marine diesel engines. Type: S70MC

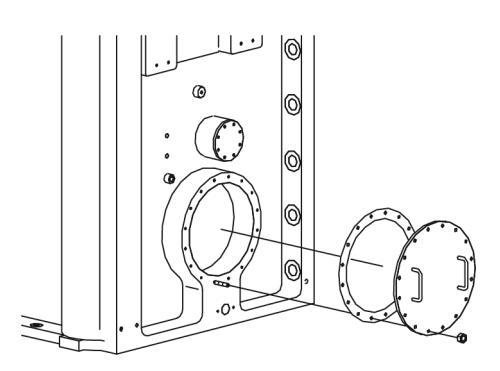
8865-4204-0001C01

- Check that the engine is stopped and blocked according to the safety precautions given on the data sheet D10201 or 2265-0400.
- 2. Open the acces hatch to the scavenge air reciever and remove the acces cover of the scavenge air box for the relevant cylinder.

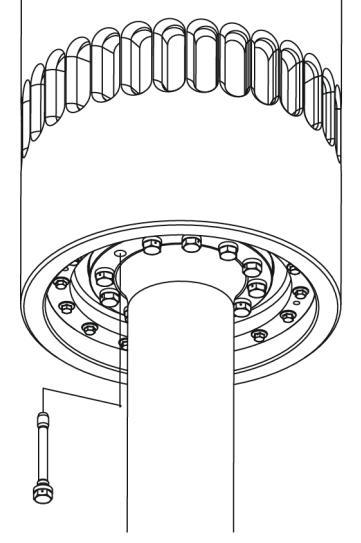
8865-4204-0001C04

Remove the locking wire from one of the screws connecting the piston rod and the piston crown. Loosen and remove the screw from the piston

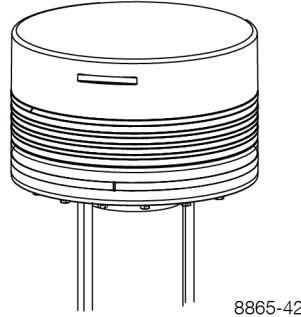
8865-4204-0001D01

Turn the relevant piston to TDC position.

Mount the piston lifting tool on the piston crown as described in the standard piston instruction M90201 or 2265-0401.

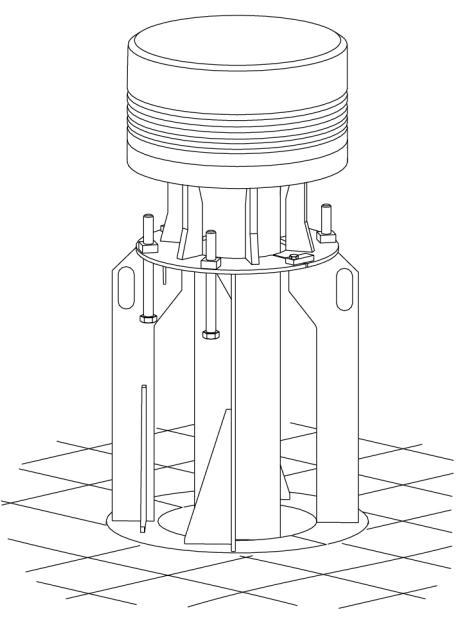
2265-0401-0001C07

Work Card 8865-4204-0001 The piston MUST be mounted in the support iron during dismantling of the piston crown and mounting of the new piston crown.

A damaged piston crown (as described in the checking section of this S-instruction) can NOT be re-used or reconditioned.
