Fleet Advisory 2025-01 (Accumulated fleet advisories of 2024)

#### Fleet Advisory 2024-02

PSC deficiencies in Tianjin, China on 08 April 2024

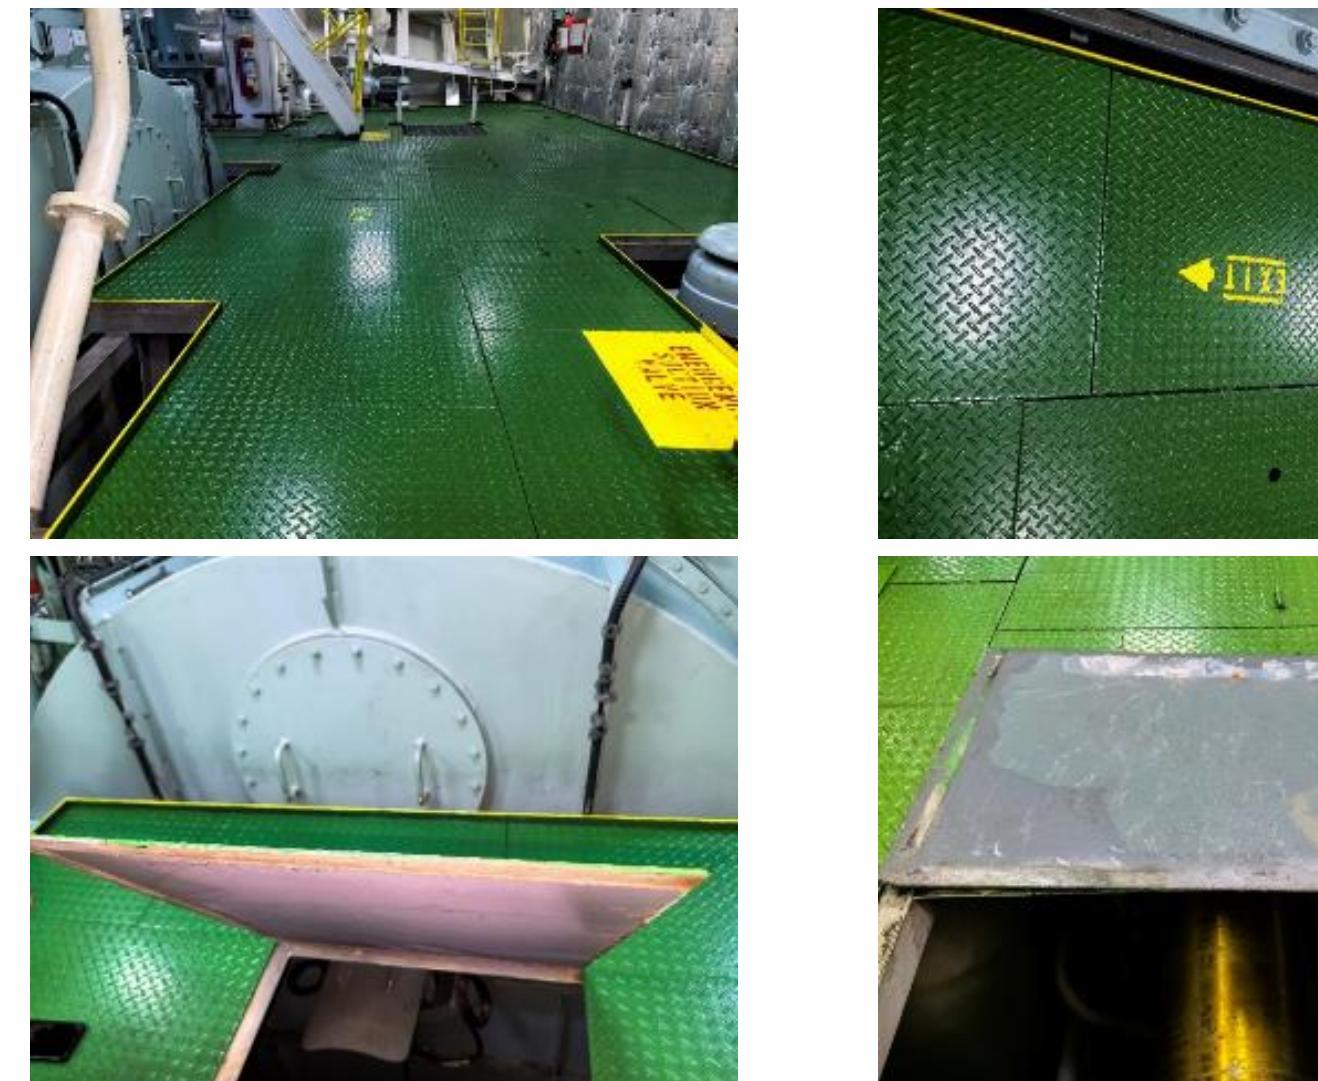
As per PSCO requirement, the floor plates in ER should be secured on the frame to avoid shifting in case of ship rolling & pitching at sea / listing / flooding.

At delivery from shipyard, the floor plates are not secured.

Floor plates to be secured as per attached guidelines where the details of tools and brass countersunk screws to be used for securing, are provided.
	Floor plates with hinge or the sections of floor plates that need to be removed for valve operation below the floor plate should not be secured permanently by screws.
	The valve number should be stencilled on the top of these plates for easy identification of the valve underneath the plate.
	Requisition for necessary tools and screws to be raised , if not on board . The PO raised shall be informed to the Ship Manager .
	The Chief Engineer to confirm present condition and send pictures of the floor plates to the Ship Manager using picture submission form.
	Target date for compliance: 30th July 2024

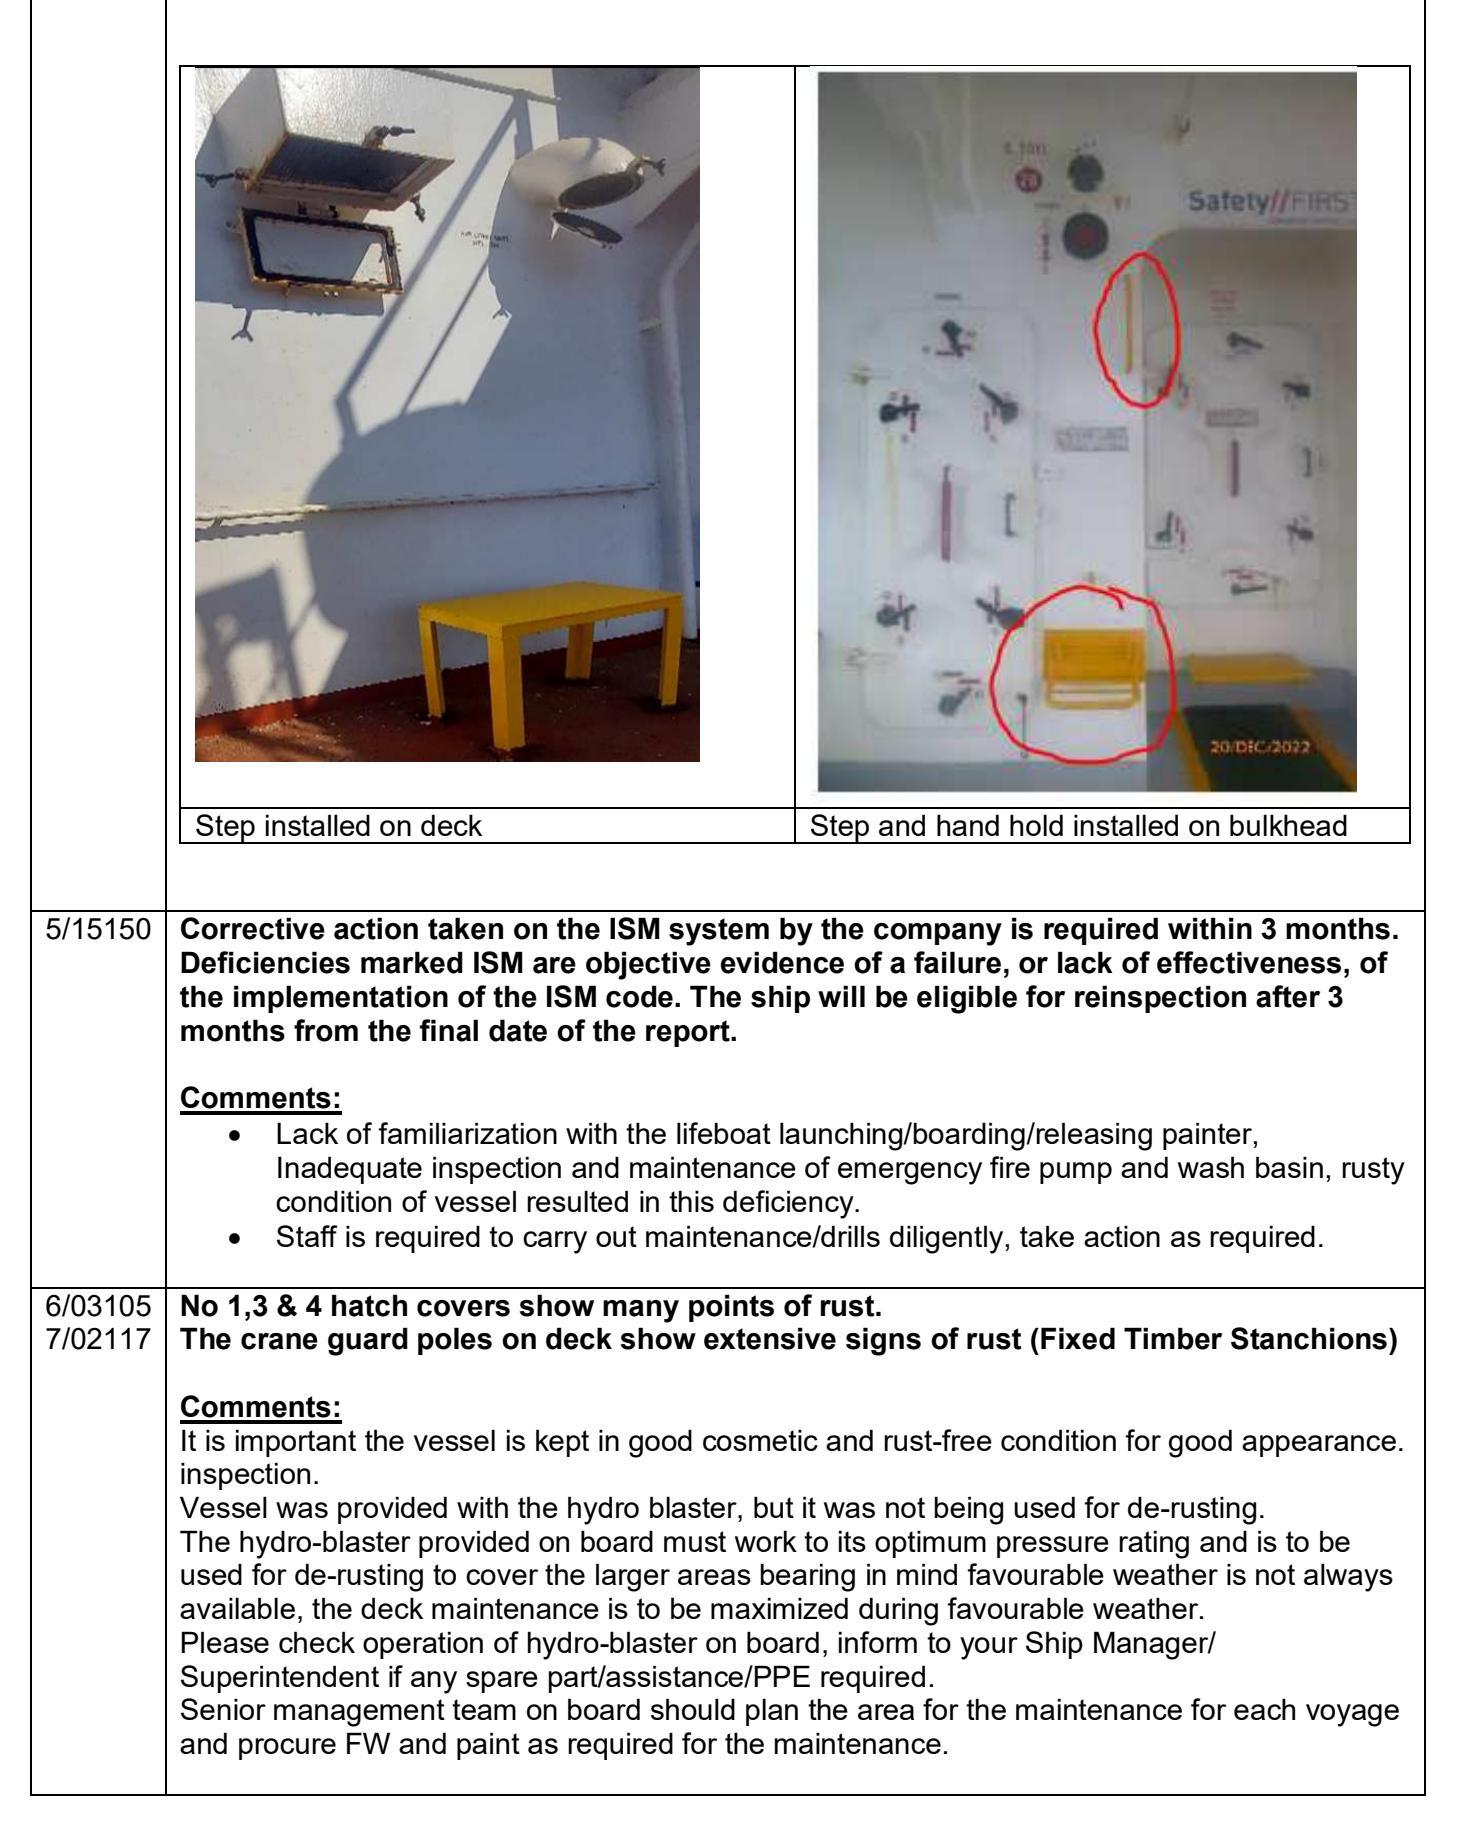
position that cannot be reached in safely because	e steps are missing.

• If the air vents around accommodation are not reachable safely from the deck level, please inform your Ship Manager/Superintendent for installing the step below the air vent.

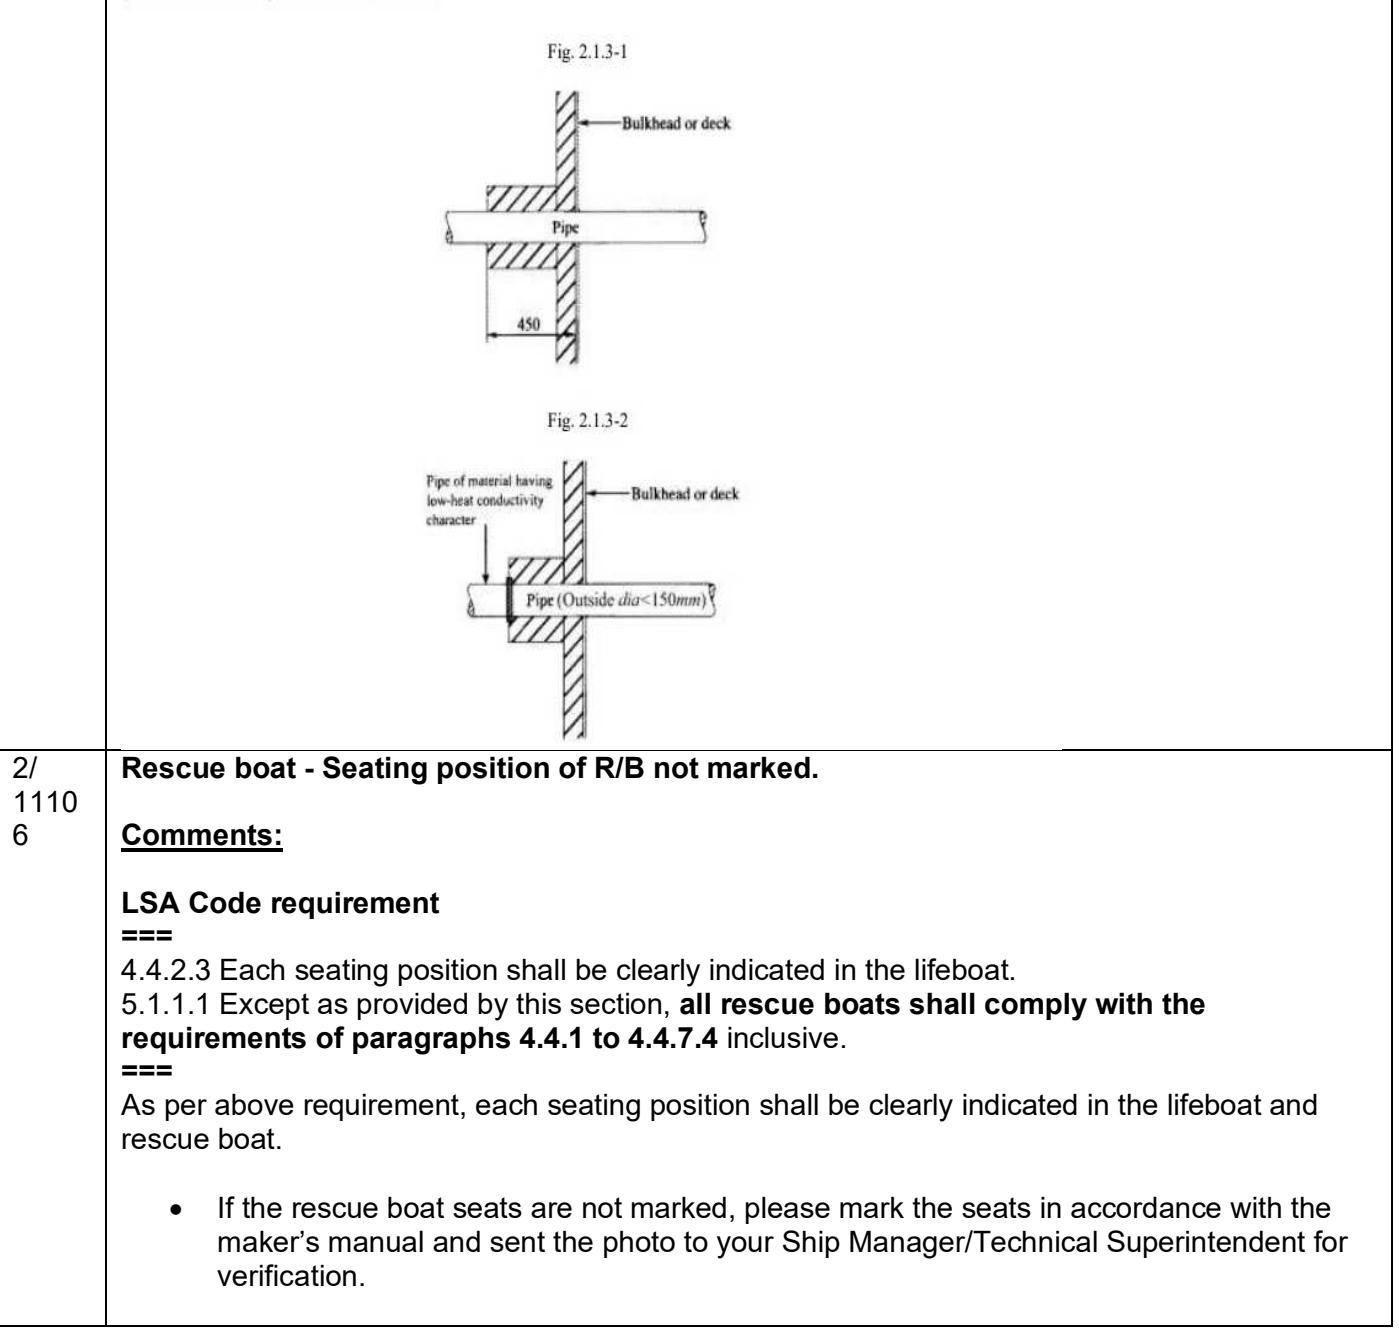
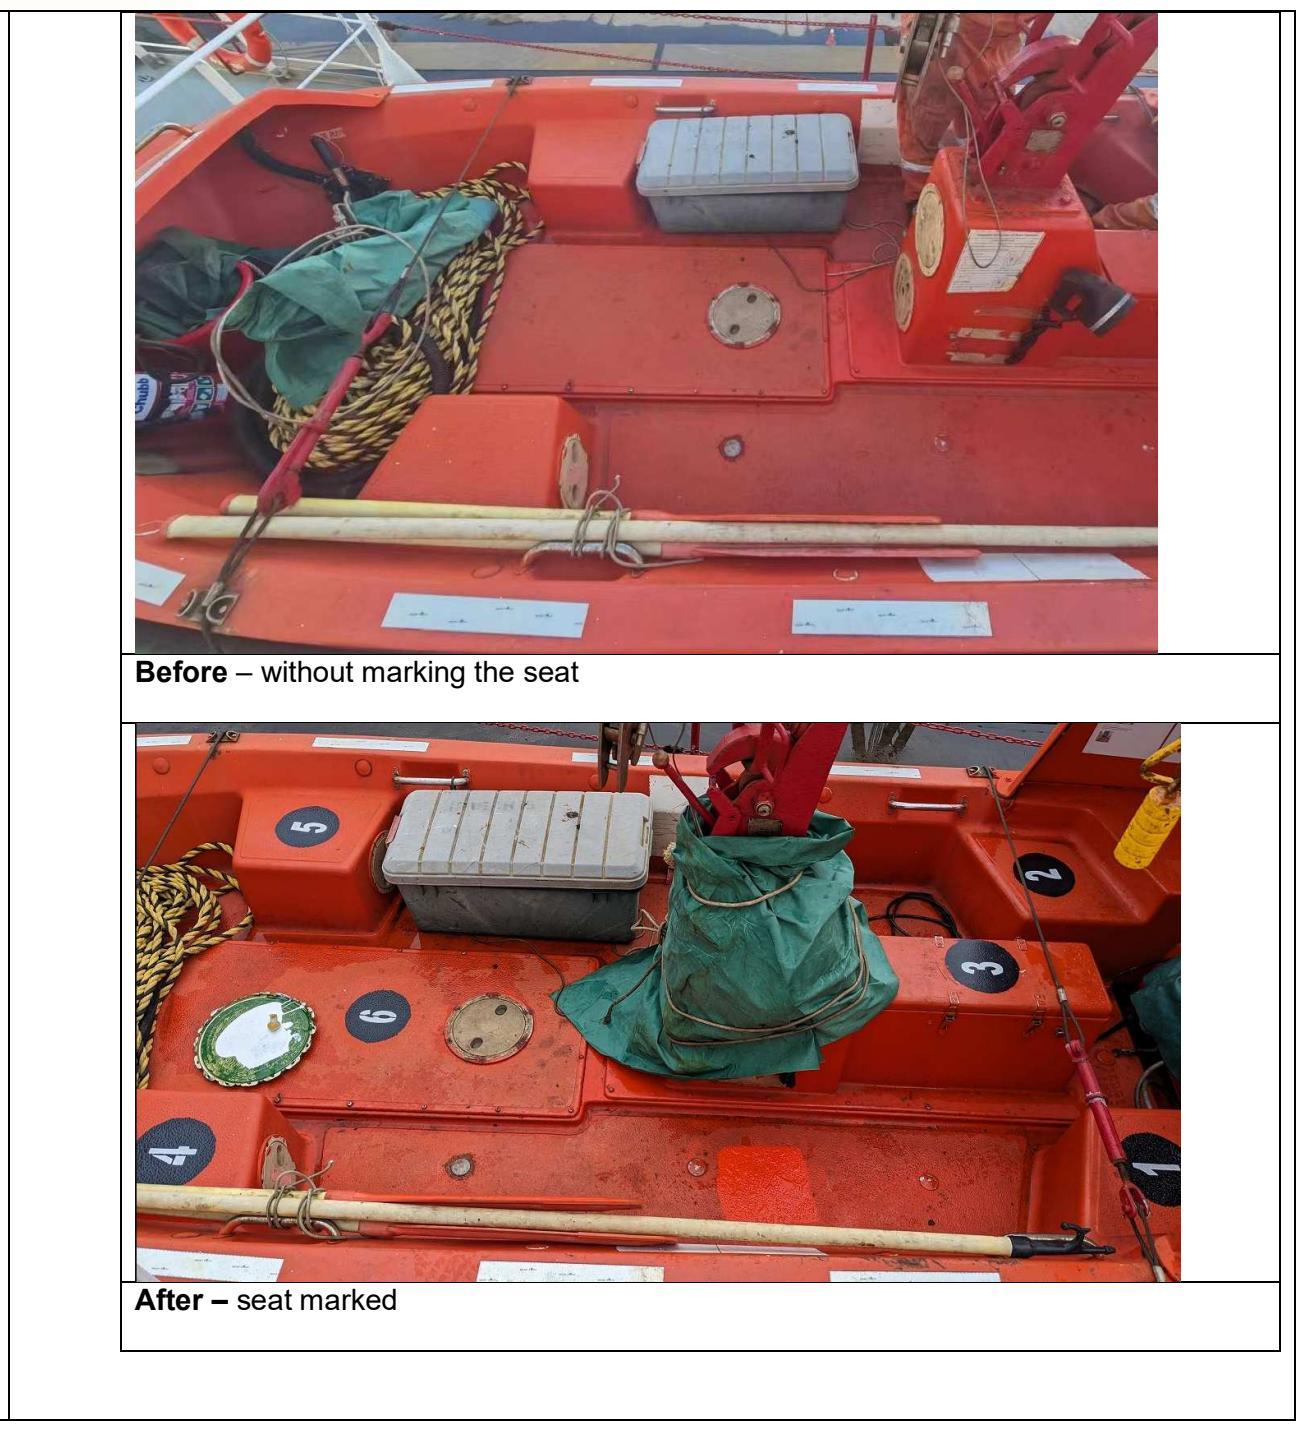
S.No.	Description
/	
Code	
1/	Decks bulkheads and penetrations -
0710	Insulation materials for pipes from E/R to fire station on A-60 deck not extended 450mm.
1	
	Comments:
	• The insulation was not installed on the two compressed air pipes passing through the A
	Class floor to the fire station.
	• All other pipes, ducts and penetrations passing through the A-Class protection deck are
	to be insulated up to 450 mm.
	<ul> <li>Check pipes penetrating the A-Class division are insulated until length of 450mm.</li> </ul>
	Before - without insulation After - with insulation
	Following ClassNK Guidance Part R Annex R9.3.1 Fig.2.1.3-1 for quick reference in accordance with SOLAS II-2 / Reg.9.3.

1 Where a pipe penetrates in a deck or a bulkhead which is required to be insulated, the insulation is to be carried past the penetration for a distance at least 450 mm. (See Fig. 2.1.3-1)

2 Notwithstanding <u>1</u> above, for a penetration of a pipe made of material having low-heat conductivity character (e.g. a metalic pipe) and an outside diameter of less than 150 mm in a "B" class division, the insulation may be terminated at the end of penetration piece or sleeve as required. (See Fig. 2.1.3-2)
