**Grindrod Ship Management, a division of Grindrod Shipping Pte. Ltd.**

**MAN ME-B9 Electronic Main Engines Mark 9 and above  
MAN MC-C Main Engines Mark 8 and below  
Main Engine Running in, Inspections, Oil Sampling/consumption**

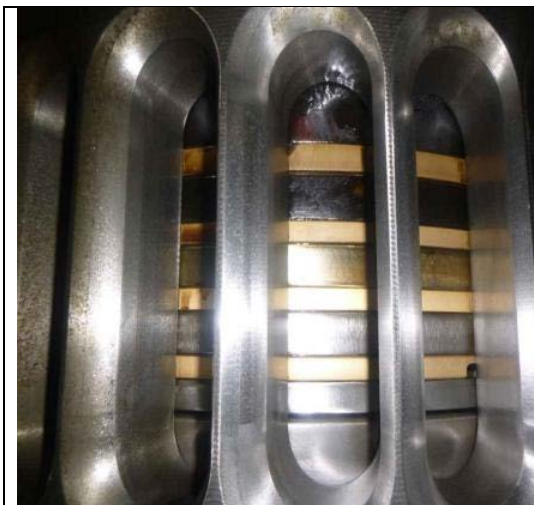
Correct and closeup of all rings

<p>Correct magnification to establish ring's performance  </p>	<p>Nothing can be made of the ring's performance – no magnification.  </p>

4. Use BN100 oil as this is part of Category II, Other oils may be allowed with office permission after consultation with MAN/Lukoil.
5. Please see Form 6.6.6.2 guidelines that you need to assess the photos you will be taking at each step. Please find examples on the left of good quality reports and on the right a report that the Office would not be able to interpret.

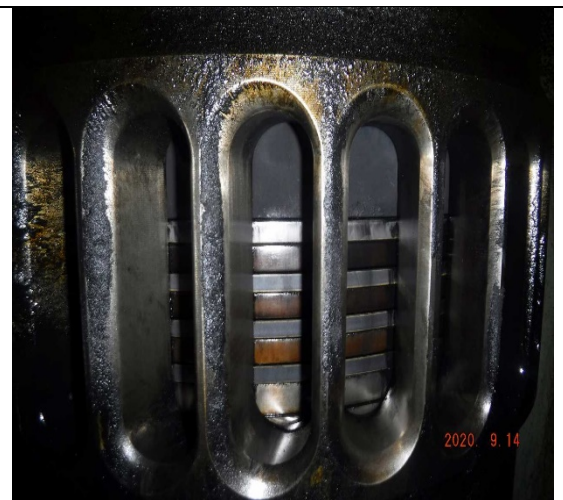
Photo taken too far away for the detail required to

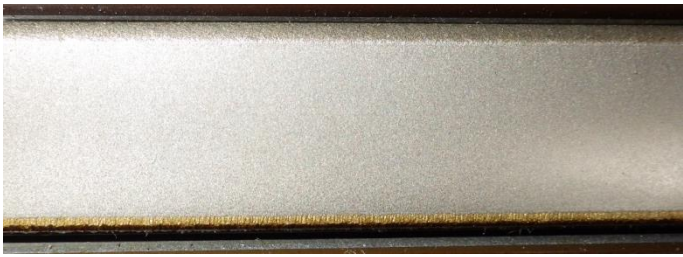
<p><b>Title: (Id: 3.1.1)</b> Cermet coated piston ring, good condition</p>

<p><b>Description:</b> Cermet coated piston ring in good condition, with a smooth running surface and rounded edges</p>	
<p><b>Action code: No action</b> No action is required</p>

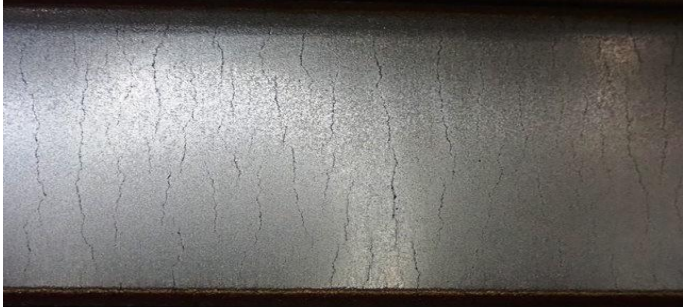
<p><b>Title: (Id: 3.1.2)</b> Cermet coating, vertical cracks</p>

<p><b>Description:</b> Visual vertical cracks found on the piston ring face.</p>	
<p><b>Action code: No action</b> No action is required</p>

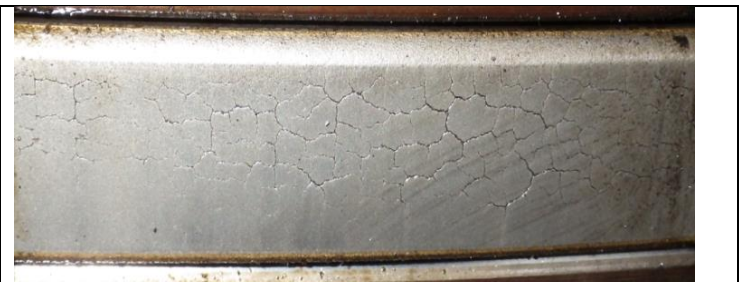
<p><b>Title: (Id: 3.1.3)</b> Cermet coating, vertical &amp; horizontal cracks</p>

<p><b>Description:</b> Visual vertical &amp; horizontal cracks found on the piston ring face.</p>	
<p><b>Action code: Monitor the condition</b> Monitor the piston ring condition. If the cermet coating starts to peel-off in minor spots, action is required. Please go to <b>Id 3.1.5</b></p>

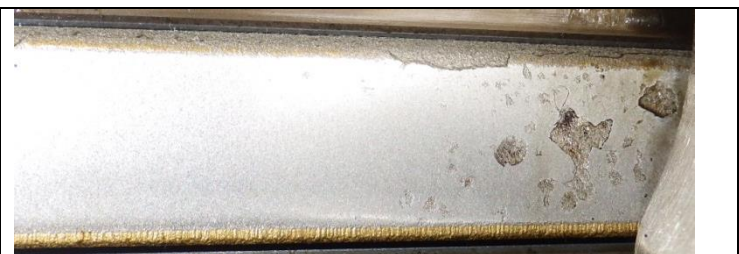
<p><b>Title: (Id: 3.1.4)</b> Cermet coating minor damage</p>

<p><b>Description:</b> Minor peeling-off</p>	
<p><b>Action code: Monitor the condition</b> No action is required</p>

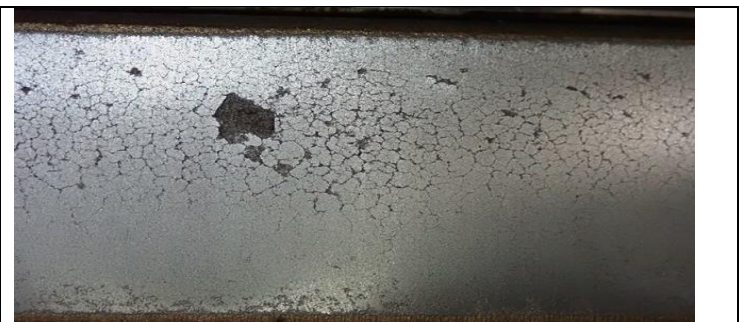
<p><b>Title: (Id: 3.1.5)</b> Cermet coating peeling off in spots</p>

<p><b>Description:</b> The cermet coating is peeling off, in minor pieces. Vertical and horizontal cracks are found on the remaining piston ring surface.</p>	
<p><b>Action code: At first Opportunity</b> - Increase the lubrication to a minimum of 1.2g/kWh - Replace the piston ring at first opportunity.</p>

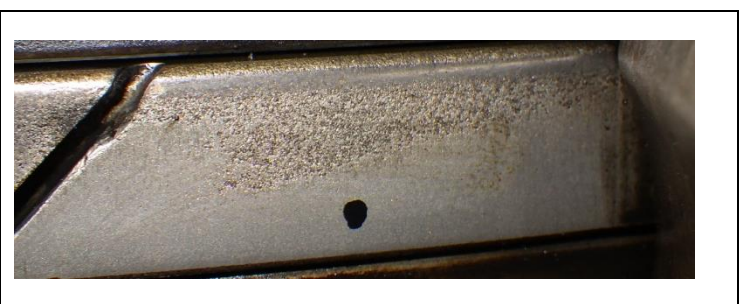
<p><b>Title: (Id: 3.1.6)</b> Cermet coating is almost worn off</p>

<p><b>Description:</b> On the top part of the piston ring, it is seen that the cermet coating is close to be worn off.</p>	
<p><b>Action code: At first opportunity</b> Overhaul and replace the piston rings in order to ensure cermet coating on the entire ring circumference</p>

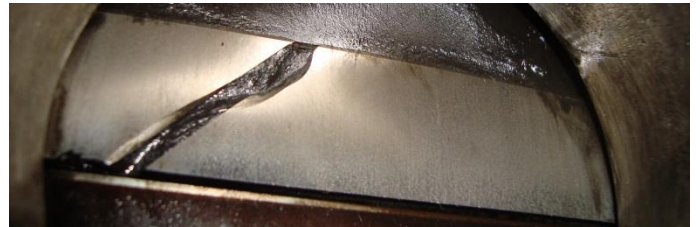
<p><b>Title: (Id 3.1.8)</b> Cermet coating peeling off at CL-Groove</p>
<p><b>Description:</b> Cermet Coating peeling-off at the CL groove</p>
<p><b>Action code: No action</b> No action is required</p>

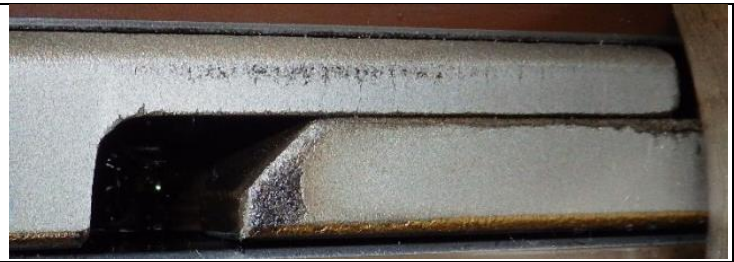
<p><b>Title: (Id 3.1.9)</b> Cermet coating peeling off at the lock (Minor)</p>
<p><b>Description:</b> Cermet Coating peeling-off at the finger lock</p>
<p><b>Action code: No action</b> No action is required</p>

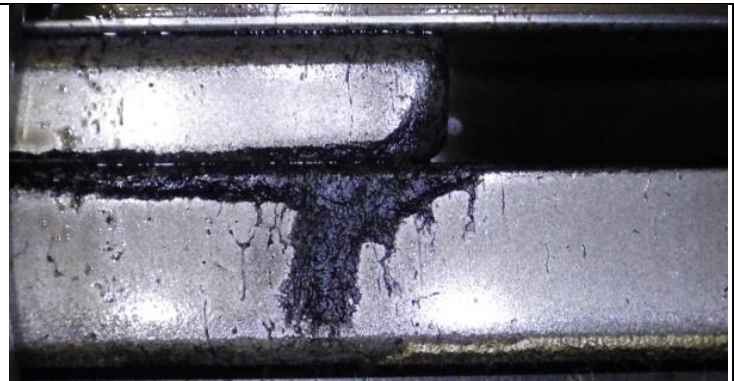
<p><b>Title: (Id 3.1.10)</b> Cermet peeling off at lock area</p>
<p><b>Description:</b> Cermet coating is peeling off on the lower finger lock</p>
<p><b>Action code: Monitor the condition</b></p> <ul style="list-style-type: none"> <li>- If the peeling off goes through the piston ring, actions is needed. <i>Please see ID 3.1.11</i></li> </ul>

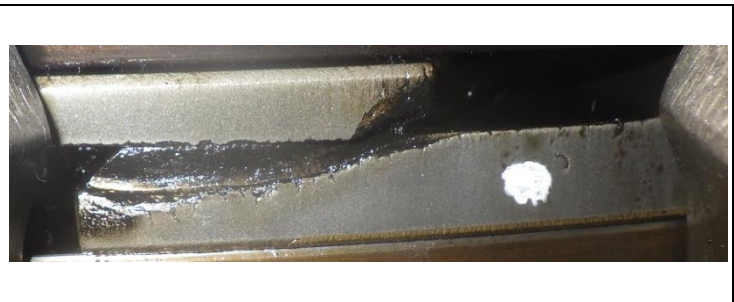
<p><b>Title: (Id 3.1.11)</b> Cermet coating peeling off at lock area</p>
<p><b>Description:</b> Cermet coating is peeling off the finger lock puncturing the piston ring lock</p>
<p><b>Action code: Monitor the condition</b></p> <ul style="list-style-type: none"> <li>- If deposit is building up on the ring land as a consequence of the punctured piston ring, replacement of the piston ring is recommended.</li> </ul>
