Service Letter

SL05-460/NHN  
November 2005

**Crosshead Bearing Condition**

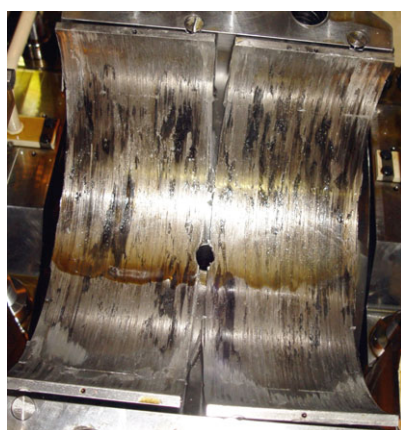
*Bearing metal worn out, steel-steel contact*

As described in earlier service letters (SL87-219, SL90-272 and SL90-273), AlSn40-based crosshead bearings must urgently be replaced as soon as possible if an open-up inspection shows more than 5% of the nickel layer exposed. If one bearing unit has more than 5% of the Ni-layer exposed, it is very likely that all the other units suffer from a similar extraordinary wear, and they should therefore be replaced as well.

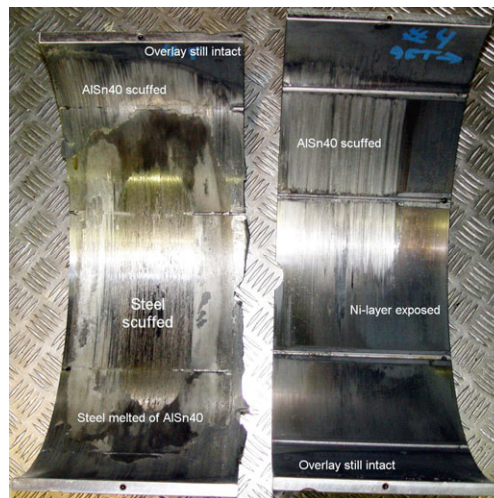
Overlay completely corroded away, partly scuffing between Ni-layer and pin, partly steel-to-steel contact. **Not acceptable.**

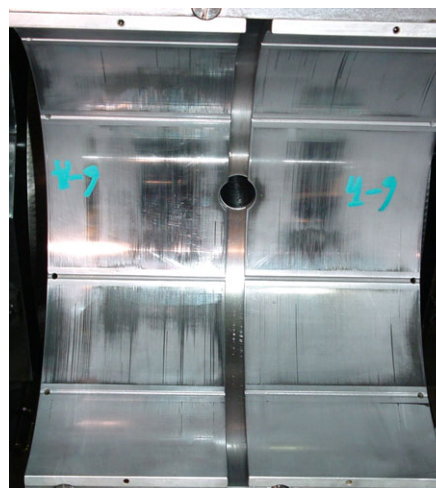
Fully intact overlayer. **Acceptable!**

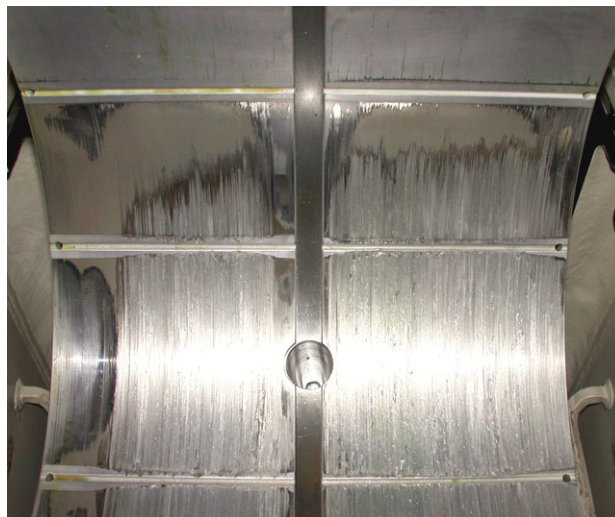
Almost completely corroded-off  
overlayer, severe scuffing  
between Ni-layer,  
AlSn40 lining and XH-pin.

**Not** acceptable.

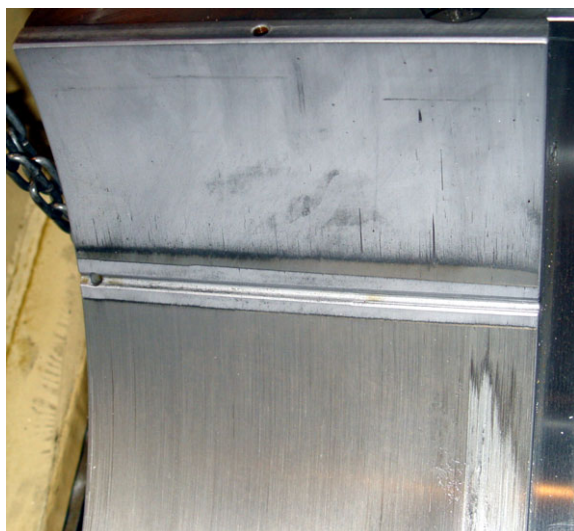
Upper pad: intact overlayer.  
Lower pad: 100% exposed Ni.

**Not** acceptable
