Spark Erosion Update

August 2008
SL08-498/AAB

Owners and operators of all MAN B&W two-stroke marine diesel engines.

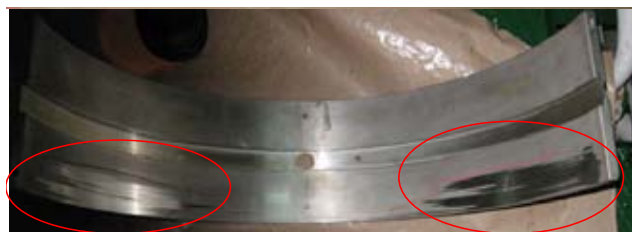
Upper main bearing shell

This is a journal, main bearings and thrust collar with clear signs of spark erosion. Spark erosion signs are obvious, even in the upper main bearing shell.

The bearing damage is irreparable: This bearing cannot be re-used, it has to be replaced.

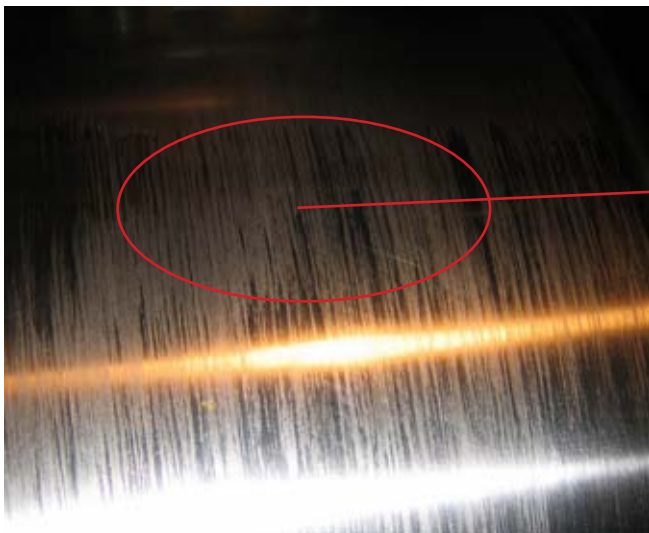
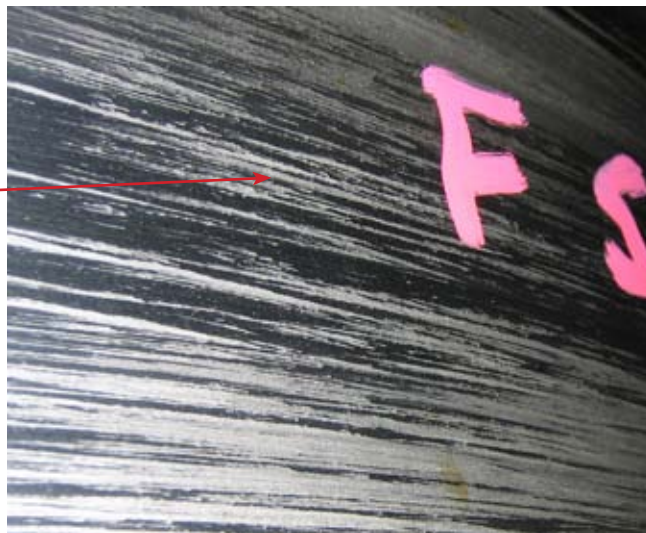
Main bearing journal with signs of severe spark erosion. The condition was not discovered in time, so this main bearing cannot be saved; it has to be replaced. The journal can be used, but has to be polished to meet surface roughness specifications.

The consequences of undiscovered spark erosion are shown below. The best protection against severe spark erosion incidents like this, is to use a correctly installed and well-maintained shaftline earthing device.

This journal MUST be polished to meet surface roughness specifications

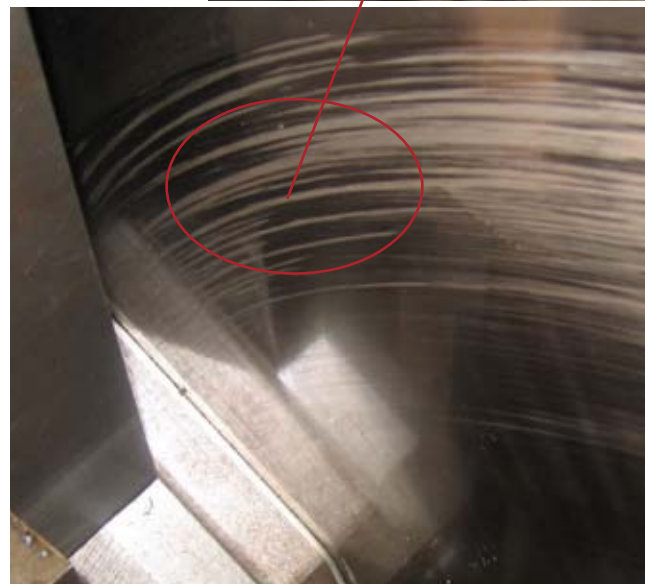
This is a thrust collar face with clear signs of spark erosion. Spark erosion may not be visible on the entire surface.

The greyish stripes on this thrust collar face indicate spark erosion

When inspecting the thrust collar surface or the main bearing journal, remember:
Slowly turn the engine 360°/1 revolution, and inspect the entire surface very carefully.

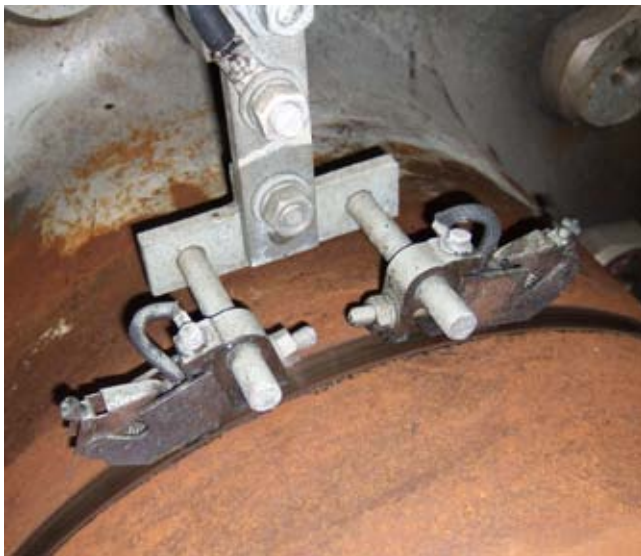
No seperate slip ring installed

2-year-old vessel, incorrect installation.

Here, the carbon brushes run directly on the propeller shaft, and so electrical contact between brushes and shaft is reduced.

- Install a silver covered slip ring between the brushes and the shaft to ensure sufficient electrical contact
- Replace the slip ring before the silver layer is worn through.
- Inspect brushes regularly, and re-adjust brushes when necessary.

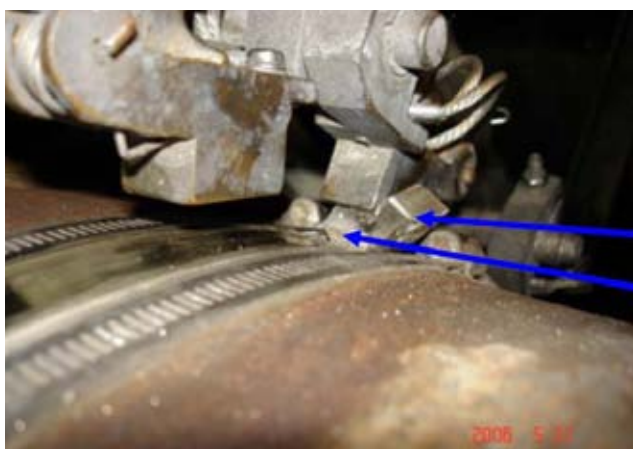
Poorly adjusted brushes

This picture shows a set of incorrectly adjusted brushes. The brushes have slipped out, and so the distance between brushes and slip ring is too long.

- Inspect the brushes if the voltmeter reads more than 50 mV.
- Re-adjust the brushes if they have insufficient contact with the slip ring.

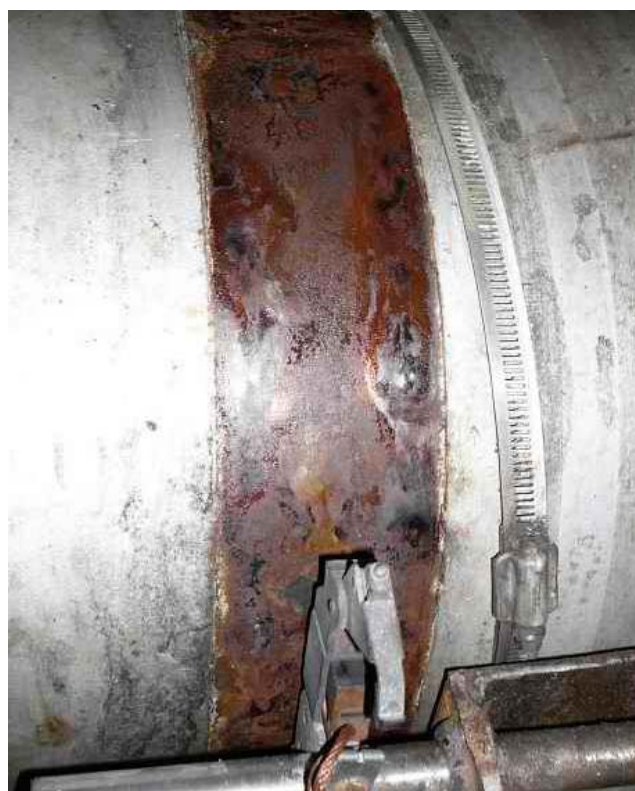
Corrosion hiding behind the slip ring

Here, the voltmeter readings were ok, so the shaftline earthing device appeared to be in an acceptable condition.

However: High electrical resistance was measured between the slip ring and the shaft, indicating insufficient electrical contact between slip ring and shaft. Removing the slip ring revealed heavy corrosion on the shaft and on the back side of the slip ring.

ALWAYS polish the propeller shaft carefully and apply rust protection (e.g. **Dinitrol 300**) between the Ag band and the shaft when assembling and overhauling.
