Correct installation of lubricating oil supply valve for the Alpha Lubricator

Non-flow cylinder oil alarm

SL2022-731/TOV

Incorrect installation of the main line lubricating oil supply valve can block the cylinder oil supply to the Alpha lubricator and the running main engine without sounding the alarm “Non-flow cylinder oil”.

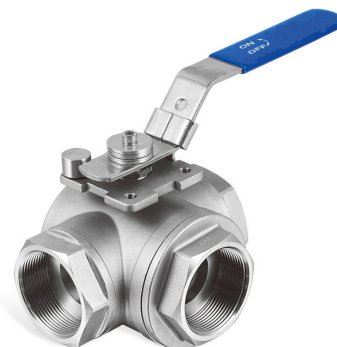
In the reported scuffing cases, the main line lubricating oil supply valve was closed but without connecting the cylinder oil lubricator system to the venting line, see Fig. 1. Unfortunately, this valve position will not activate the “Non-flow cylinder oil” alarm due to the missing venting. If the engine is operated in this state, it will undoubtedly damage combustion chamber components.

the cylinder oil lubricator system has not been performed. Operating the engine in this state will undoubtedly damage combustion chamber components.

For this reason, we find it necessary to emphasise the need for proper action according to the instruction manual, plate No. 3055-0110-0004, and common good workmanship in general.

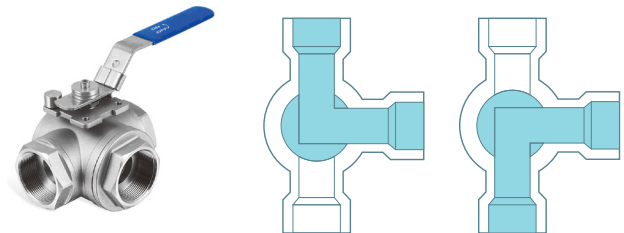
Fig. 2: Three-way valve with two locked positions secured by an end-stop

IMPORTANT: It is very important that the three-way valve (main line lubricating oil supply valve) has only two locked positions secured by an end-stop, see Fig. 2.

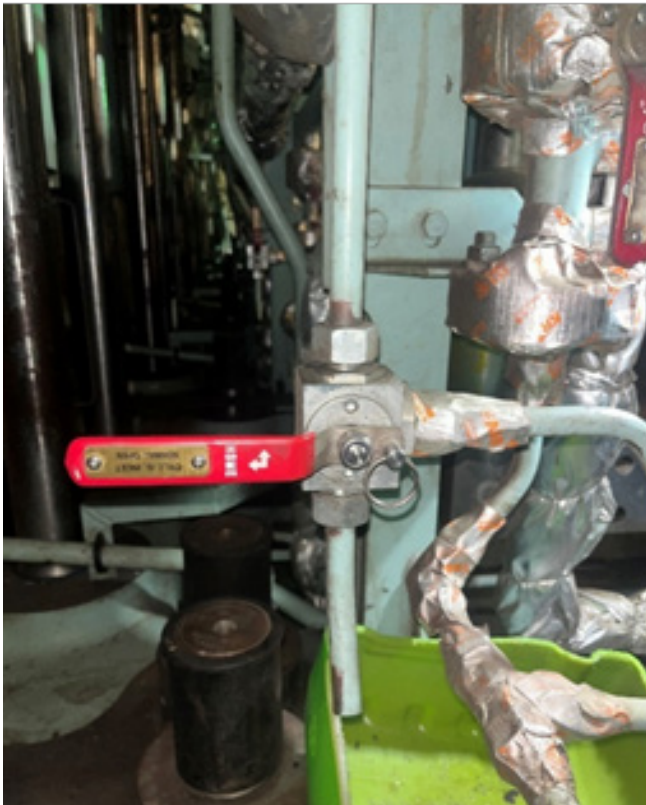
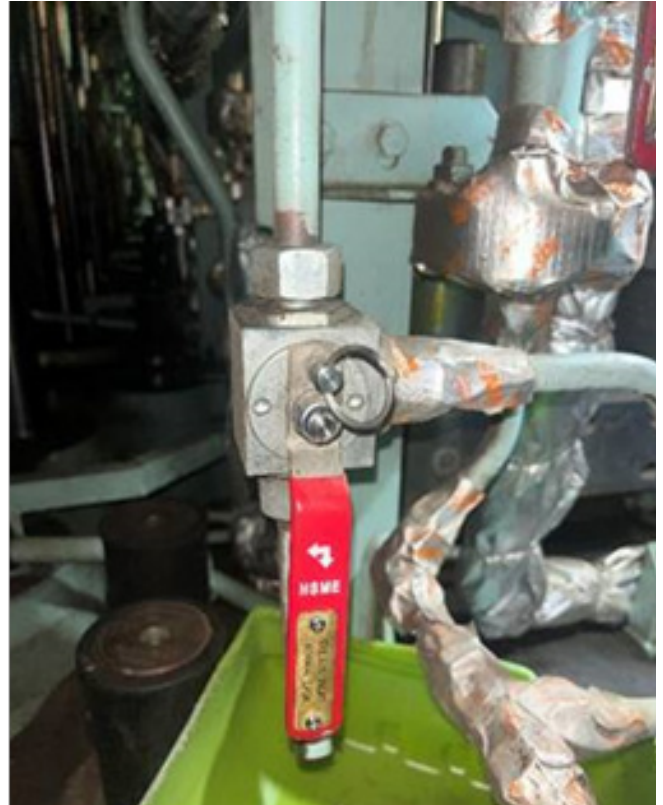
Fig. 3: Three-way valves **without** end-stops in an **incorrect** closed position, the necessary connection to the venting line has not been established

Unfortunately, this **incorrect** valve position will **NOT** activate the “Non-flow cylinder oil” alarm since venting of

Fig. 3 shows three-way valves **without** end-stops in an **incorrect** closed position where the connection to the venting line has not been established. It means that there is no cylinder oil supply to the Alpha lubricator, but the “Non-flow cylinder oil” alarm is **NOT** activated.
