Making waves IVSS CAMPAIGN APR 2025

Table of Contents

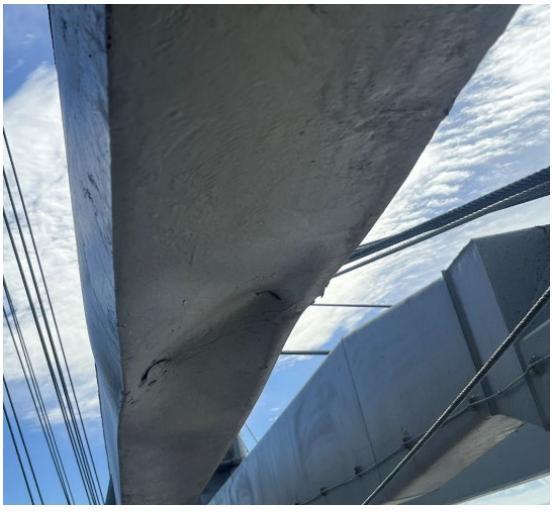
On one of our vessels, the indentation damage to crane no.4 jib was reported to office by THE Superintendent on 7th Feb 25 during his visit to vessel in Port. The ship staff was unaware of the indentation. There was no report from the ship about the indentation on the jib.

- 1. The cranes are normally parked/unparked by Bosun when bypass key is used. There is one more person on deck for removing/putting the lashing wire on the hook.
- 2. Stevedores also operate cranes on bypass mode for picking up the Forklift/Bulldozer. The duty person takes the key with him to crane cabin and stays there until bypass function is completed. There is no other deck person on deck near the crane when crane is operated on bypass mode.
- 3. The contact damage occurred during luffing operation, with lower limit bypassed. The damage / indentation is on the bottom of the jib and occurred when No. 4 crane jib, came in contact with top side of No. 3 crane parking post on No. 4 Crane platform. This damage cannot occur during parking of No. 4 crane or during its slewing operation.

The crane was repaired as per the maker's repair plan and to the satisfaction of Class incurring huge cost and off hire of vessel.

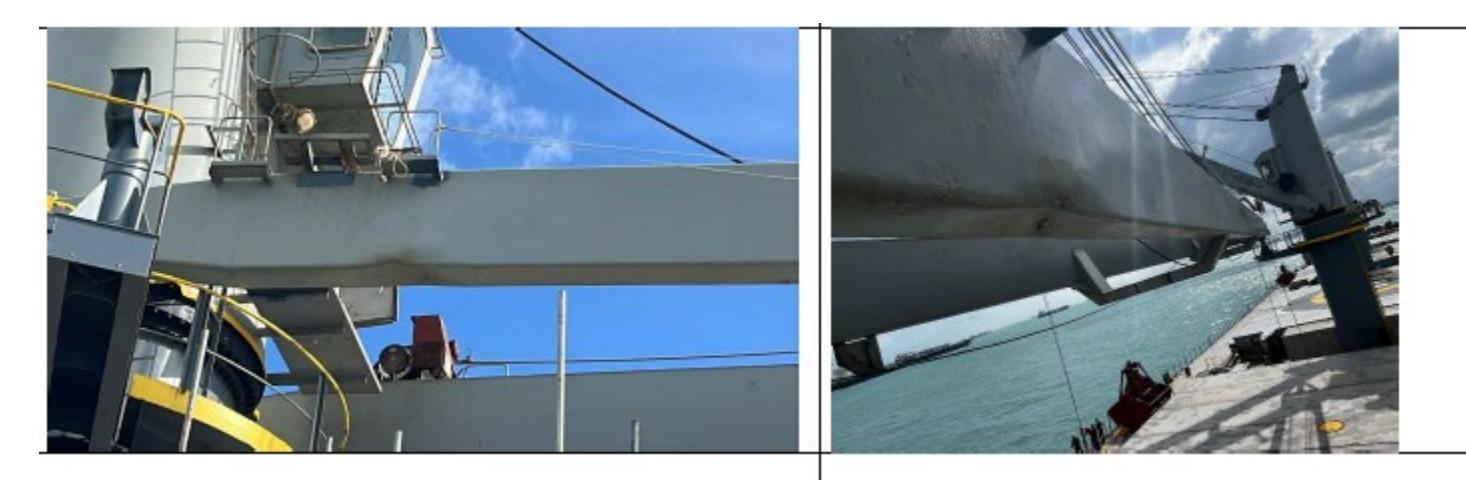
- 4. Contact point of damage "No. 3 crane jib parking post "is not visible from No. 4 crane cabin, is in a blind spot.
- 5. Possible reason for contact damage

b) Contact during lowering of No. 4 crane jib on starboard side, for maintenance/ repairs on grab fittings and accessories, fitted on crane jib. As per CO, he suspects that jib damage occurred when jib was lowered to repair guide wire of no. 4 grab Tamatave, using the No. 4 crane stowage platform for repair. However, as per C/E, the repairs on No. 4 Grab were carried out in Tamatave with crane jib in mid-ship position. No photos or evidence was available. The ETO involved in the grab repairs in Tamatave, had already signed off the vessel.

- 1. Crane not to be operated on bypass mode without informing the deck duty officer except when housing the crane.
- 2. Shore crane driver and shore signal person is to be made aware of the possible contact damage to crane jib with the crane housing when stevedore requires crane to operate at bypass mode for lowering the jib to pick up bulldozer/forklift etc.

- 4. One deck personal present on deck for overseeing the operation of the crane, when bypass mode is used.
- 5. Cranes are inspected using checklist Form 2.3.7 during pre-arrival checks. Refer item 1.7 in the checklist. Any damage to crane is to be immediately reported to office.

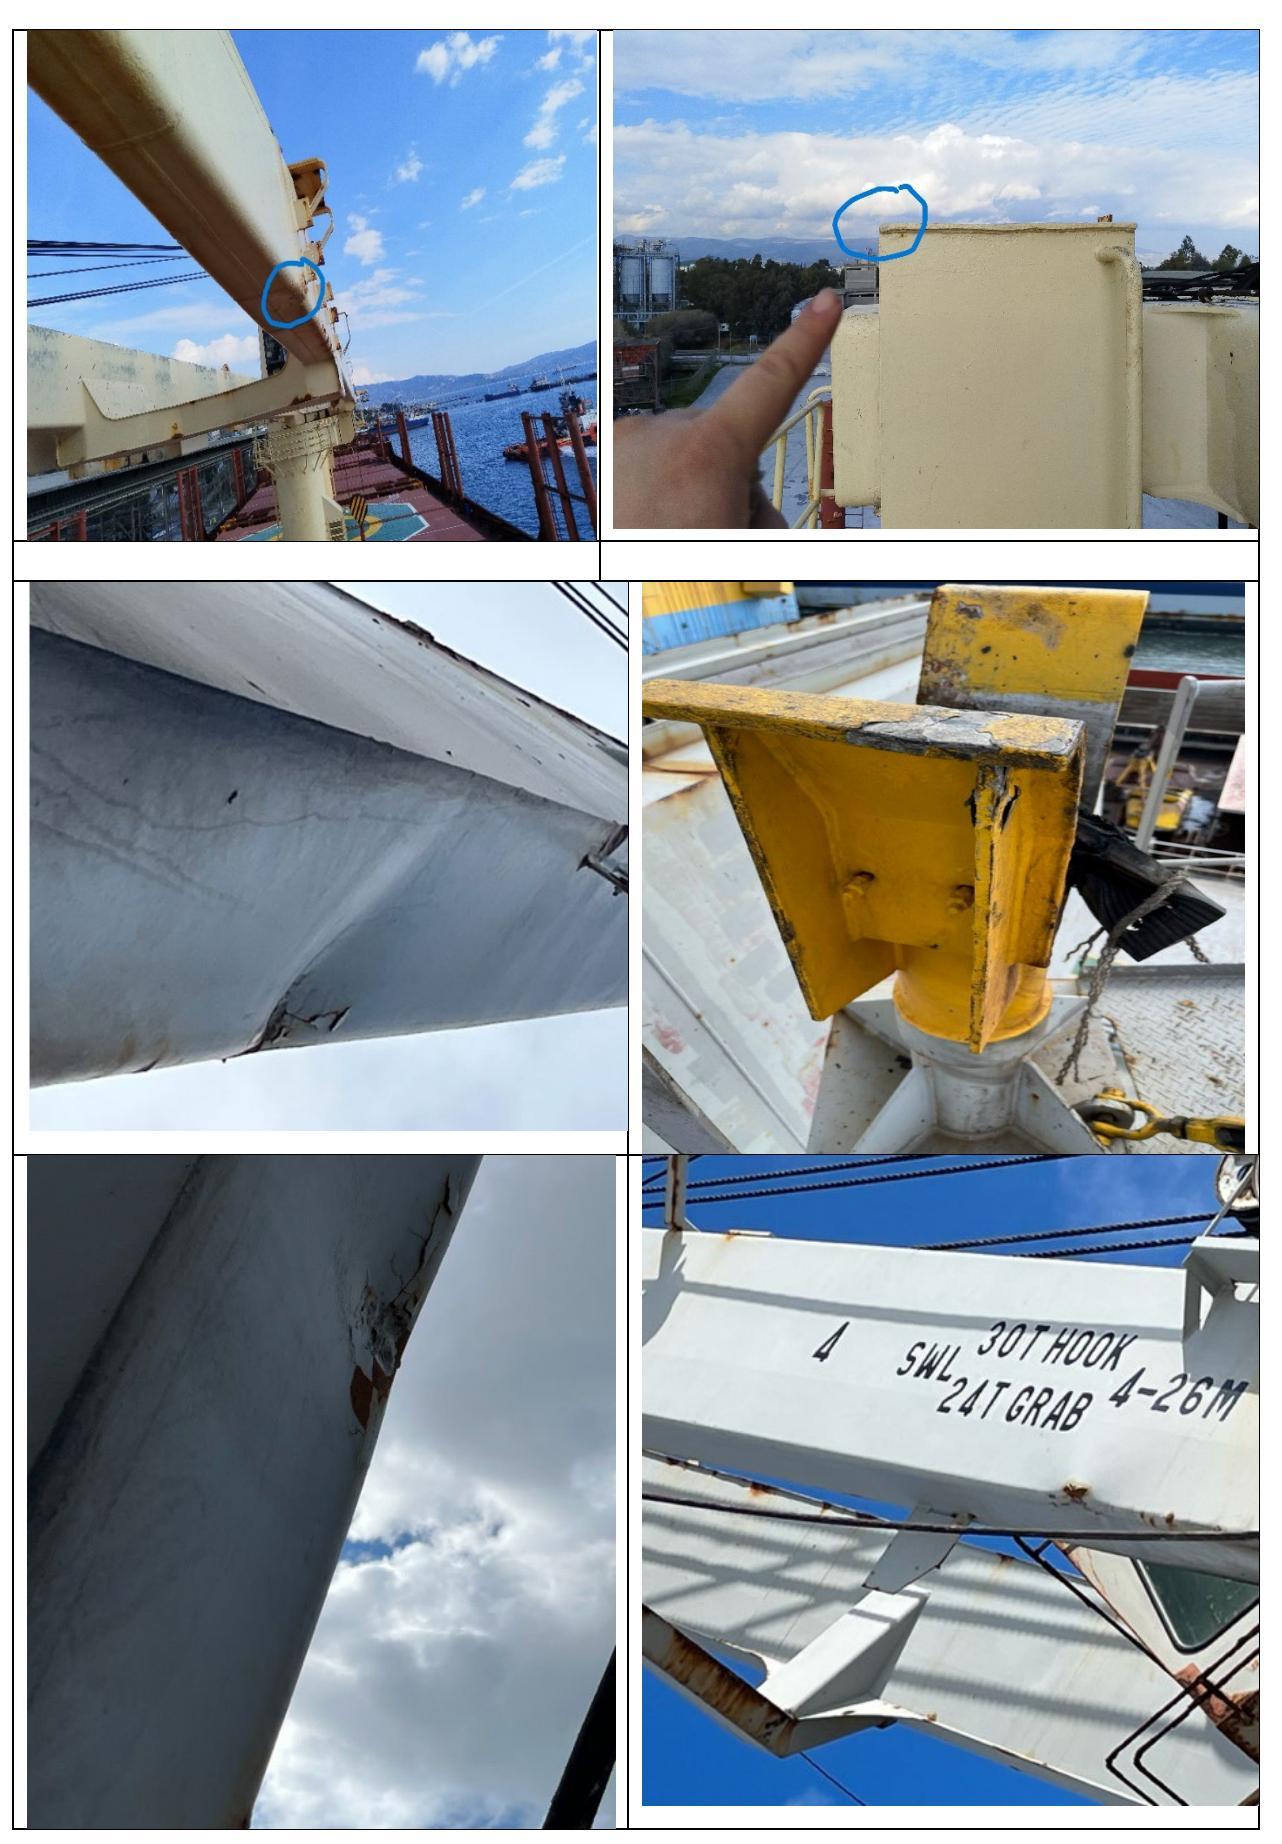
Similar crane jib indentation in fleet vessels ship staff failed to notice and found during office staff ship visit:
