## Company Circular no. 02 - 2026

### MONTHLY SAFETY CAMPAIGNS - FEB 2026

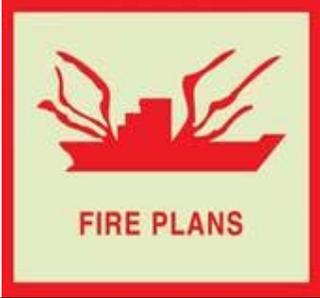
| Code | Description |
|---|--|
| 07122 | <p><b>Fire control plan stored in the weathertight enclosure outside the deckhouse without prominently standard IMO mark posted.</b></p> <p><b>Comments:</b></p> <ul style="list-style-type: none"> <li>The IMO symbol for the fire plan was already posted near the weathertight enclosure on the port and stbd side. The PSC inspector insisted that each IMO symbol shall also have an IMO logo printed on the bottom.</li> <li>Company consulted CLASSNK who confirmed that it is not a mandatory requirement to have IMO logo printed at the bottom of the symbol.</li> </ul> |

| <p>IMO SYMBOL as per fire plan</p> | <p>SYMBOL as required by MSC/Circ. 451</p> |

- Ensure both symbols IMO and symbol required by MSC/Circular.451 showing fire on ship are posted near the fire plan enclosure on both side of the accommodation.

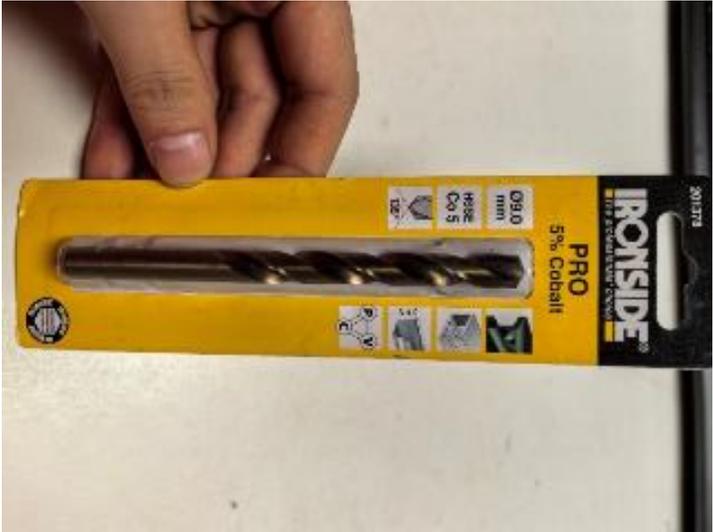
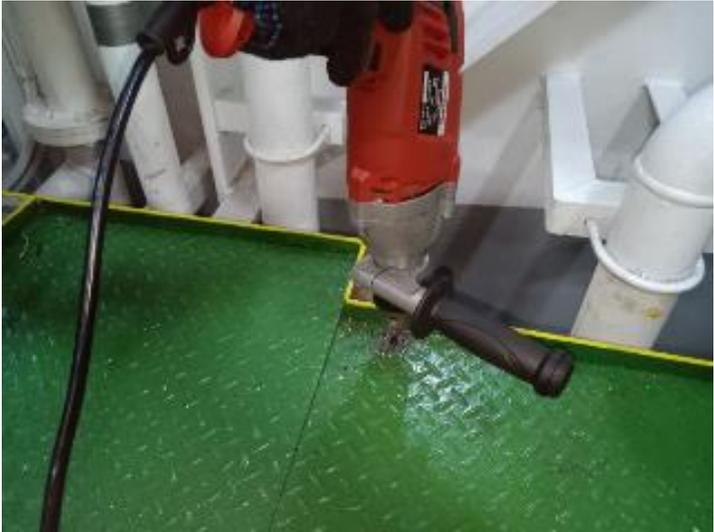
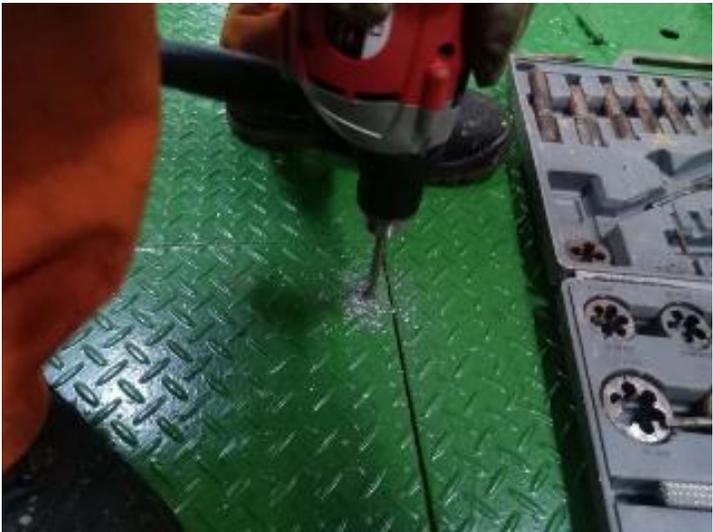
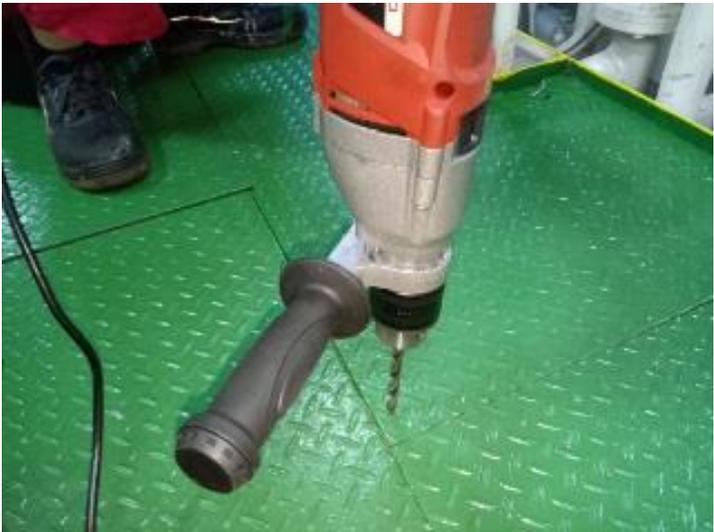
| Code | Description |
|---|--|
| | <p><b>DEFICIENCY</b> - Floor Plates in Engine room not secured or properly fastened. As per PSCO requirement, the floor plates in ER should be secured on the frame to avoid shifting in case of ship rolling &amp; pitching at sea / listing / flooding.</p> <p><b>Company comments:</b><br/>It was observed that many vessels were delivered from the shipyard and the floor plates were not secured.</p> <p><b>Root cause:</b></p> <ul style="list-style-type: none"><li>• <b>Inadequate design</b></li><li>• <b>Lack of situational awareness</b></li><li>• <b>Inadequate identification of hazards</b></li></ul> <p><b>Preventive Actions:</b><br/>The Engine room floor plates should be secured on the frame to avoid injury to the crew .<br/>The floor plates may shift due to<br/>a) heavy rolling and pitching at sea<br/>b) listing of ship during cargo operations in port<br/>c) flooding of engine room (water sloshing the bilge area due to rolling creating a hydraulic hammer and forcing the deck plates upwards)</p> <p>Floor plates to be secured as per attached guidelines where the details of tools and brass countersunk screws to be used for securing, are provided.</p> <p>Floor plates with hinge or the sections of floor plates that need to be removed for valve operation below the floor plate should not be secured permanently by screws.</p> <p>The valve number should be stencilled on the top of these plates for easy identification of the valve underneath the plate.</p> <p>Requisition for necessary tools and screws to be raised , if not on board . The PO raised shall be informed to the Ship Manager .</p> <p>The Chief Engineer to confirm present condition and send pictures of the floor plates to the Ship Manager using picture submission form.</p> <p><b>Target date for compliance: 30th July 2024</b></p> |

At delivery from shipyard, the floor plates are not secured.

# Drill holes in the plates and supporting frames with straight twist drill (Drill $\Phi$ : 9mm)

Drill through the plate and the frame bar.

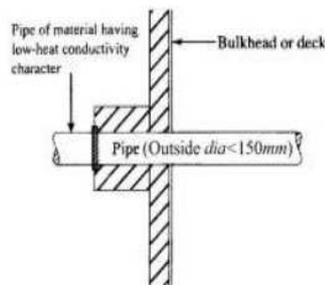
Fig. 2.1.3-2

2 Notwithstanding 1 above, for a penetration of a pipe made of material having low-heat conductivity character (e.g. a metallic pipe) and an outside diameter of less than 150 mm in a "B" class division, the insulation may be terminated at the end of penetration piece or sleeve as required. (See Fig. 2.1.3-2)
